Town of Paradise

ADA self-evaluation transition plan

June 2015

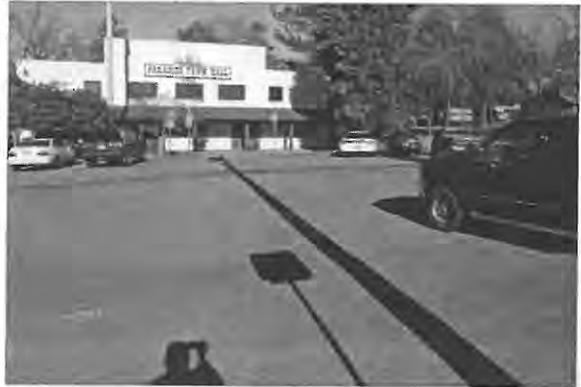
Finding: The Paradise Town Hall facility consists of a two-story main building, a single-story storage building, and a single story office building located at 5555 Skyway in Paradise. The facility was inspected by Disability Access Consultants, Inc., on January 15, 2002. It is noted that there have been permits issued for construction or renovation in this facility after January 26, 1992.

Full Rec: Any renovation or new construction that occurred after January 26, 1992, is subject to meet full code specifications for the California Building Code and ADAAG guidelines. All recommendations in this report that specify relocating Programs, Services or Activities, or make other allowances which avoid physical barrier removal as an alternative minimum compliance will have no effect or bearing on the non-compliant elements of newly constructed or renovated facilities. Consult with your Architect to determine which elements are affected by this requirement. It is recommended that Disability Access Consultants, Inc. is consulted for inspection of any new construction or renovation at the facility.

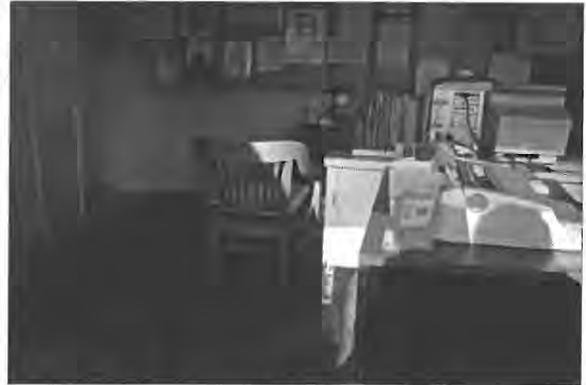
Finding: At the time of facility inspection, the Community Action Agency was locked and unavailable for a complete ADA compliance inspection.

Full Rec: Due to the unavailability of a specific element at the time of the facility inspection process, it is recommended that at a further date all elements should be inspected for ADA compliance.

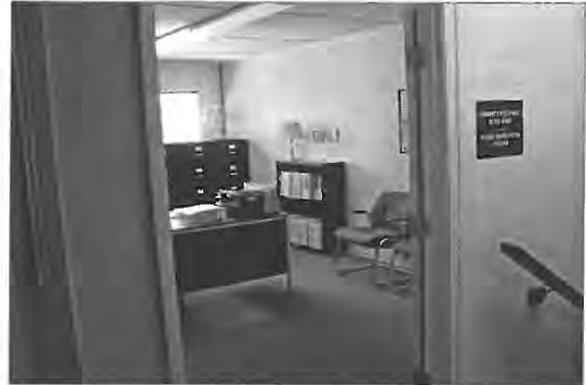
Accessible Path of Travel to the Upper Floor, Main Building

Citations: ADAAG 4.33.5; ADAAG 4.1.3(21); ADAAG 4.35.1

Full Rec: Since programs, services and activities to staff and the public are provided in this location, those programs, services and activities are required to be made accessible. It is recommended that an elevator be installed or other means of vertical access.

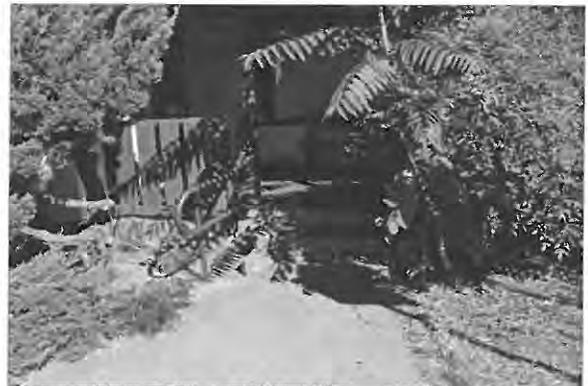
Path of Travel to Help 4 People/Community Action Agency

Citations: ADAAG 4.33.5; ADAAG 4.1.3(21); ADAAG 4.35.1

Full Rec: Since programs, services and activities to staff and the public are provided in this location, those programs, services and activities are required to be made accessible. It is recommended that a ramp be installed or other means of vertical access.

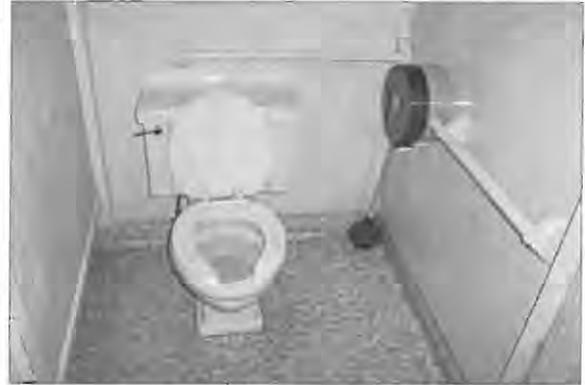
Men's Restroom Next to the Administrative Offices

Citations: CBC 1115B.8.1; ADAAG 4.26

Alternative No action is required at this time regarding the
Rec: replacement of grab bars in the stall designated to be
(Where accessible in the restroom, unless major renovation
Available) occurs in the area.

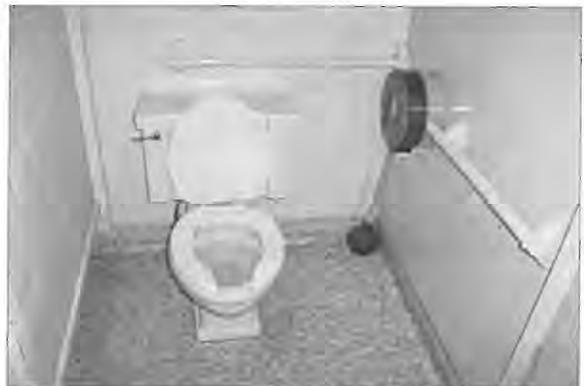
Men's Restroom Next to the Administrative Offices

Citations: CBC 1115B.8.1; ADAAG 4.26

Alternative No action is required at this time regarding the
Rec: replacement of grab bars in the stall designated to be
(Where accessible in the restroom, unless major renovation
Available) occurs in the area.

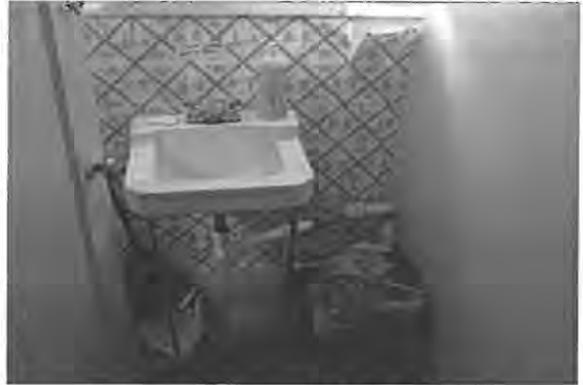
Finding: The bottom edge of the reflecting surface of the mirror in the restroom is greater than 40 inches above the finished floor.

Alternative Rec: No action is required at this time regarding the mirror in the restroom, unless major renovation occurs in the area.
(Where Available)

Full Rec: Lower the mirror in the restroom so that the bottom edge of the reflecting surface is no higher than 40 inches above the finished floor and the topmost portion of the reflecting surface extends at least 74 inches above the finished floor (see ADAAG A4.19.6). A single, full-length mirror is recommended since it can accommodate all people. Make certain to provide a minimum clear floor space in front of the mirror of 30 inches in width and 48 inches in length.

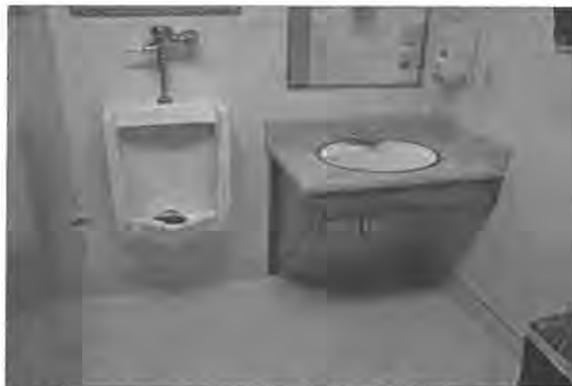
Men's Restroom Next to the Staff Lounge

Citations: ADAAG 4.18.2

Alternative Rec: No action is required at this time regarding the replacement of the urinal designated to be accessible in the restroom, unless major renovation occurs in the area.
(Where Available)

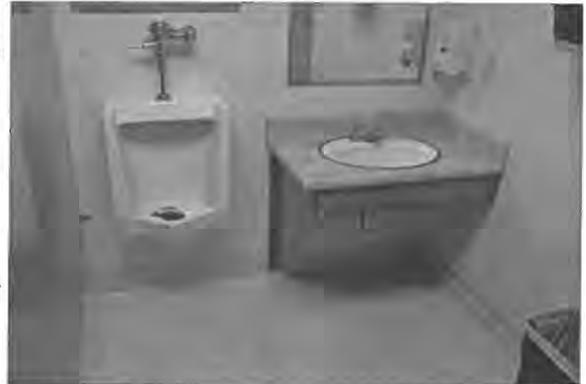
Men's Restroom Next to the Staff Lounge

Citations: ADAAG A4.19.6; CBC 1115B.9.1.2; ADAAG 4.19.6

Full Rec: Lower the mirror in the restroom so that the bottom edge of the reflecting surface is no higher than 40 inches above the finished floor and the topmost portion of the reflecting surface extends at least 74 inches above the finished floor (see ADAAG A4.19.6). A single, full-length mirror is recommended since it can accommodate all people. Make certain to provide a minimum clear floor space in front of the mirror of 30 inches in width and 48 inches in length.

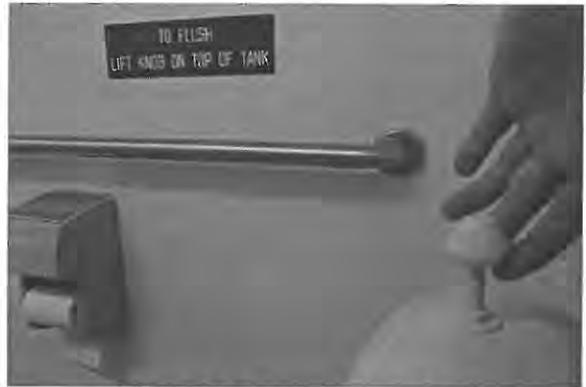
Finding: The flush control on the toilet in the restroom requires tight grasping, pinching, or twisting of the wrist and is not accessible.

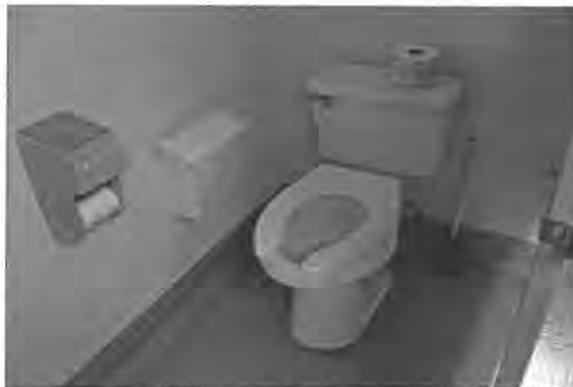
Women's Restroom in the Locker Room

Citations: CBC 1115B; ADAAG 4.17.3; ADAAG A4.17.3

Alternative Rec: No action is required at this time regarding the modification or replacement of the stall designated to be accessible in the restroom, unless major renovation occurs in the area.

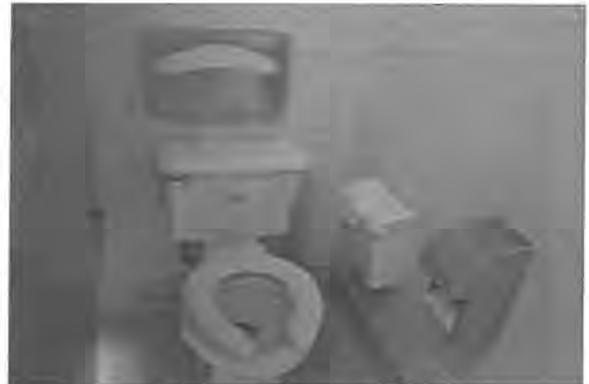
Finding: There is insufficient clear floor space in the stall designated to be accessible in the restroom.

Alternative Rec: No action is required at this time regarding the modification or replacement of the stall designated to be accessible in the restroom, unless major renovation occurs in the area.
(Where Available)
