Wetlands (CEST and EA) – Partner

8-STEP WETLANDS REVIEW

Cypress Family and Senior Housing Project

Aquatic Resources Delineation Report

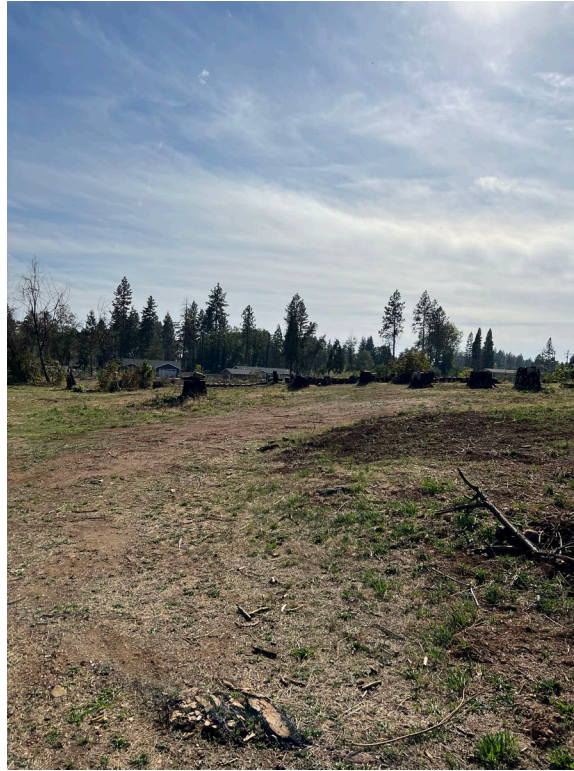
Photograph Point (PP) 1: Standing between Dry Creek and Stream Channel 1, looking south

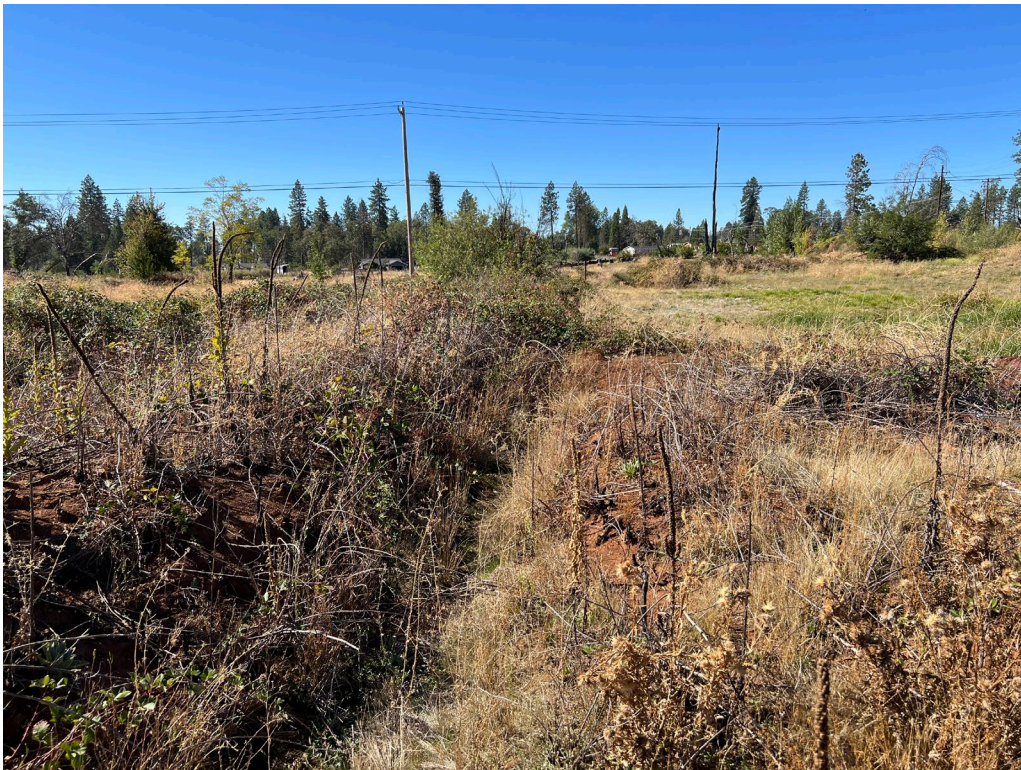
PP2: Standing in the northern portion of Stream Channel 1, looking south

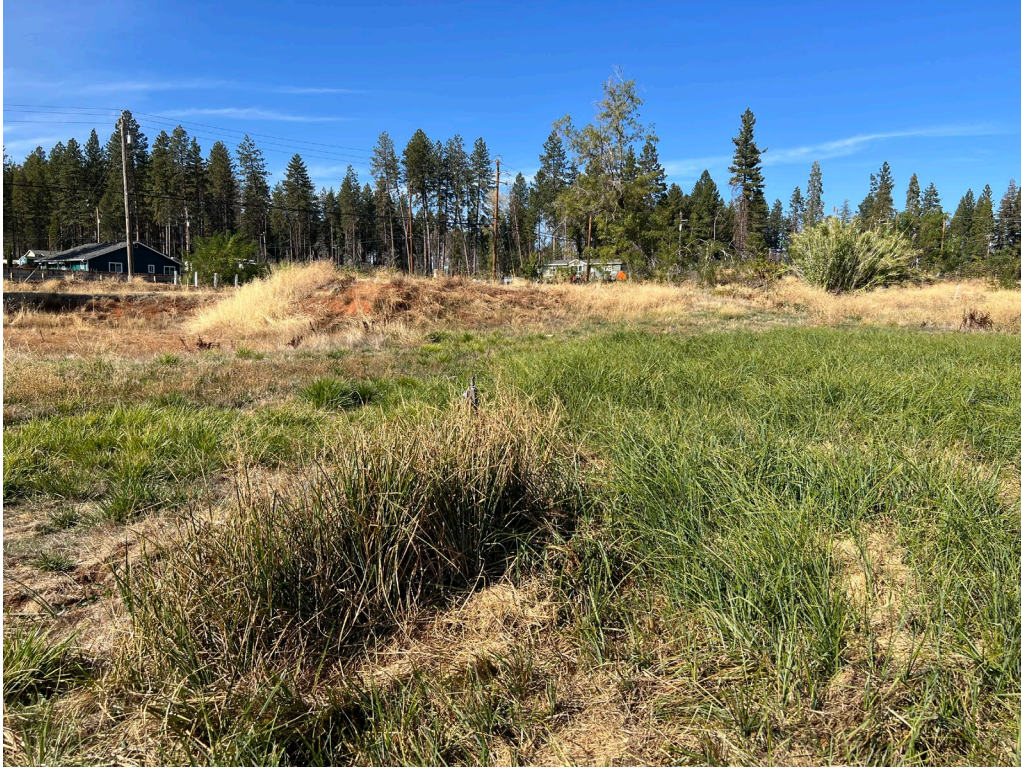
PP3: Standing in Wetland A, looking north

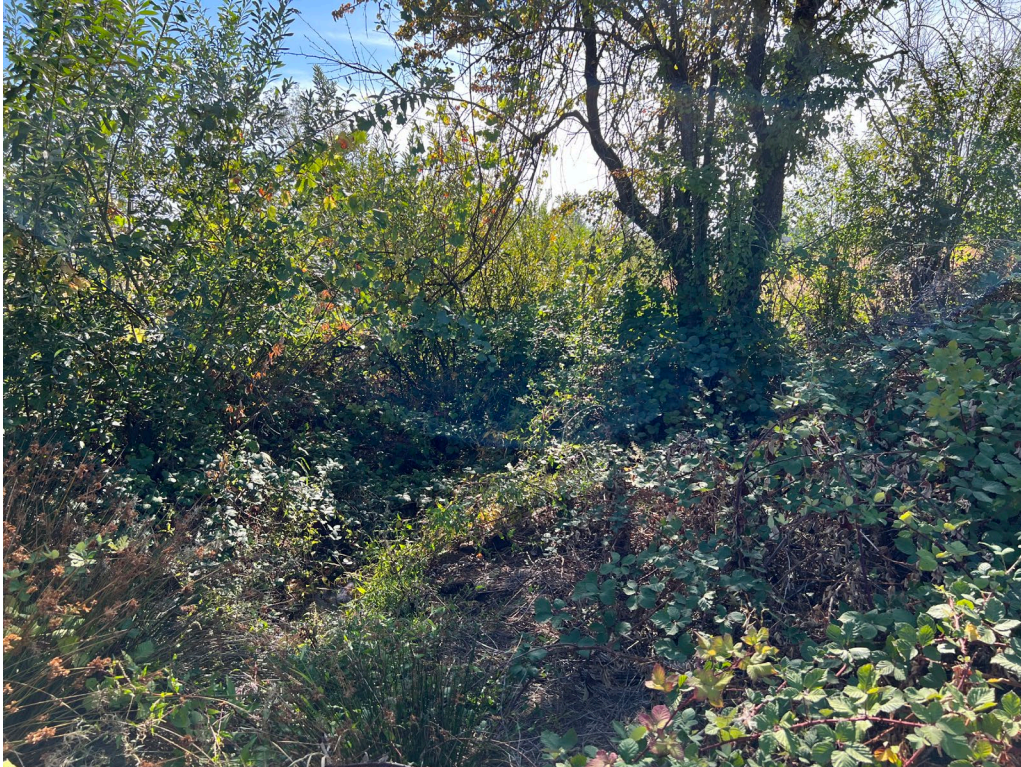
PP4: Standing in the northern portion of Dry Creek, looking west

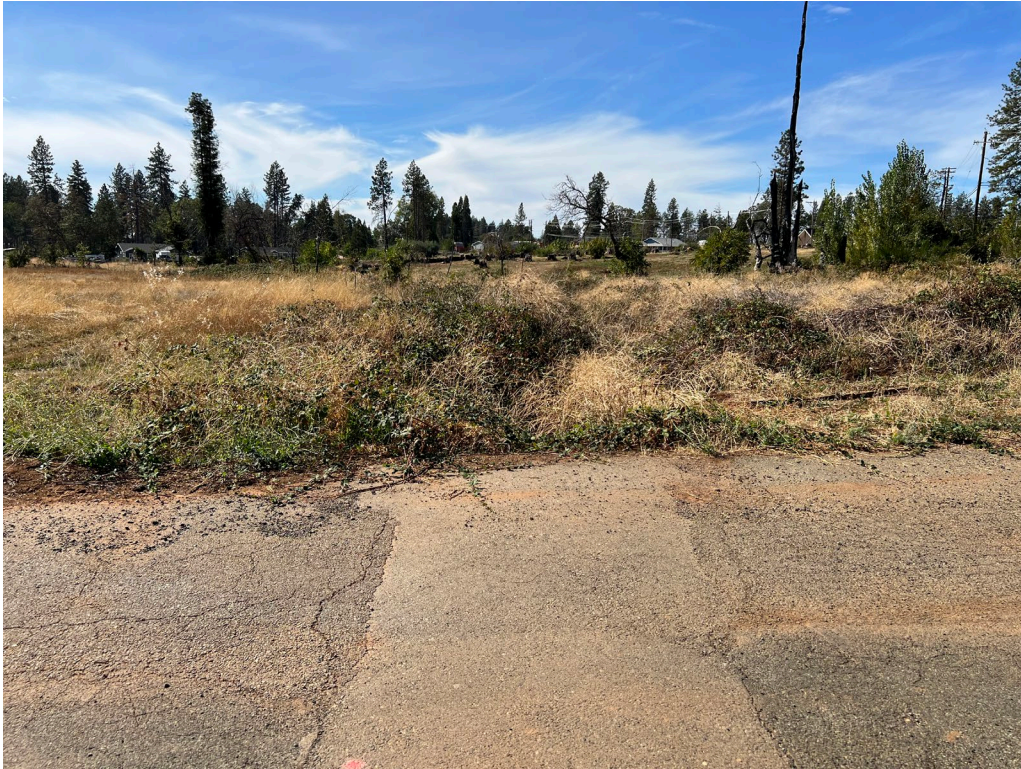
PP5: Standing over the Cypress Ln culvert of Stream Channel 1, looking southwest

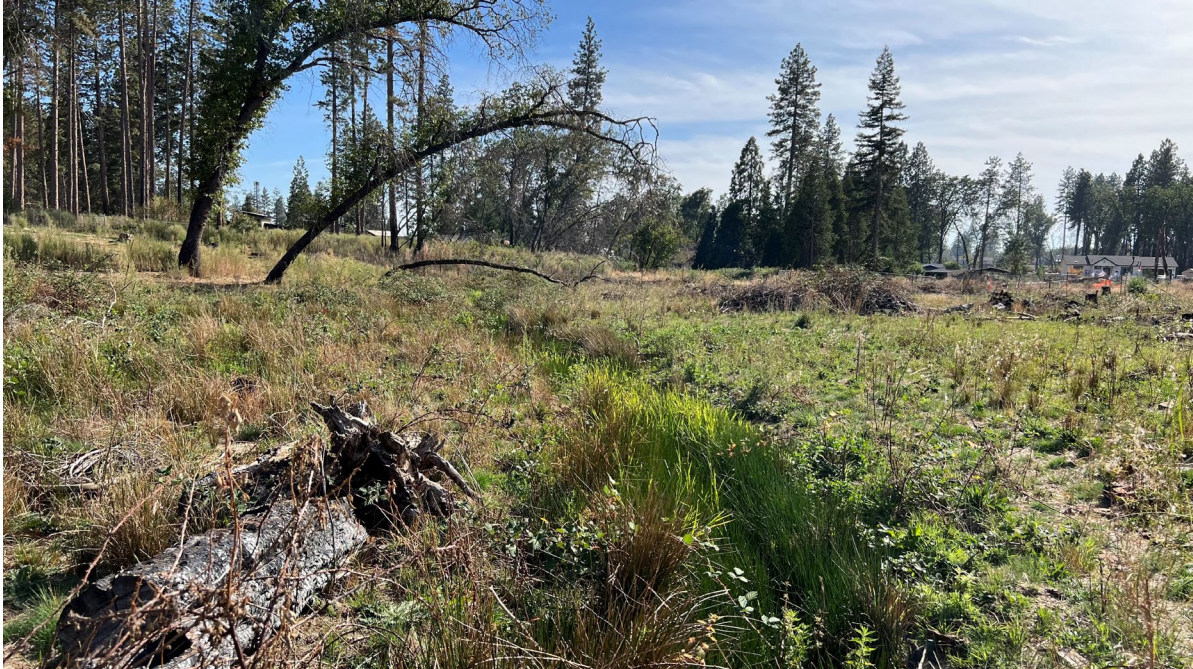
PP6: Standing northwest of Wetland C and D, looking southeast

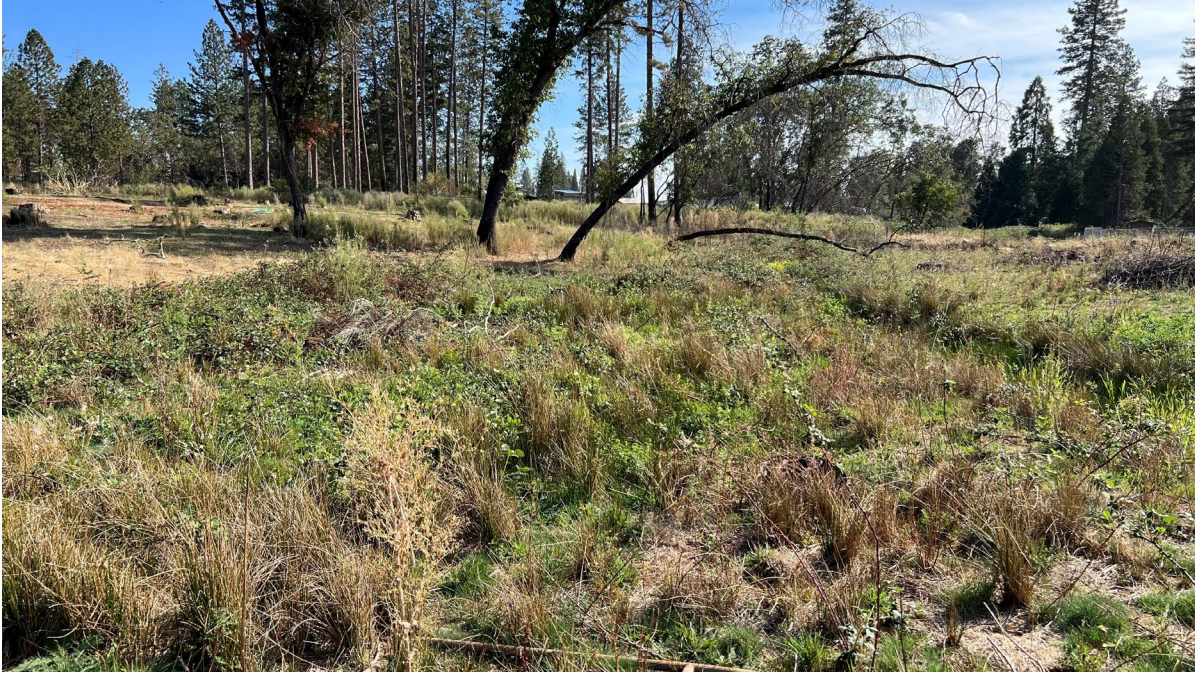
PP7: Standing in the southern portion of Wetland C, looking north

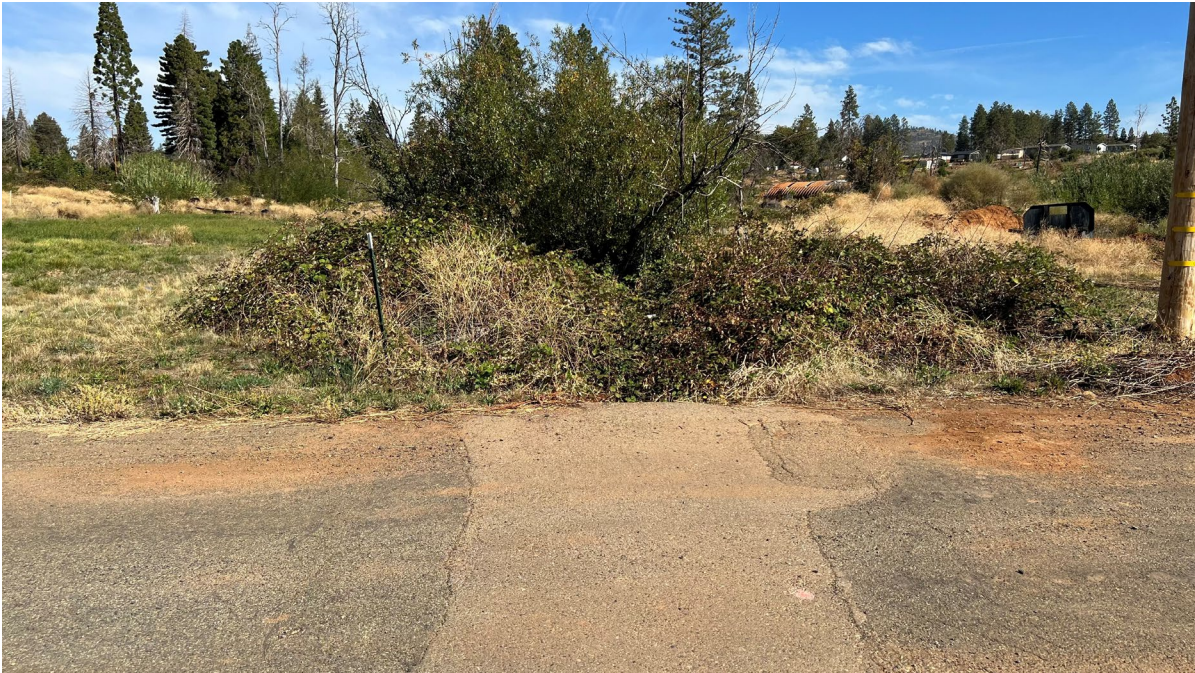
PP8: Standing over the Cypress Ln culvert of Dry Creek, looking north

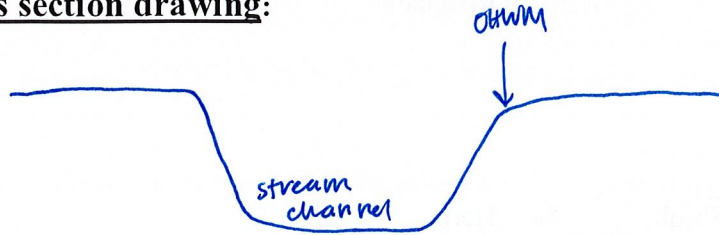
Cross section drawing:

OHWM

GPS point: OHWM1

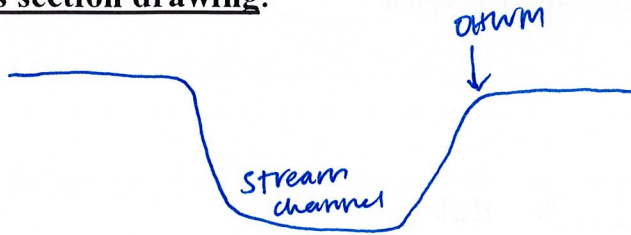
Cross section drawing:

OHWM

GPS point: OHWM 2

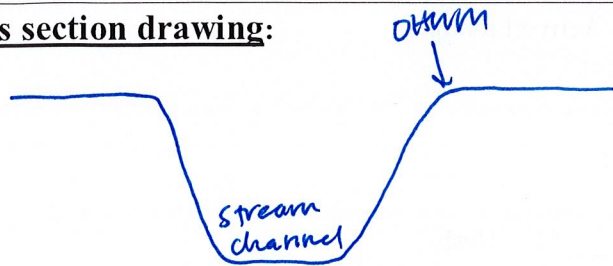
Cross section drawing:

OHWM

GPS point: OHWM3

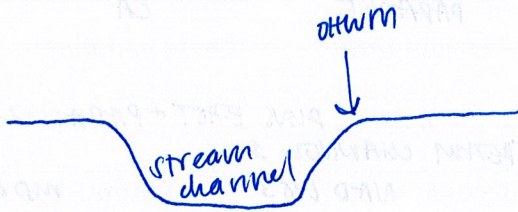
Cross section drawing:

OHWM

GPS point: OHWM 4

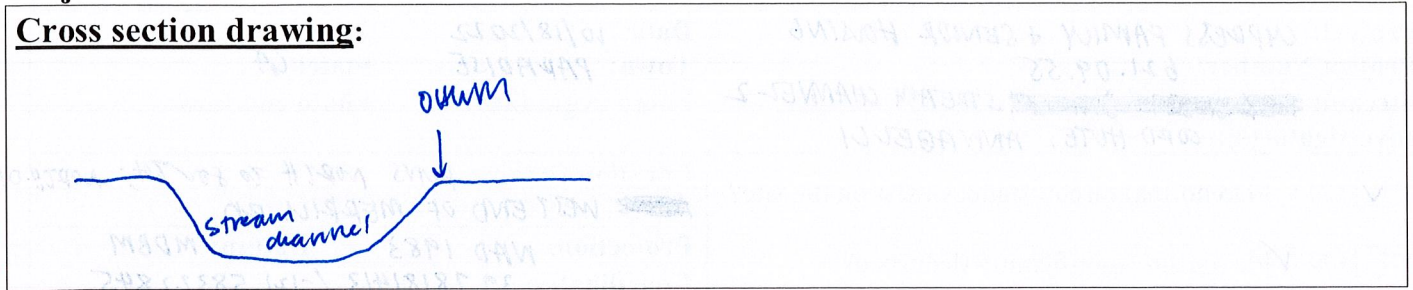
Cross section drawing:

OHWM

GPS point: OHWM5
