Town of Paradise

ADA self-evaluation transition plan

June 2015

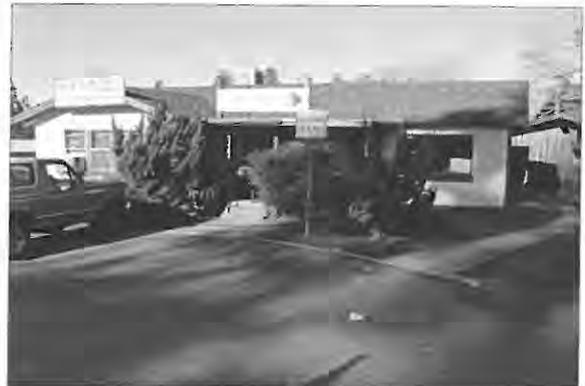
Finding: The single story office building is a lease site for the Town of Paradise and is currently leased to the Community Action Agency and the Help 4 People Program.

Full Rec: All programs, services, and activities held at facilities owned by the Town of Paradise are required to be accessible, even if they are provided by outside entities. Specify responsibility for ADA compliance in a written lease agreement between the Town of Paradise and Community Action and Help 4 People, that includes provisions for an accessible path of travel to areas where the programs, services and activities are held and to adjacent accessible restrooms.

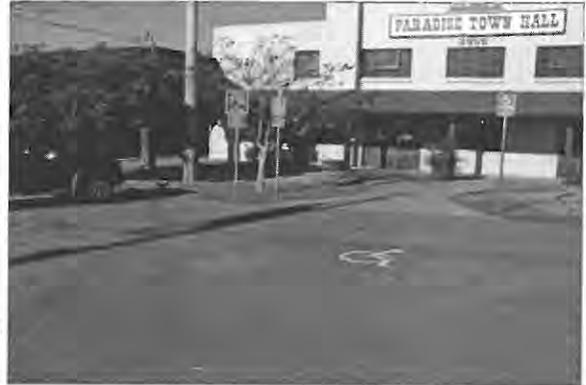
Finding: There are three accessible parking spaces designated out of 85 total parking spaces marked in the parking lot, though it does not meet the minimum number of accessible parking spaces for the parking lot. The accessible parking space across from the main entrance measures 110 inches wide and 220 inches long, with an access aisle on the right side measuring 64 inches wide. There are two accessible parking spaces southeast of the building. The accessible parking space, to the left, measures 108 inches wide and 216 inches long. The accessible parking space shares a common access aisle measuring 96 inches wide with an adjacent accessible parking space measuring 108 inches wide and 216 inches long. Accessible parking spaces are not dispersed to provide the shortest accessible route of travel to each primary entrance (Help 4 People).

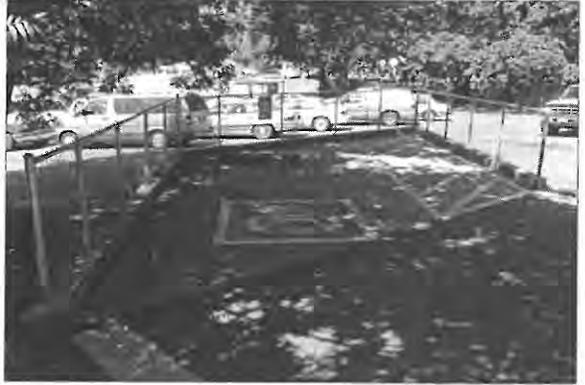
Parking Lot Southwest and Southeast of the Facility

Finding: The bottom edge of the fence-mounted signage designating accessible parking, outside of the main entrance, is less than 36 inches above the parking space finished grade and cannot be viewed when a vehicle is parked in the space.

Citations: CBC 1129B; ADAAG 4.6.4

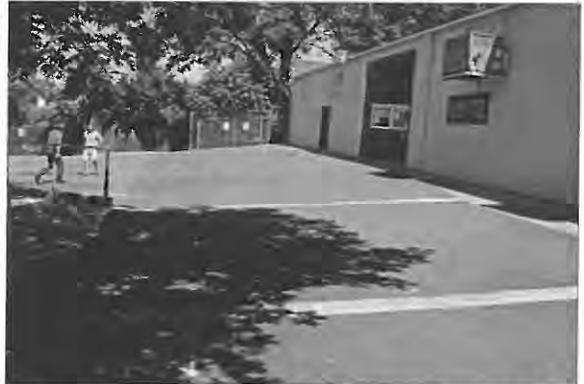
Parking Lot Southwest and Southeast of the Facility

Finding: There is no crosswalk provided on the path of travel from the accessible parking space, outside of the main entrance to the facility. The required accessible route crosses a vehicular way.

Citations: ADAAG 4.7.9

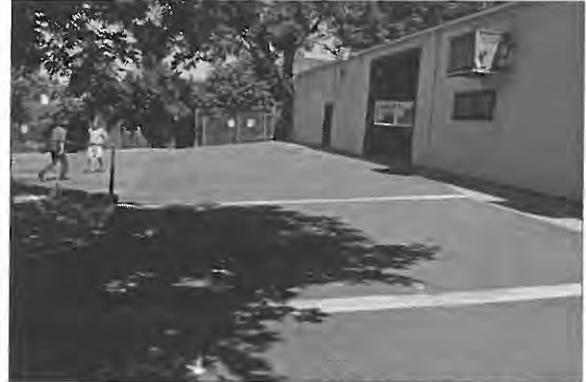
Parking Lot Southwest and Southeast of the Facility

Finding: There are slopes greater than 5% on the primary path of travel from the accessible parking space, outside of the main entrance, to the facility

Citations: CBC 1133B.7.1.3; CBC 1133B.7.3; ADAAG 4.3.7

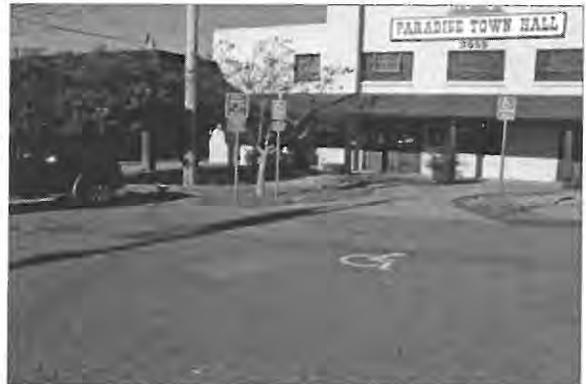
Parking Lot Southwest and Southeast of the Facility

Finding: The surface of the accessible parking space, southeast of the facility on the left side, in the parking lot has a cross slope greater than 2%.

Citations: CBC 1129B; ADAAG 4.6.3

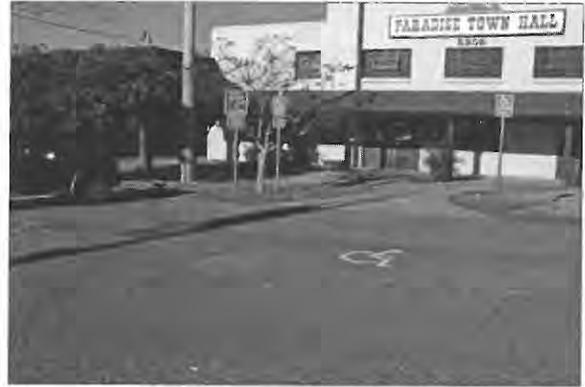
Parking Lot Southwest and Southeast of the Facility

Finding: Pavement markings at the designated accessible parking spaces, across from the main entrance, are not visible when a vehicle is parked in the space.

Citations: CBC 1129B; ADAAG 4.6.4

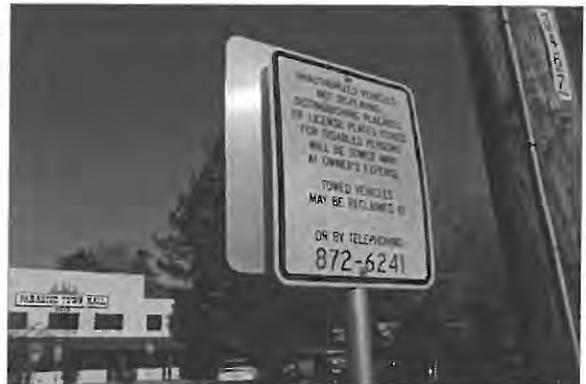
Parking Lot Southwest and Southeast of the Facility

Finding: Warning signage regarding unauthorized use of disabled parking spaces is provided.

Citations: CBC 1129B.5

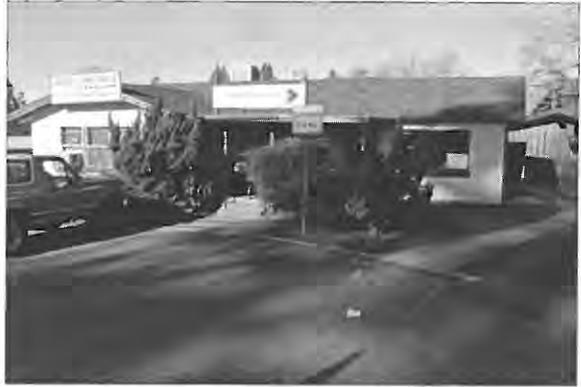
Passenger Loading Zone Next to Help 4 People

Finding: There is no required striped access aisle adjacent to the passenger loading zone. There is no signage designating accessibility posted at the passenger loading zone.

Citations: CBC 1131B; ADAAG 4.6.6; ADAAG 4.1.2(7)(b)

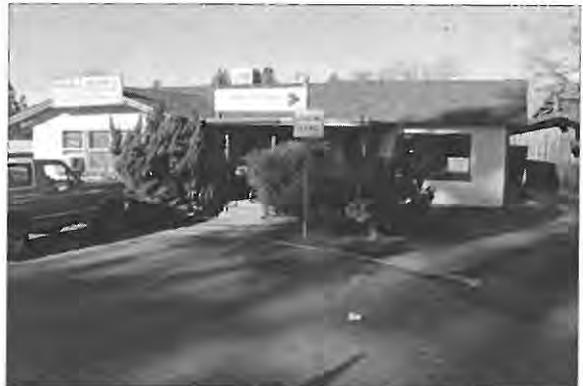
Passenger Loading Zone Next to Help 4 People

Finding: The slope of the asphalt surface for the access aisle at the passenger loading zone is greater than 2%.

Citations: CBC 1131B; ADAAG 4.6.6

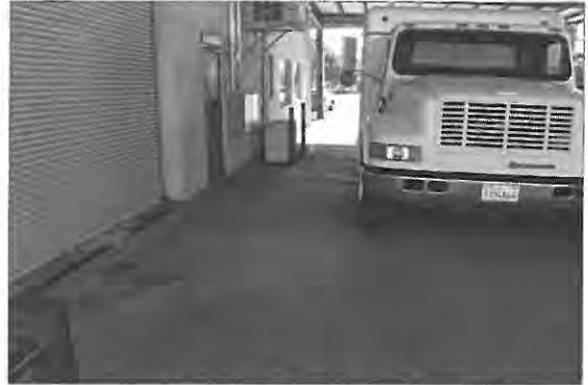
Passenger Loading Zone Outside the Main Entrance

Finding: There is no required striped access aisle adjacent to the passenger loading zone. There is no signage designating accessibility posted at the passenger loading zone.

Citations: CBC 1131B; ADAAG 4.6.6; ADAAG 4.1.2(7)(b)

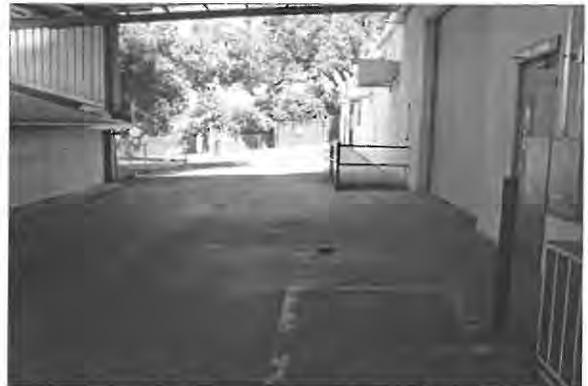
Passenger Loading Zone Outside the Main Entrance

Finding: The slope of the asphalt surface for the access aisle at the passenger loading zone is greater than 2%. The cross slope of the passenger loading zone is greater than 2%.

Citations: CBC 1131B; ADAAG 4.6.6

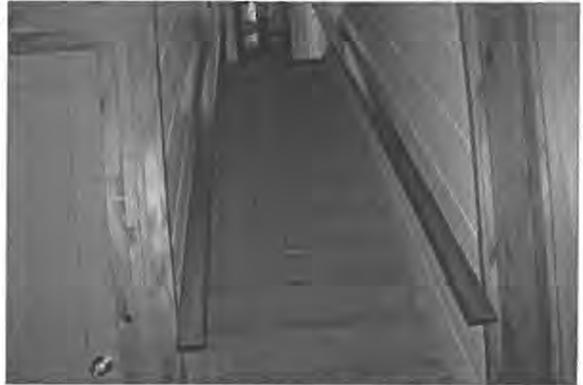
Accessible Path of Travel to the Upper Floor, Main Building

Finding: There are only stairs to the primary functions provided on the upper floor of the main building, preventing access to individuals with mobility impairments.

Citations: CBC 1133B.5; ADAAG 4.3.2

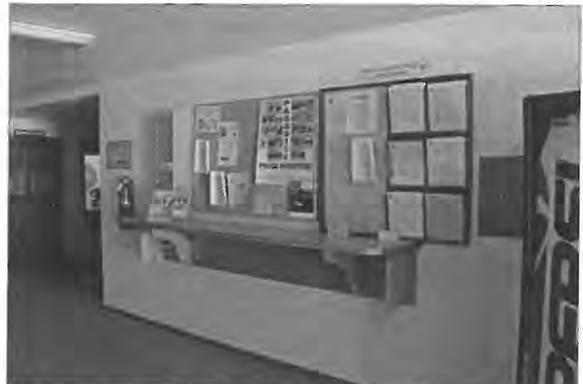
Application Slots/Bulletin Board Next to the Main Entrance

Finding: The reach height of the wall-mounted application slots/bulletin board, next to the main entrance, is greater than 48 inches above the finished floor.

Citations: CBC 1106B.4; ADAAG 8.4

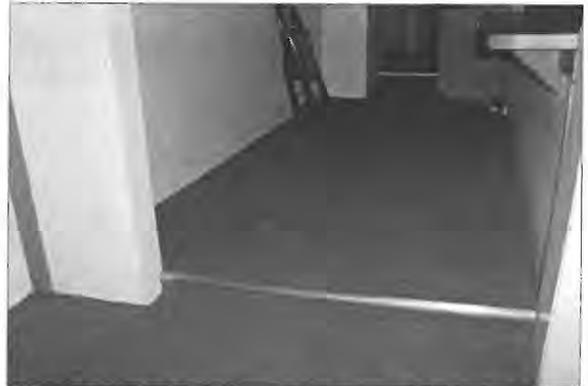
Finding: There is a change in elevation greater than 1/2 inch on the primary path of travel in the chamber room to the sound area (for assistive listening systems)/press area (next to the raised seating area).

Full Rec: Since programs, services and activities to staff and the public are provided in this location, those programs, services and activities are required to be made accessible. Bevel the area or resurface the area to provide a smooth and level path of travel (see CBC 1133B.7.4 and ADAAG 4.3.8 and ADAAG 4.5.2).

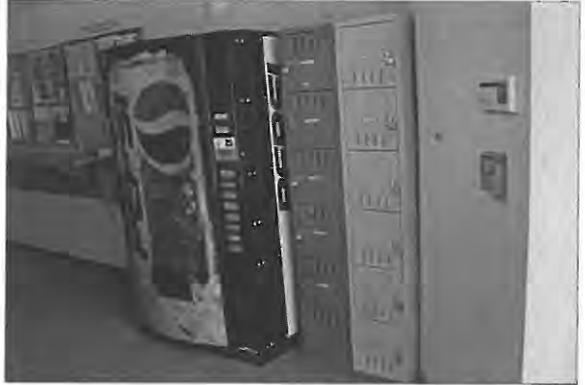
Finding: Lockers are available for use by the staff.

Full Rec: At least one locker or no less than one percent of the lockers shall be made accessible for individuals with disabilities. Make certain that the accessible lockers are located on an accessible path of travel that is at least 36 inches in width (see CBC 1115B.6.4 and ADAAG 4.27).

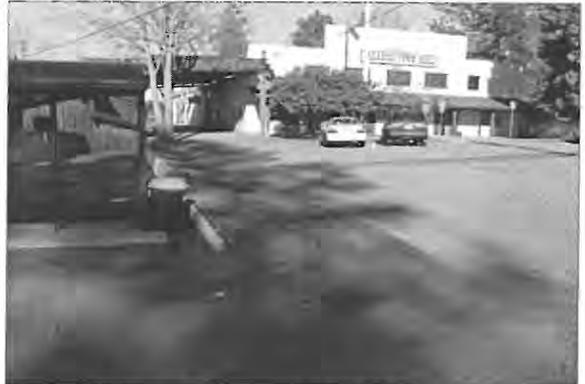
Finding: There is no crosswalk provided on the path of travel from the city bus stop to the facility. The required accessible route crosses a vehicular way.

Full Rec: Stripe a crosswalk not less than 48 inches wide on the path of travel. Detectable warnings should be placed at the entrance and exit of the crosswalk.

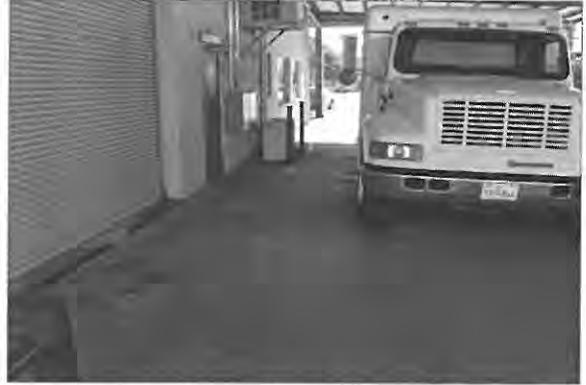
Path of Travel from the Southeast Parking to the Entrance

Finding: There is a partial crosswalk provided on the path of travel from the two accessible parking spaces to the main entrance of the facility. The required accessible adjoins a vehicular way.

Citations: ADAAG 4.7.9

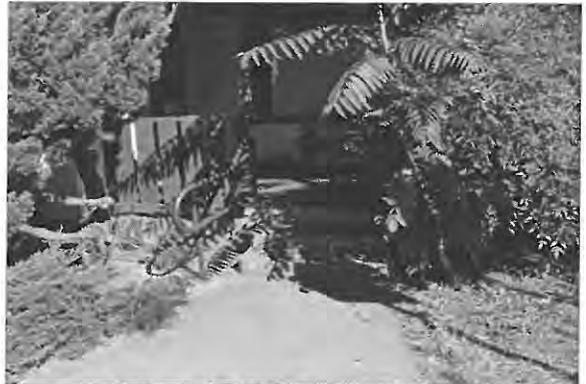
Path of Travel to Help 4 People/Community Action Agency

Finding: There are only stairs to the primary functions provided in the building housing both Help 4 People and Community Action Agency, preventing access to individuals with mobility impairments.

Citations: CBC 1133B.5; ADAAG 4.3.2

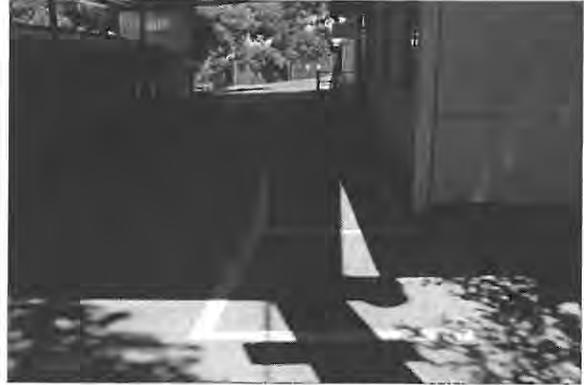
Path of Travel to the Main Entrance

Citations: CBC 1133B.7.1.3; CBC 1133B.7.3; ADAAG 4.3.7

Alternative Rec: Provide assisted service upon request on the primary path of travel. Make certain that information regarding assisted service is thoroughly publicized in all facility publications.
(Where Available)

Full Rec: Upon major renovation, resurface the path of travel to provide a level surface that does not exceed a cross slope greater than 2%.

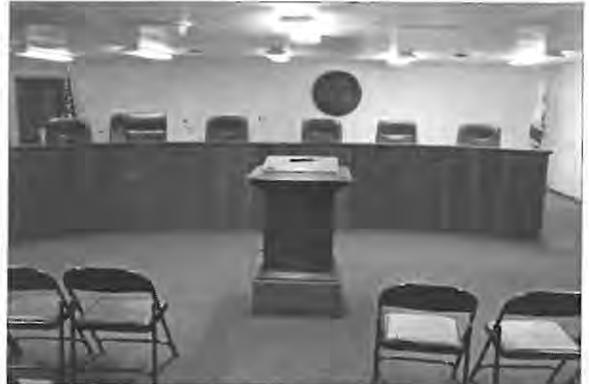
Podium in the Chamber Room

Citations: CBC 1122B.4; ADAAG 7.2

Alternative Rec: Provide a portable microphone that may be adjusted to a lower height. Otherwise, place a desk or a table with a top surface height no greater than 34 inches next to the podium. Make certain a clear 36-inch minimum width accessible route to the desk/table is provided.
(Where Available)

Full Rec: Install an additional podium with a maximum height between 28 and 34 inches (see CBC 1122B.4). The podium shall provide knee clearance of at least 27 inches in height, 30 inches in width and 19 inches in depth (see CBC 1122B.3, ADAAG 4.32.2 and ADAAG Figure 45).

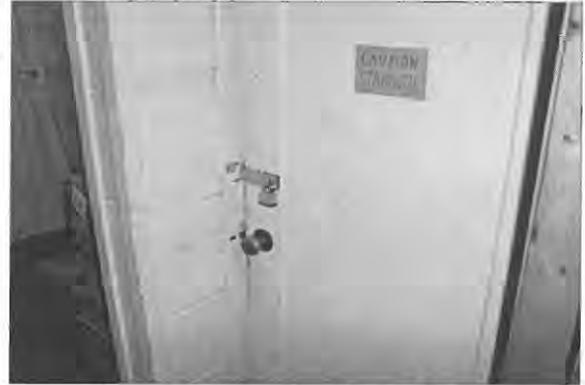
Storage Area Below Help 4 People

Finding: There are stairs on the primary path of travel to the storage area below Help 4 People, preventing access to individuals with mobility impairments. The storage area is an employee only area.

Citations: CBC 1114B.1.2; CBC 1133B.7.4; ADAAG 4.3.8

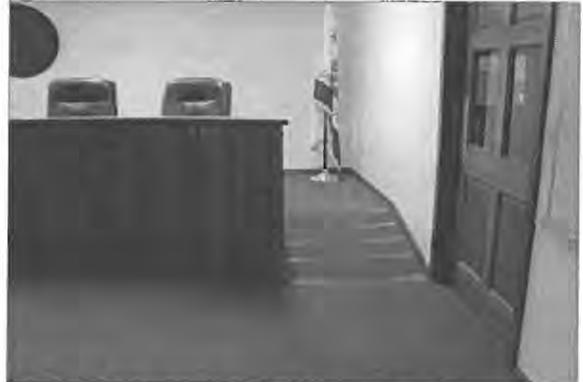
**Interior Ramp to the Counsel Chambers,
Front Right Side**

Finding: The slope of the hallway ramp is greater than 8.33%

Citations: CBC 1133B.5.3.1; ADAAG 4.8

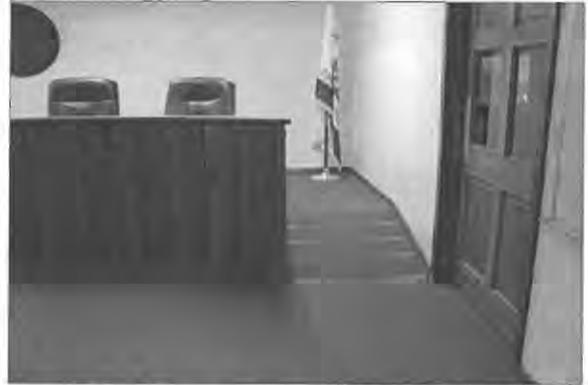
**Interior Ramp to the Counsel Chambers,
Front Right Side**

Finding: The width of the run of the interior ramp is less than 36 inches.

Citations: CBC 1133B.5.2

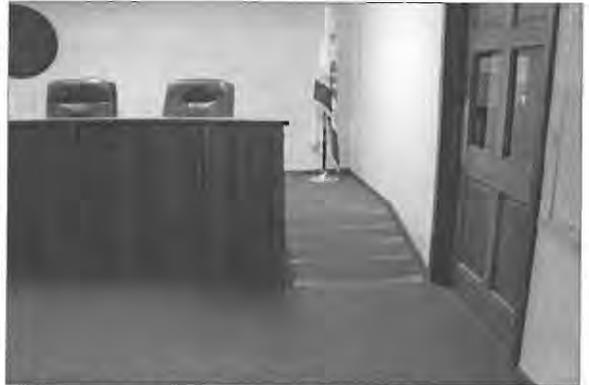
**Interior Ramp to the Counsel Chambers,
Front Right Side**

Finding: The distance between the latch side of the door on the push side from the bottom landing is less than 12 inches.

Citations: CBC 1133B.4.2; ADAAG 4.8

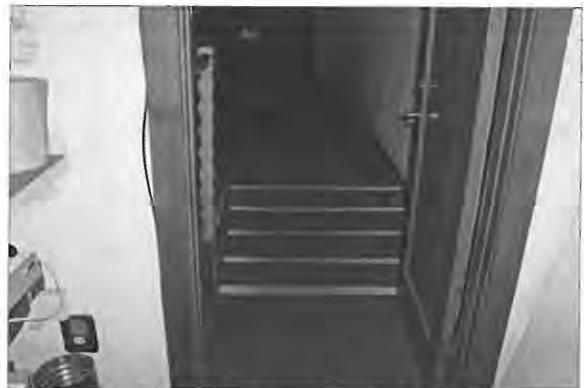
***Interior Ramp to the Counsel Chambers,
Rear Left Side***

Citations: CBC 1133B.4.5; ADAAG 4.8

Full Rec: Resurface the bottom landing of the ramp to provide at least 72 inches in length (see CBC 1133B.5.4.5).

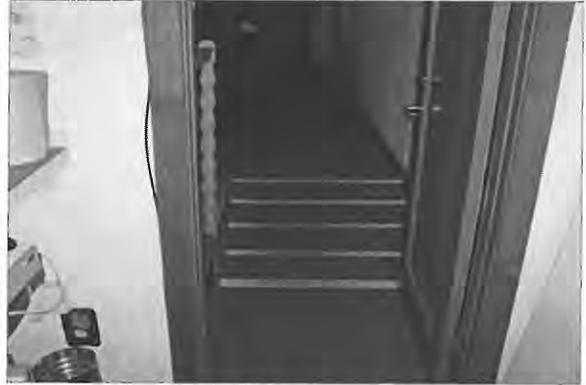
***Interior Ramp to the Counsel Chambers,
Rear Left Side***

Finding: The slope of the hallway ramp is greater than 8.33%

Citations: CBC 1133B.5.3.1; ADAAG 4.8

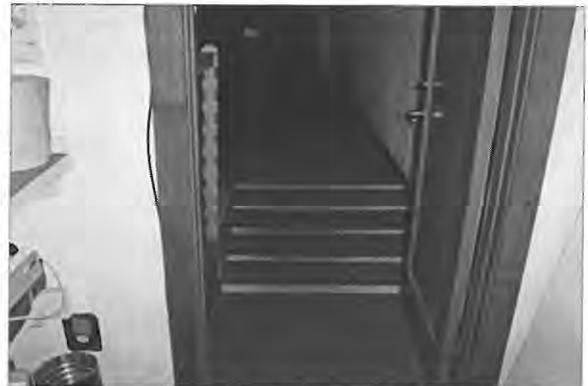
***Interior Ramp to the Counsel Chambers,
Rear Left Side***

Finding: The ramp has no handrails.

Citations: CBC 1133B.5.5; ADAAG 4.8.5

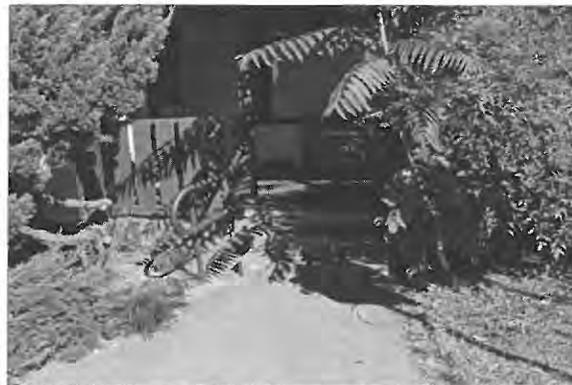
Exterior Stairs Next to Help 4 People

Finding: There is no detectable striping on each tread of the exterior stairway.

Citations: CBC 1006.16.1; CBC 11133B.4.4; ADAAG 4.9.5

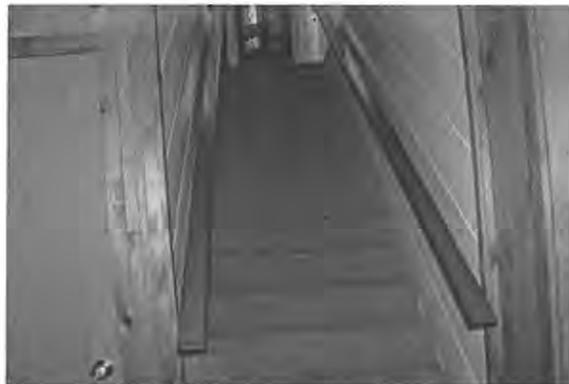
Interior Stairs to the Upper Floor, by the Office

Finding: There is no detectable striping on the top and bottom treads of the interior stairway.

Citations: CBC 1006.16.1; CBC 11133B.4.4; ADAAG 4.9.5

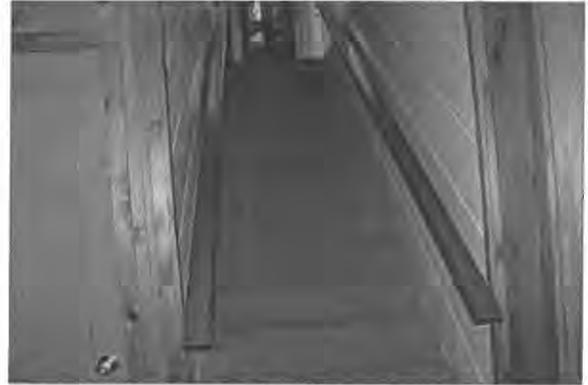
Interior Stairs to the Upper Floor, by the Office

Finding: The handrails do not provide 12-inch extensions beyond the top and bottom treads and the ends of the handrails end abruptly. The diameter of the gripping surface is greater than 1 1/2 inches. The gripping surface at the bottom of the handrails are interrupted.

Citations: CBC 1133B.4.2; ADAAG 4.9.4

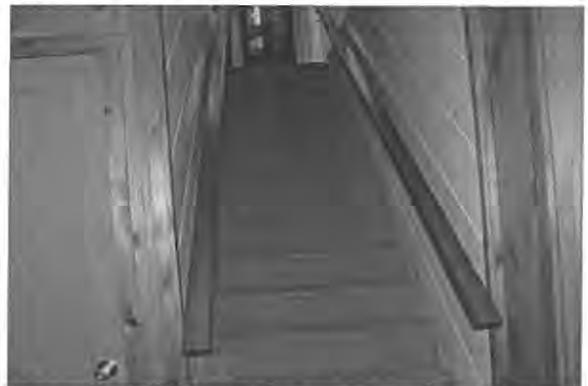
Interior Stairs to the Upper Floor, by the Office

Finding: There is less than 11 inches of tread depth (width).

Citations: CBC 1006.3.4.9.2; ADAAG 4.9.2

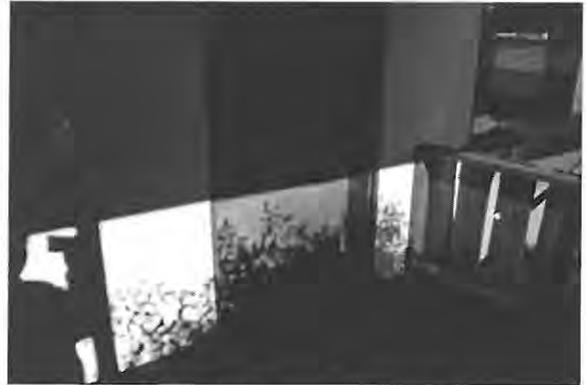
Exterior Door Hardware

Finding: Exterior passage doors, to Help 4 People and Community Action Agency, have round doorknobs, which require twisting of the wrist to operate.

Citations: ADAAG 4.13.9

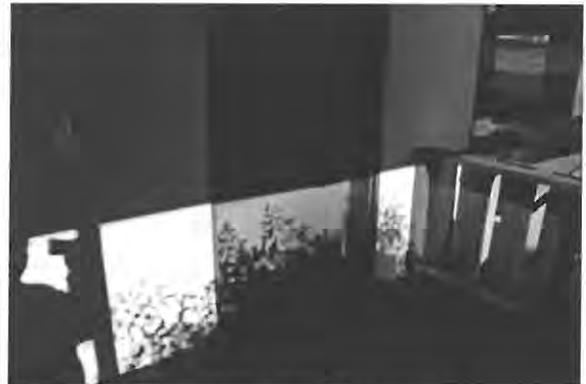
Exterior Door Threshold

Finding: The height of the threshold at each entrance door, to Help 4 People and Community Action Agency, is greater than 1/2 inch.

Citations: CBC 1133B.2.4.1; ADAAG 4.1.6(3)(d)(ii); ADAAG 4.5.2

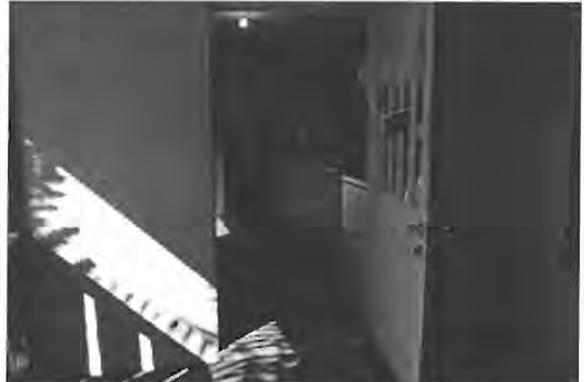
Finding: Interior passage doors, in Help 4 People, have round doorknobs, which require twisting of the wrist to operate.

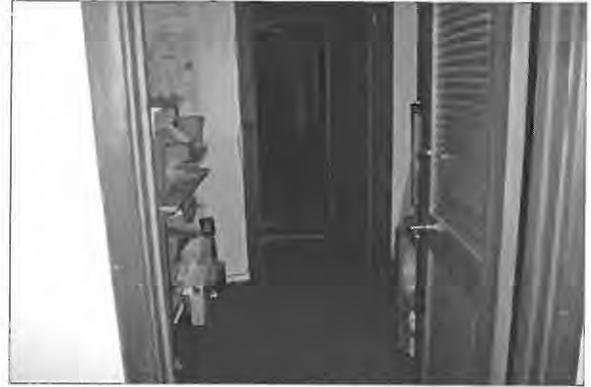
Interior Doors

Finding: The clear opening width of each interior door, between the manager's office and the counsel chamber's seating area is less than 32 inches.

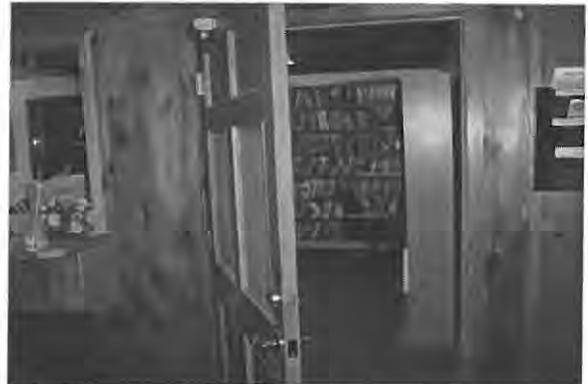
Interior Doors

Finding: The vertical clearance height of most interior entrance doors, along the main hallway, provide less than 80 inches.

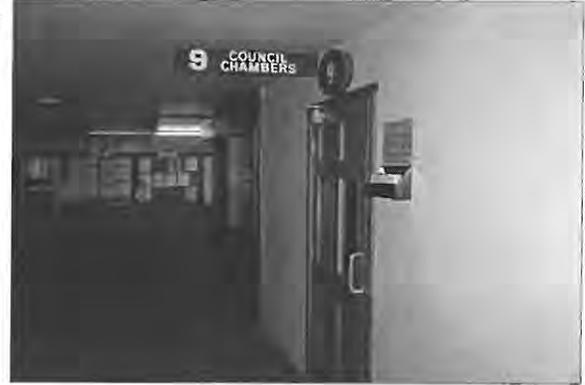
Interior Doors

Finding: The door opening force for some interior doors is greater than 5 pounds of force.

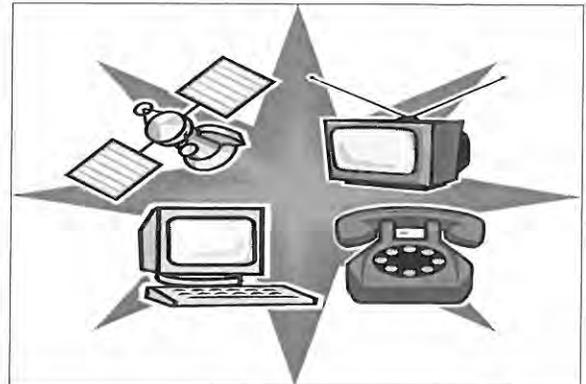
Finding: The facility does not provide information at the main office about accessible services, such as TDD/TTY machines, assistive listening systems (ALS), and alternative formats of facility materials. There is assistive listening systems in the chamber room.

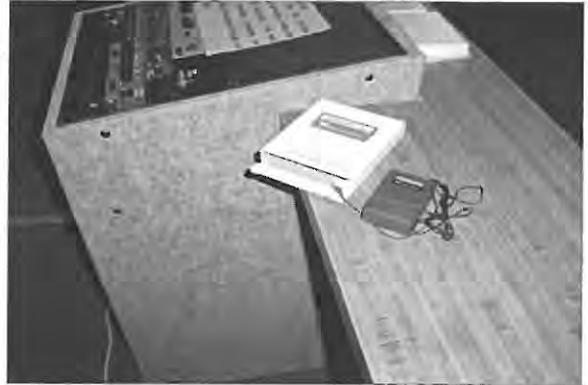
Finding: There is assistive listening systems in the chamber room. There is no signage provided next to the assistive listening systems.

Full Rec: Provide signage for the assistive listening systems (ALS) (see ADAAG 4.30).

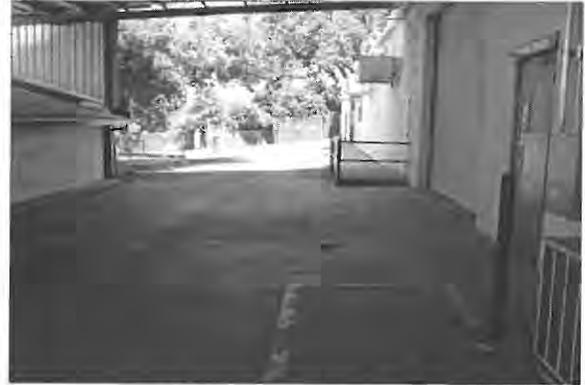
Directional Signage

Finding: There is not sufficient directional signage to the main entrance from the parking lot, along the accessible path of travel.

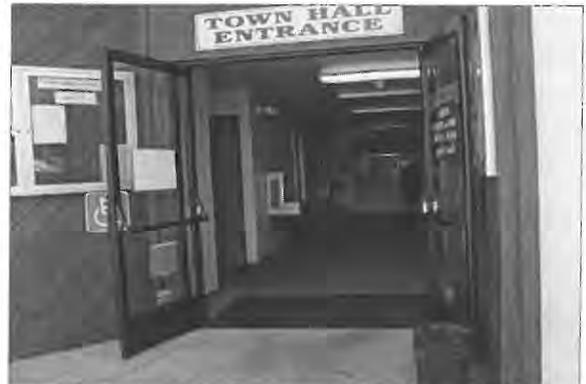
Facility Signage

Finding: The main entrance, chamber room, town clerk and other common use rooms do not have accessible signage mounted on the wall adjacent to the latch side of the door.

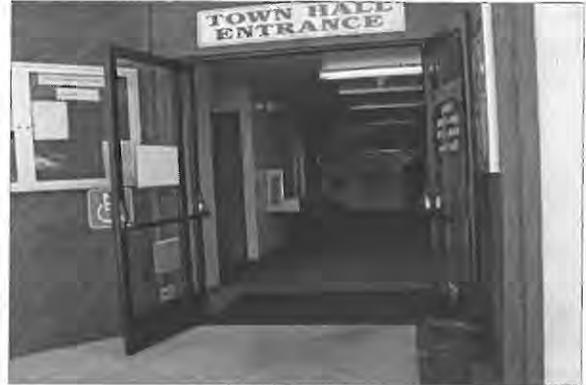
Facility Signage

Finding: There is no signage with the International Symbol of Accessibility on the entrance door to the facility designating it as accessible.

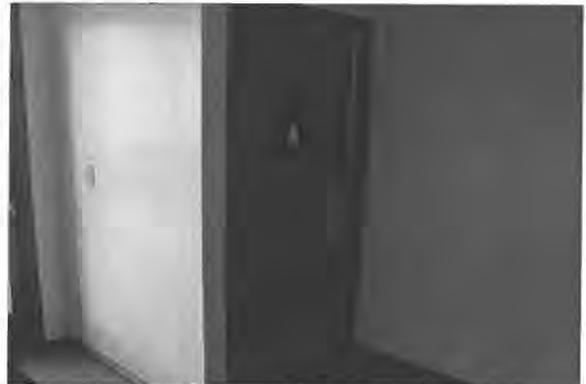
Men's Restroom in the Main Lobby

Finding: There is signage posted on the entry door to the restroom. The signage is not centered 60 inches above the floor on the latch side of the entrance door and does not include Braille and raised lettering or the ISA symbol.

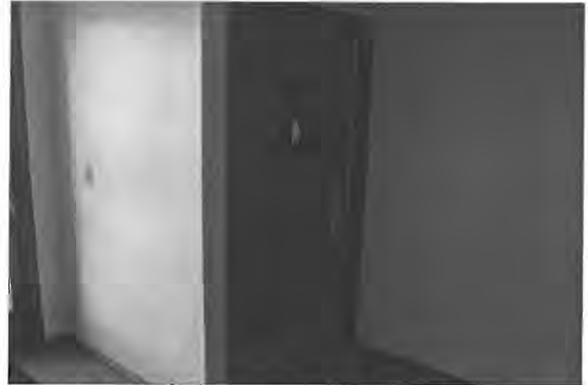
Men's Restroom in the Main Lobby

Finding: There is less than 12 inches on the latch side of the entrance door to the restroom from the push side.

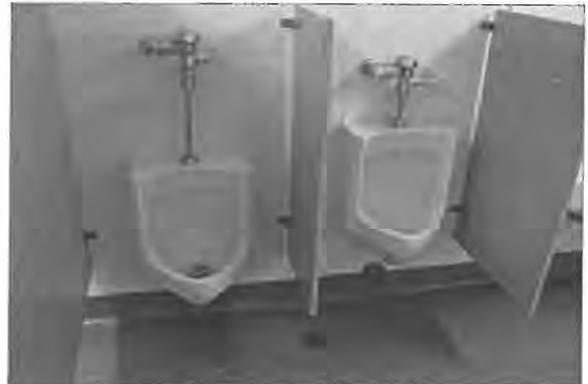
Men's Restroom in the Main Lobby

Finding: The height of the urinal flush control in the restroom is greater than 44 inches above the finished floor.

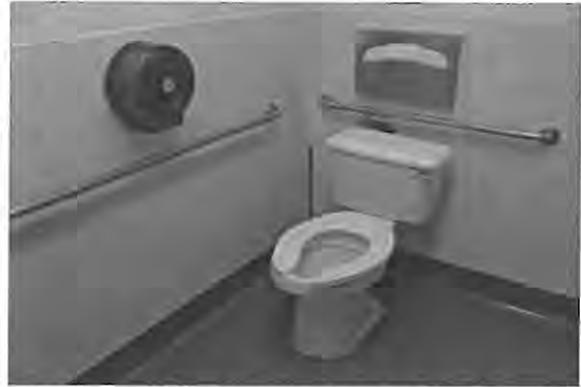
Men's Restroom in the Main Lobby

Finding: The door to the stall designated to be accessible in the restroom does not close automatically and does not provide accessible hardware. There is insufficient clear floor space in the stall designated to be accessible in the restroom. The width of the stall in the restroom is less than 60 inches.

Full Rec: Modify or replace the stall designated to be accessible in the restroom so that it complies with ADAAG 4.17.3, CBC 1115B and CBC Figures 11B-1A and 1B. Standard accessible stalls require 60 inches in width with 56 inches depth for wall-mounted toilets or 59 inches depth for floor-mounted toilets to accommodate individuals in wheelchairs. A minimum 48 inches of clear space shall be provided in front of the toilet. Door shall swing outward, close automatically and provide accessible hardware.

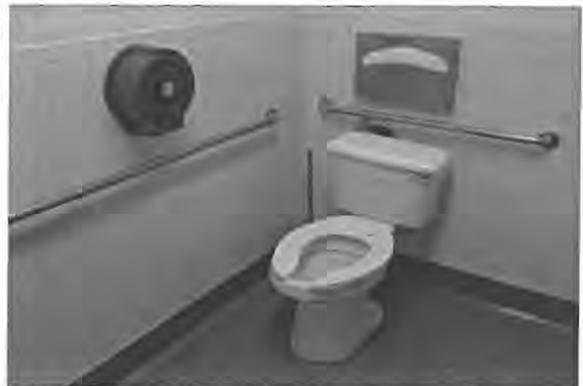
Men's Restroom in the Main Lobby

Finding: The side grab bar in the stall designated to be accessible in the restroom does not extend 54 inches from the back wall.

Full Rec: Replace or remount the side grab bar in the stall designated to be accessible in the restroom with a 42-inch/ 48 -inch side grab bar complying with ADAAG 4.26 and CBC 1115B.8. The front end of the grab bar shall extend at least 54 inches from the back wall and the back end of the grab bar shall be mounted within 12 inches from the back wall. Grab bars must be able to support a point load of at least 250 pounds and shall be less than the allowable shear stress of the grab bar material.

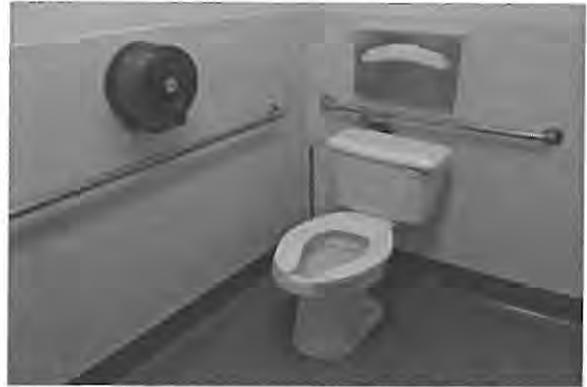
Men's Restroom in the Main Lobby

Finding: The toilet paper dispenser in the stall designated to be accessible in the restroom interferes with the use of the side grab bar.

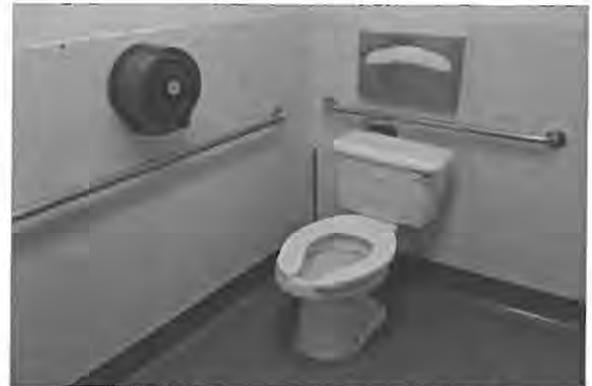
Men's Restroom in the Main Lobby

Finding: The height of all operable parts of the seat cover dispenser in the stall designated to be accessible in the restroom is greater than 40 inches. The seat cover dispenser interferes with the use of the back grab bar.

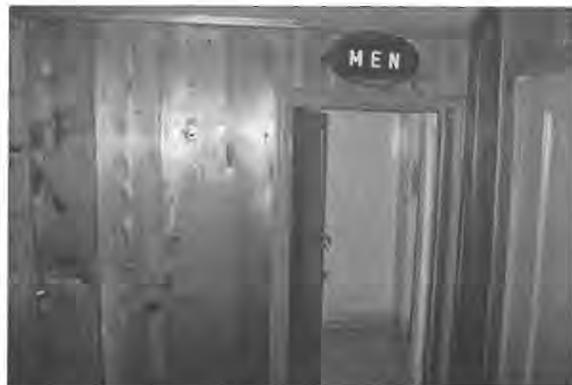
Men's Restroom Next to the Administrative Offices

Finding: There is no signage at the restroom directing individuals to accessible restrooms.

Alternative Rec: Post signage directing individuals with mobility impairments to accessible restrooms (see CBC 1115B.5 and ADAAG 4.1.2(7)).
(Where Available)

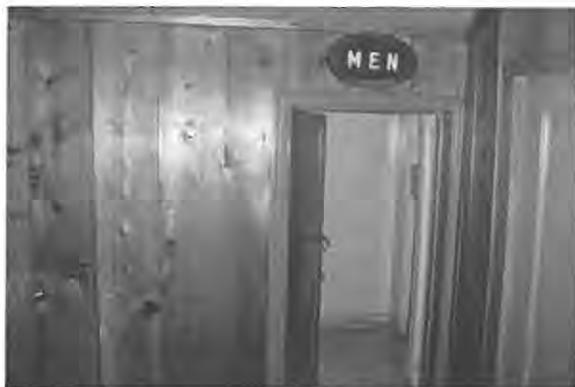
Men's Restroom Next to the Administrative Offices

Finding: The clear opening width of the entrance doorway to the restroom is less than 32 inches.

Alternative Rec: No action is required at this time regarding the width of entrance doorway to the restroom unless major renovation occurs in the area.
(Where Available)

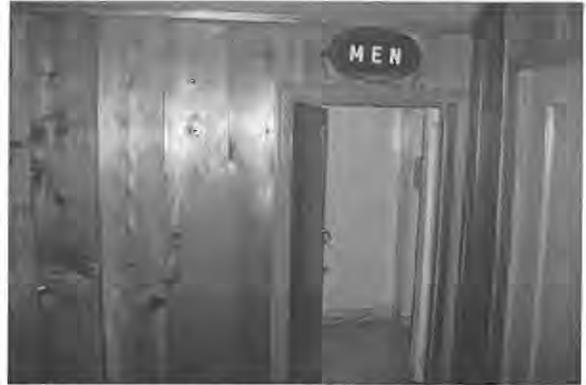
Men's Restroom Next to the Administrative Offices

Finding: This restroom is not accessible and cannot be easily altered. There is not sufficient clear floor space in the restroom to accommodate an individual in a wheelchair.

Alternative Rec: No action is required at this time regarding the clear floor space in the restroom, unless major renovation occurs in the area.
(Where Available)

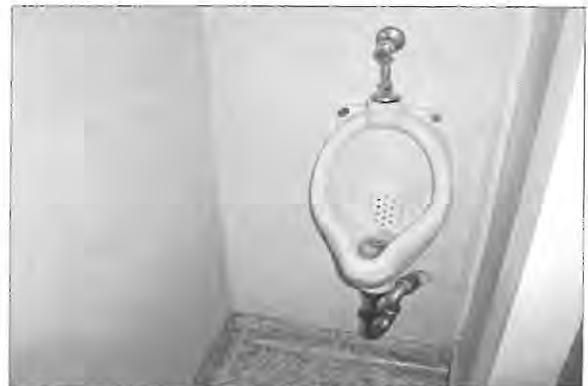
Men's Restroom Next to the Administrative Offices

Finding: The height of the urinal rim in the restroom is greater than 17 inches above the finished floor.

Alternative Rec: No action is required at this time regarding the height of the urinal designated to be accessible in the restroom, unless major renovation occurs in the area.
(Where Available)

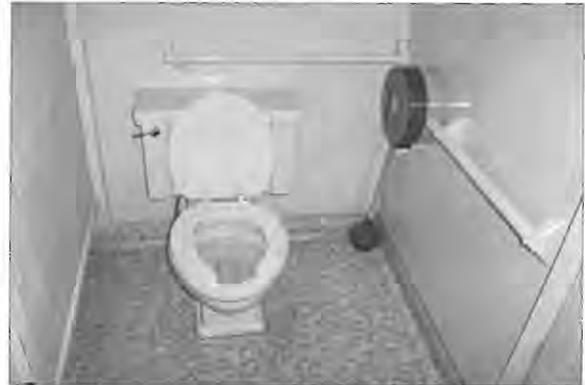
Men's Restroom Next to the Administrative Offices

Finding: There is insufficient clear floor space in the stall designated to be accessible in the restroom.

Alternative Rec: No action is required at this time regarding the modification or replacement of the stall designated to be accessible in the restroom, unless major renovation occurs in the area.

Full Rec: Modify or replace the stall designated to be accessible in the restroom so that it complies with ADAAG 4.17.3, CBC 1115B and CBC Figures 11B-1A and 1B. A standard accessible stall requires 60 inches in width with 56 inches depth for wall-mounted toilets or 59 inches depth for floor-mounted toilets to accommodate individuals in wheelchairs. The minimum width of a front-approach doorway shall provide at least 32 inches of a side-approach doorway shall provide at least 34 inches.

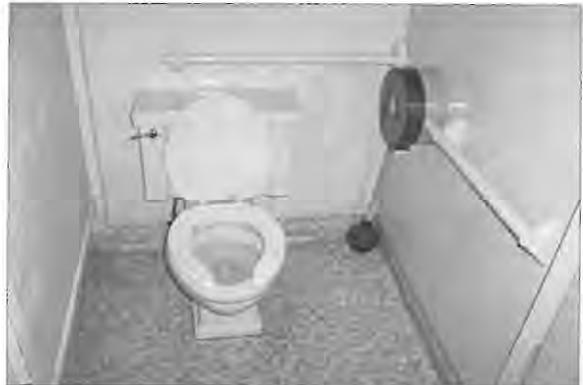
Men's Restroom Next to the Administrative Offices

Finding: The height of each the side and back grab bar in the stall designated to be accessible of the restroom is not centered at 33 inches above the finished floor.

Alternative No action is required at this time regarding the
Rec: replacement of grab bars in the stall designated to be
(Where accessible in the restroom, unless major renovation
Available) occurs in the area.

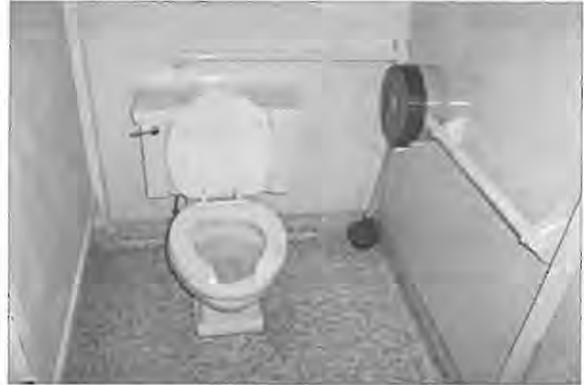
Men's Restroom Next to the Administrative Offices

Finding: The height of all operable parts of the seat cover dispenser in the stall designated to be accessible in the restroom is greater than 40 inches.

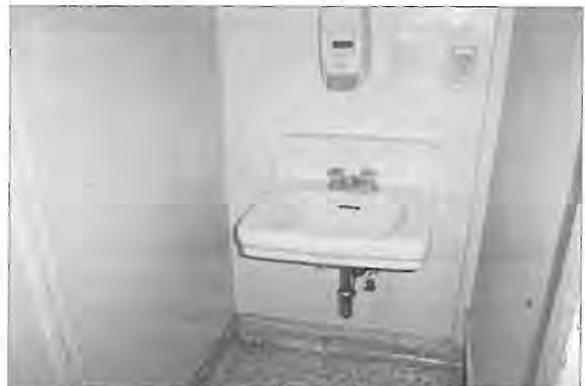
Men's Restroom Next to the Administrative Offices

Finding: The faucet controls on the lavatory in the restroom require tight grasping, pinching, or twisting of the wrist and are not accessible.

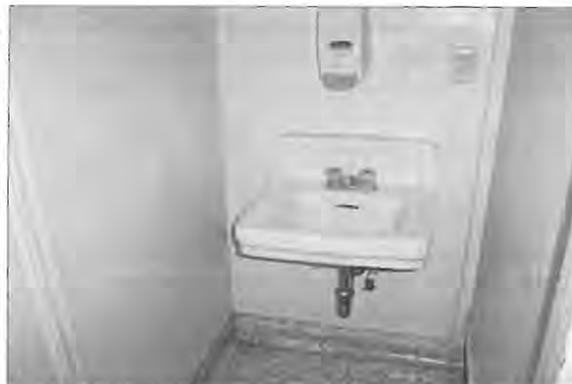
Men's Restroom Next to the Administrative Offices

Finding: The knee clearance space under the lavatory designated to be accessible in the restroom is less than 29 inches.

Alternative Rec: No action is required at this time regarding knee clearance space under the lavatory designated to be accessible in the restroom, unless major renovation occurs in the area.
(Where Available)

Full Rec: Raise or replace the lavatory designated to be accessible in the restroom to provide at least 29 inches of clear knee space between the finished floor and bottom of the lavatory apron and at least 27 inches of knee clearance under the lavatory bowl at a knee depth of 8 inches (see ADAAG 4.19.2). Make certain the height of the top of the lavatory does not exceed 34 inches above the finished floor.

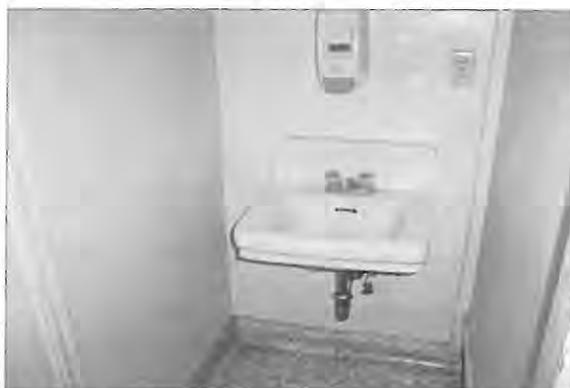
Men's Restroom Next to the Administrative Offices

Finding: The pipes under the lavatory in the restroom do not provide protection against contact.

Alternative Rec: No action is required at this time regarding insulating the pipes under the lavatory designated to be accessible in the restroom, unless major renovation occurs in the area.
(Where Available)

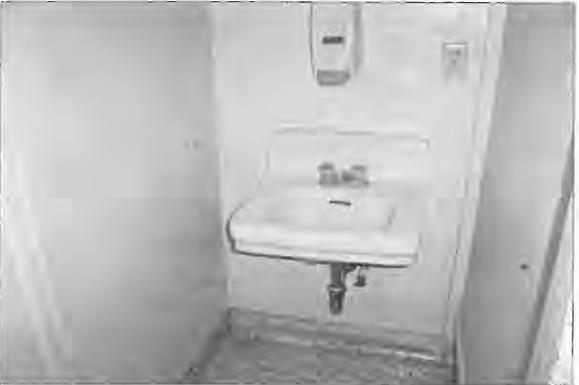
Men's Restroom Next to the Administrative Offices

Finding: The height of the controls and operating mechanisms for the soap dispenser in the restroom is greater than 40 inches above the finished floor.

Alternative Rec: No action is required at this time regarding the location of the soap dispenser in the restroom, unless major renovation occurs in the area.
(Where Available)

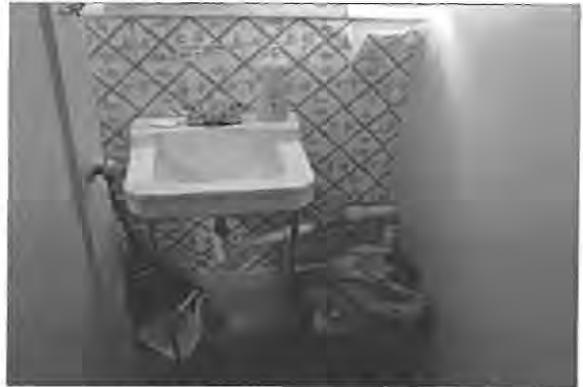
Unisex Restroom in Help 4 People

Finding: This restroom is not located on an accessible level.

Alternative Rec: Post signage directing individuals with mobility impairments to an accessible restroom on an accessible level (see CBC 1115B.5, ADAAG 4.1.2(7) and ADAAG 4.1.6(3)(e)).
(Where Available)

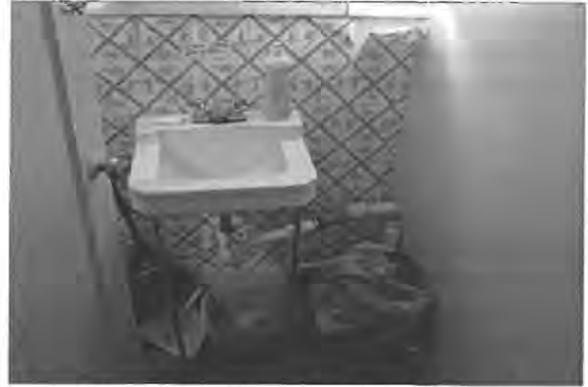
Unisex Restroom in Help 4 People

Finding: The clear opening width of the entrance doorway to the restroom is less than 32 inches.

Alternative Rec: No action is required at this time regarding the width of entrance doorway to the restroom unless major renovation occurs in the area.
(Where Available)

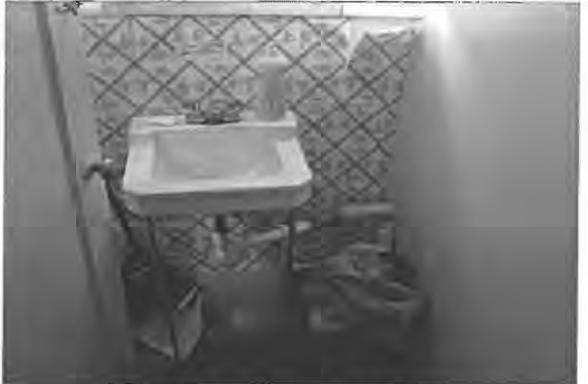
Unisex Restroom in Help 4 People

Finding: The entrance door to the restroom has a round doorknob that requires tight grasping or twisting of the wrist to operate.

Alternative Rec: No action is required at this time regarding the hardware on the entrance doorway and exit doorway at the restroom, unless major renovation occurs in the area.
(Where Available)

Full Rec: Replace the door hardware mounted on the restroom complying with ADAAG 4.13.9. Make certain accessible door hardware is mounted no higher than 48 inches above the finished floor.

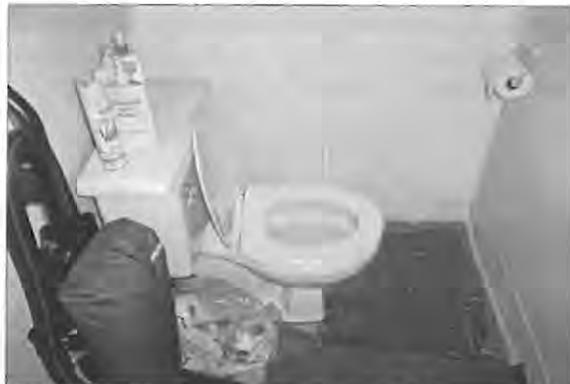
Unisex Restroom in Help 4 People

Finding: This restroom is not accessible and cannot be easily altered. There is not sufficient clear floor space in the restroom to accommodate an individual in a wheelchair.

Alternative Rec: No action is required at this time regarding the clear floor space in the restroom, unless major renovation occurs in the area.
(Where Available)

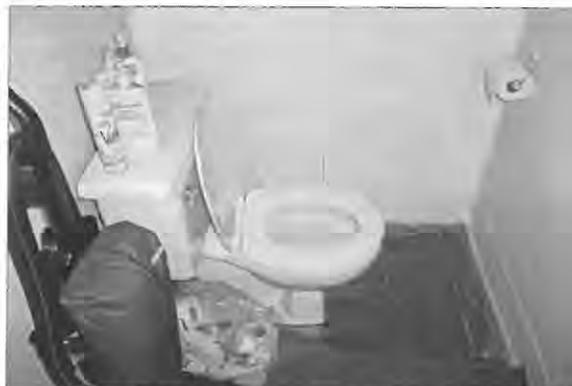
Unisex Restroom in Help 4 People

Finding: There are no grab bars in the restroom.

Alternative Rec: No action is required at this time regarding the installation of grab bars in the restroom, unless major renovation occurs in the area.
(Where Available)

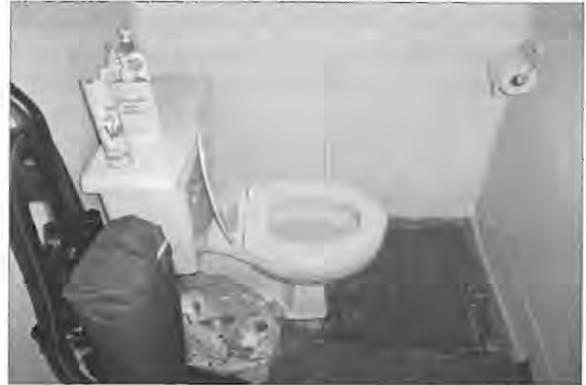
Unisex Restroom in Help 4 People

Finding: The height of the toilet seat in the restroom is less than 17 inches above the finished floor.

Alternative Rec: No action is required at this time regarding adjusting the height of the toilet seat in the restroom, unless major renovation occurs in the area.
(Where Available)

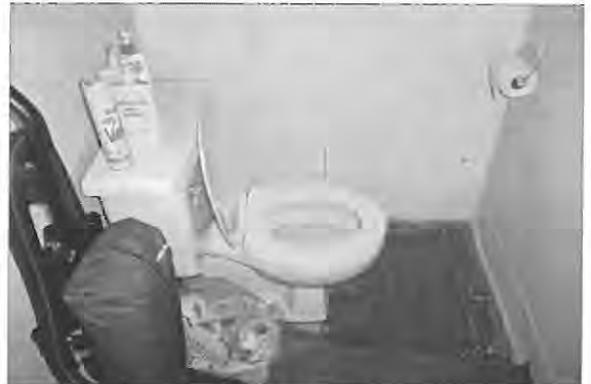
Unisex Restroom in Help 4 People

Finding: The distance from the center of the toilet to the nearest side wall in the restroom is less than 18 inches.

Alternative Rec: No action is required at this time regarding adjusting the distance to the nearest side wall from the centerline of the toilet in the restroom, unless major renovation occurs in the area.
(Where Available)

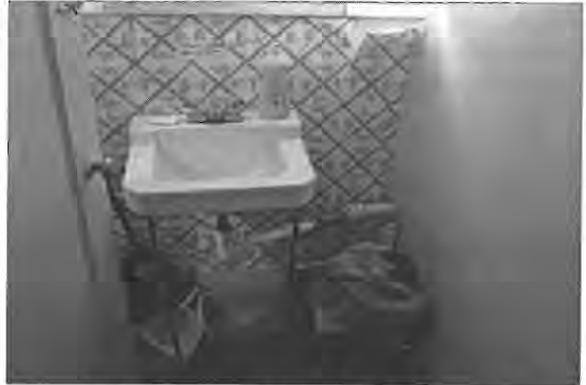
Unisex Restroom in Help 4 People

Finding: The knee clearance space under the lavatory designated to be accessible in the restroom is less than 29 inches.

Citations: ADAAG 4.19.2

Full Rec: Raise or replace the lavatory designated to be accessible in the restroom to provide at least 29 inches of clear knee space between the finished floor and bottom of the lavatory apron and at least 27 inches of knee clearance under the lavatory bowl at a knee depth of 8 inches (see ADAAG 4.19.2). Make certain the height of the top of the lavatory does not exceed 34 inches above the finished floor.

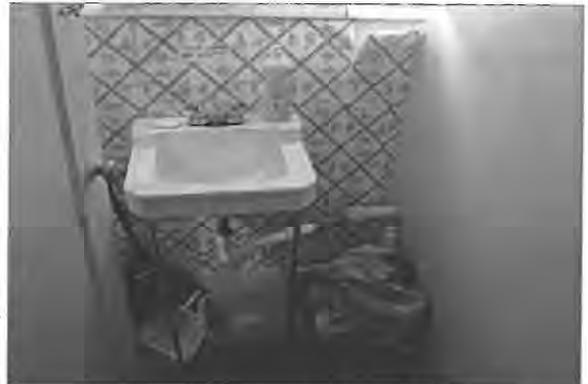
Unisex Restroom in Help 4 People

Finding: The pipes under the lavatory in the restroom do not provide protection against contact.

Citations: ADAAG 4.19.4

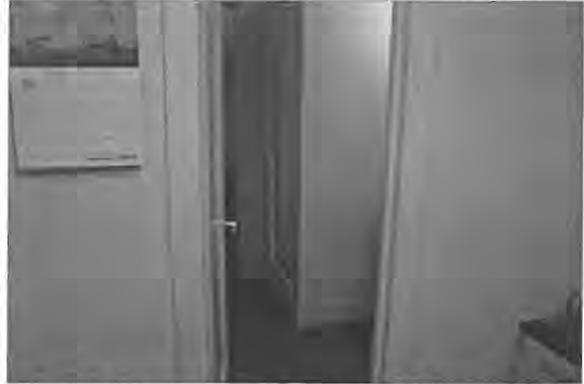
Unisex Restroom on the Upper Floor of the Main Building

Finding: This restroom is not located on an accessible level.

Citations: CBC 1104B.3; CBC 1115B.5; ADAAG 4.1.2(7); ADAAG 4.1.6(3)(e)

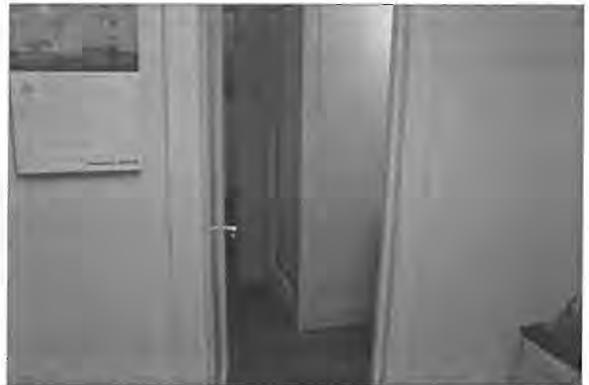
Unisex Restroom on the Upper Floor of the Main Building

Finding: The clear opening width of the entrance doorway to the restroom is less than 32 inches.

Citations: ADAAG 4.13.5

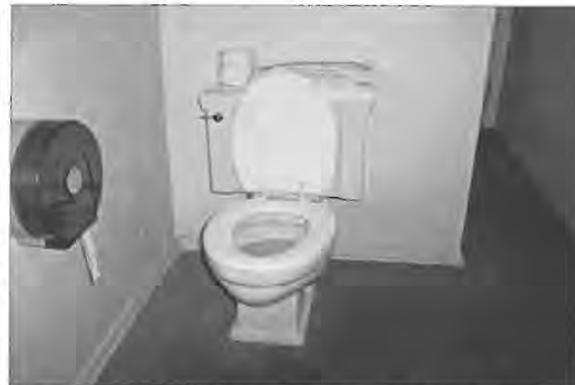
Unisex Restroom on the Upper Floor of the Main Building

Finding: This restroom is not accessible and cannot be easily altered. There is not sufficient clear floor space in the restroom to accommodate an individual in a wheelchair.

Citations: CBC 1115B.7.2; ADAAG 4.16.2
