Town of Paradise

ADA self-evaluation transition plan

June 2015

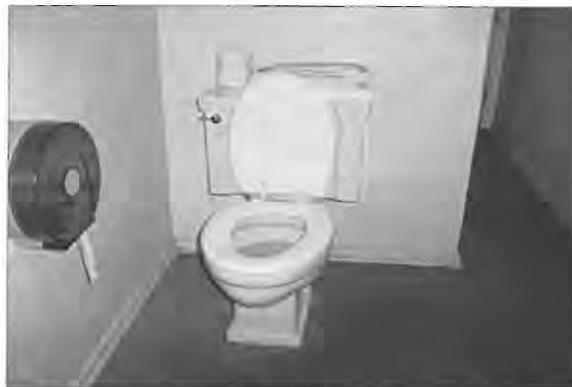
Unisex Restroom on the Upper Floor of the Main Building

Finding: There are no grab bars in the restroom.

Citations: CBC 1115B.8; ADAAG 4.17.6; ADAAG 4.26.3

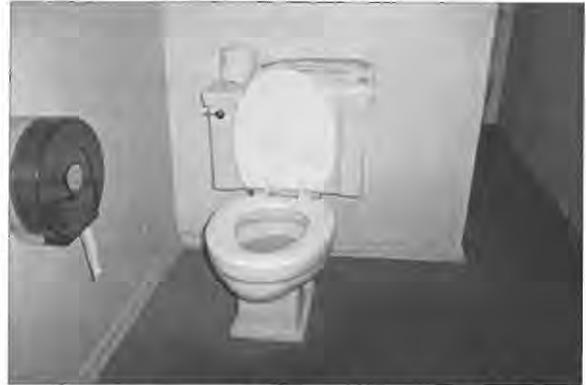
Unisex Restroom on the Upper Floor of the Main Building

Finding: The flush control on the toilet in the restroom is not on the wide (approach) side of the toilet.

Alternative Rec: No action is required at this time regarding relocating the flush control on the toilet in the restroom, unless major renovation occurs in the area.
(Where Available)

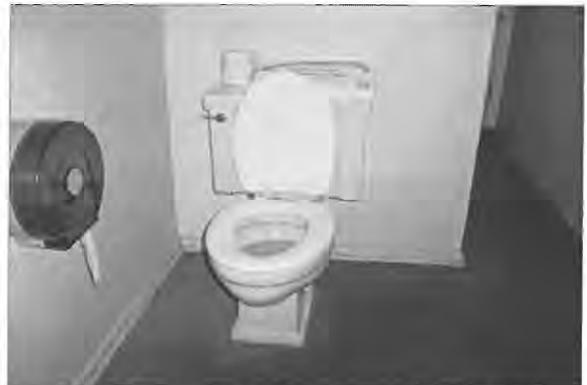
Unisex Restroom on the Upper Floor of the Main Building

Finding: The height of the toilet seat in the restroom is less than 17 inches above the finished floor.

Alternative Rec: No action is required at this time regarding adjusting the height of the toilet seat in the restroom, unless major renovation occurs in the area.
(Where Available)

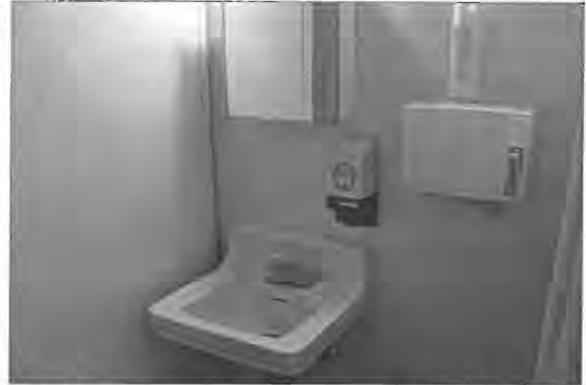
Unisex Restroom on the Upper Floor of the Main Building

Finding: The knee clearance space under the lavatory designated to be accessible in the restroom is less than 29 inches.

Citations: ADAAG 4.19.2

Alternative Rec: No action is required at this time regarding knee clearance space under the lavatory designated to be accessible in the restroom, unless major renovation occurs in the area.
(Where Available)

Full Rec: Raise or replace the lavatory designated to be accessible in the restroom to provide at least 29 inches of clear knee space between the finished floor and bottom of the lavatory apron and at least 27 inches of knee clearance under the lavatory bowl at a knee depth of 8 inches (see ADAAG 4.19.2). Make certain the height of the top of the lavatory does not exceed 34 inches above the finished floor.

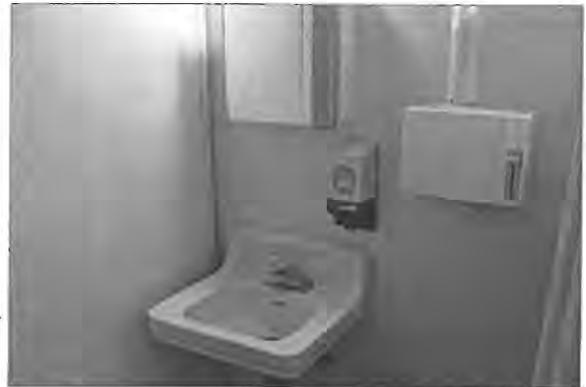
Unisex Restroom on the Upper Floor of the Main Building

Finding: The pipes under the lavatory in the restroom do not provide protection against contact.

Citations: ADAAG 4.19.4

Alternative Rec: No action is required at this time regarding insulating the pipes under the lavatory designated to be accessible in the restroom, unless major renovation occurs in the area.
(Where Available)

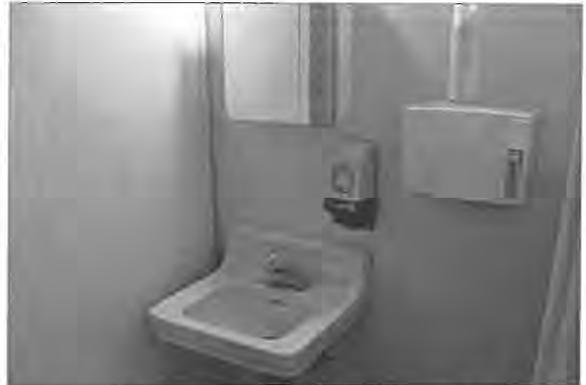
Unisex Restroom on the Upper Floor of the Main Building

Finding: The height of the controls and operating mechanisms for the paper towel dispenser in the restroom is greater than 40 inches above the finished floor.

Alternative Rec: No action is required at this time regarding the location of the paper towel dispenser in the restroom, unless major renovation occurs in the area.
(Where Available)

Full Rec: Relocate the paper towel dispenser in the restroom to a maximum height of 40 inches for all the controls and operating mechanisms (see CBC 1115B.9.2).

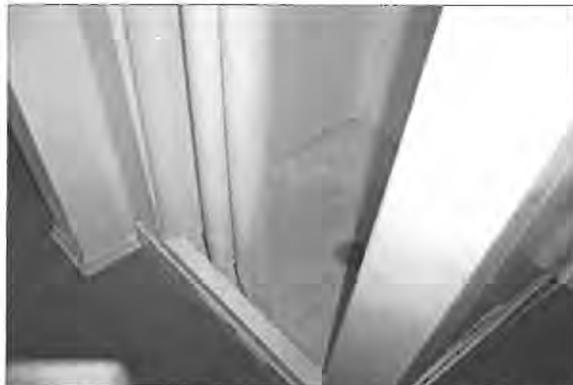
Unisex Restroom on the Upper Floor of the Main Building

Finding: There is a shower stall provided in the restroom.

Citations: CBC 1115B.6.2; ADAAG 4.21

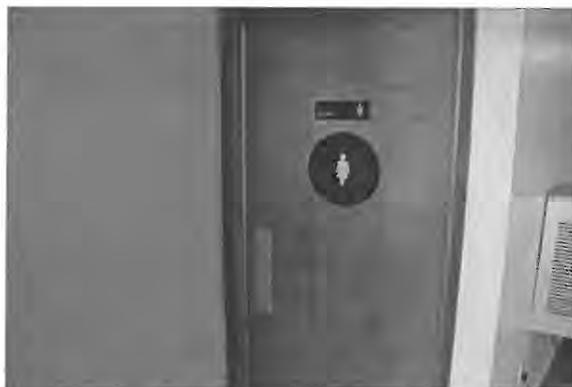
Women's Restroom in the Main Lobby

Finding: There is signage posted on the entry door to the restroom. The signage is not centered 60 inches above the floor on the latch side of the entrance door and does not include Braille and raised lettering or the ISA symbol.

Citations: CBC 1115B.5; ADAAG 4.1.6; ADAAG 4.1.2(7)); ADAAG 4.1.6(3)(e); ADAAG 4.30

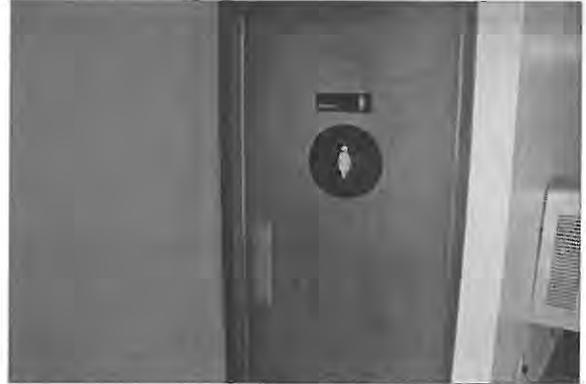
Women's Restroom in the Main Lobby

Finding: There is less than 12 inches on the latch side of the entrance door to the restroom from the push side.

Citations: ADAAG 4.13.6; CBC 1133B.2.4.2

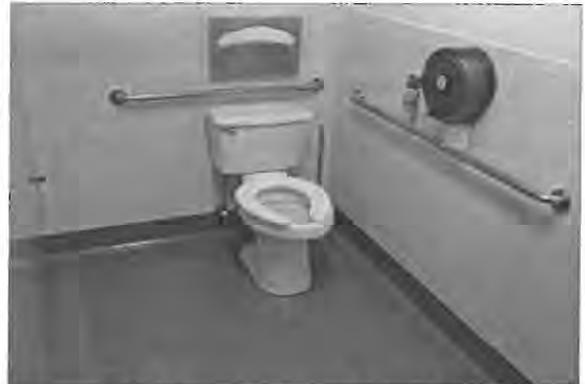
Women's Restroom in the Main Lobby

Finding: The door to the stall designated to be accessible in the restroom does not close automatically and does not provide accessible hardware. There is insufficient clear floor space in the stall designated to be accessible in the restroom. The width of the stall in the restroom is less than 60 inches.

Citations: CBC 1115B; ADAAG 4.17.3; ADAAG A4.17.3

Full Rec: Modify or replace the stall designated to be accessible in the restroom so that it complies with ADAAG 4.17.3, CBC 1115B and CBC Figures 11B-1A and 1B. Standard accessible stalls require 60 inches in width with 56 inches depth for wall-mounted toilets or 59 inches depth for floor-mounted toilets to accommodate individuals in wheelchairs. A minimum 48 inches of clear space shall be provided in front of the toilet. Door shall swing outward, close automatically and provide accessible hardware.

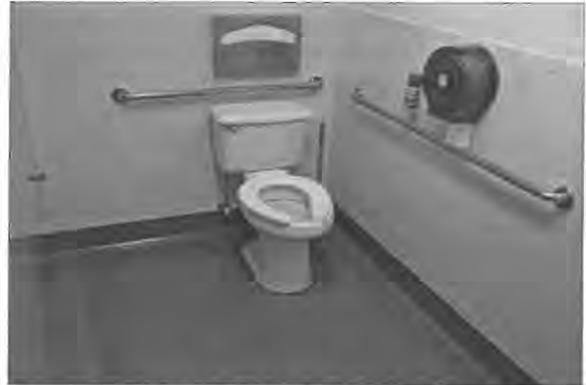
Women's Restroom in the Main Lobby

Finding: The toilet paper dispenser in the stall designated to be accessible in the restroom interferes with the use of the side grab bar.

Citations: CBC 1115B.9.3; ADAAG 4.16.6

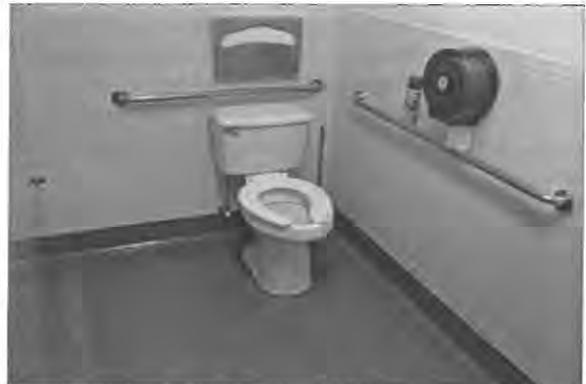
Women's Restroom in the Main Lobby

Finding: The distance from the center of the toilet to the nearest side wall in the stall designated to be accessible in the restroom is less than 18 inches.

Citations: CBC 1115B; ADAAG 4.17; ADAAG Figure 28

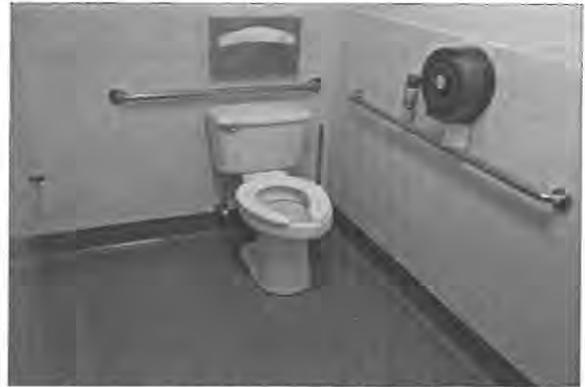
Women's Restroom in the Main Lobby

Finding: The height of all operable parts of the seat cover dispenser in the stall designated to be accessible in the restroom is greater than 40 inches. The seat cover dispenser interferes with the use of the back grab bar.

Citations: CBC 1115B.9.2

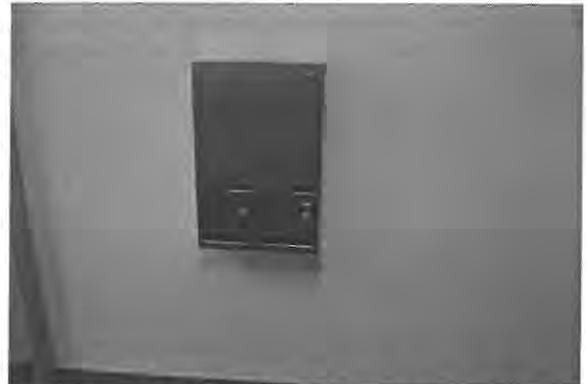
Women's Restroom in the Main Lobby

Finding: The controls and operating mechanisms on the feminine products dispenser in the restroom require tight grasping, pinching, or twisting of the wrist and the use of two hands to operate.

Citations: ADAAG 4.27.4, CBC 1117B.6.4

Full Rec: Modify or replace the feminine products dispenser in the restroom so that its controls and operating mechanisms can be operated with one hand and comply with ADAAG 4.27.4 and CBC 1117B.6.4. Make certain that the force to activate the operating controls shall be no greater than 5 pounds and that the height shall be no greater than 40 inches above the finished floor.

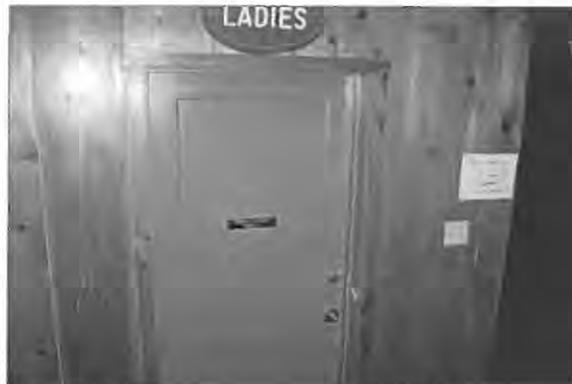
Women's Restroom Next to the Administrative Offices

Finding: There is no signage at the restroom directing individuals to accessible restrooms.

Citations: CBC 1115B.5; ADAAG 4.1.2(7); ADAAG 4.1.6(3)(e)

Alternative Rec: Post signage directing individuals with mobility impairments to accessible restrooms (see CBC 1115B.5 and ADAAG 4.1.2(7)).
(Where Available)

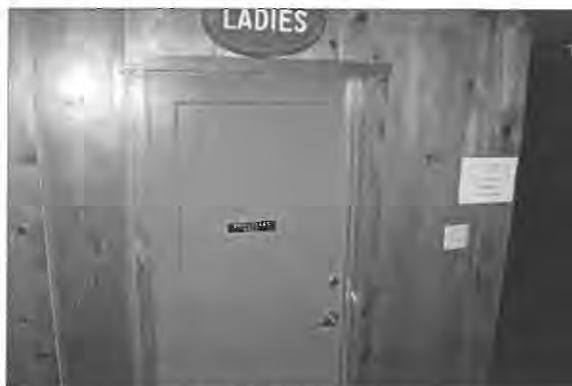
Women's Restroom Next to the Administrative Offices

Finding: The clear opening width of the entrance doorway to the restroom is less than 32 inches.

Citations: ADAAG 4.13.5

Alternative Rec: No action is required at this time regarding the width of entrance doorway to the restroom unless major renovation occurs in the area.
(Where Available)

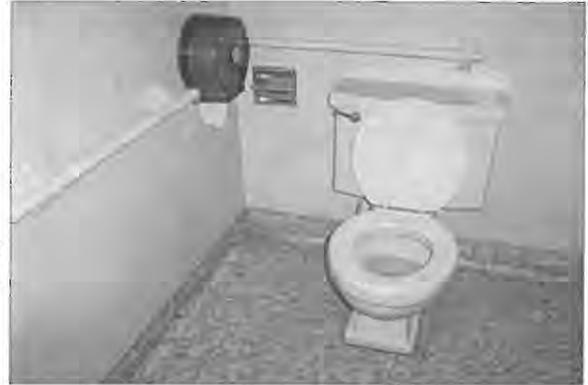
Women's Restroom Next to the Administrative Offices

Finding: This restroom is not accessible and cannot be easily altered. There is not sufficient clear floor space in the restroom. The inward swing of the entrance door reduces the clear floor space in the restroom.

Citations: CBC 1115B.7.1.2; ADAAG 4.16.2

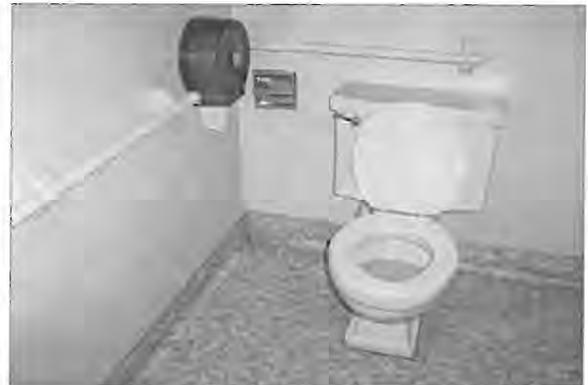
Women's Restroom Next to the Administrative Offices

Finding: The height of each the side and back grab bar in the restroom is not centered at 33 inches above the finished floor.

Citations: CBC 1115B.8.1; ADAAG 4.26

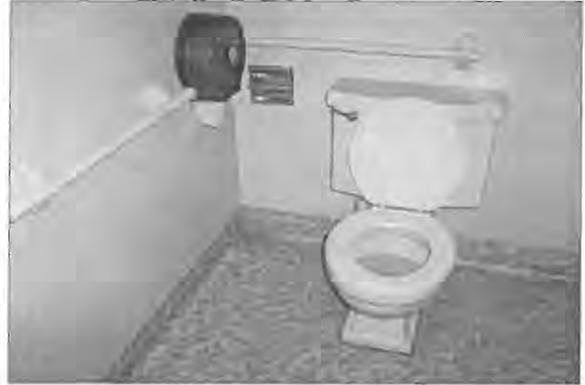
Women's Restroom Next to the Administrative Offices

Finding: The length of the back grab bar in the restroom is less than 36 inches.

Citations: CBC 1115B.8.1; ADAAG 4.26

Alternative No action is required at this time regarding the
Rec: replacement of grab bars in the restroom, unless major
(Where renovation occurs in the area.
Available)

Full Rec: Replace the back grab bar in the restroom with a 36-inch back grab bar complying with ADAAG 4.26 and CBC 1115B.8. Grab bars must be able to support a point load of at least 250 pounds and shall be less than the allowable shear stress of the grab bar material.

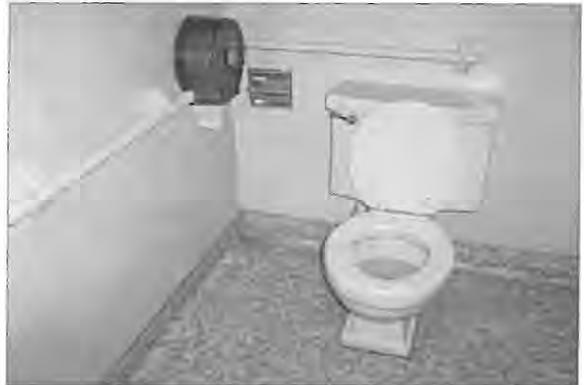
Women's Restroom Next to the Administrative Offices

Finding: The length of the side grab bar in the restroom is less than 42 inches. The side grab bar does not extend 54 inches from the back wall. The distance from the end of the side grab bar to the back wall is greater than 12 inches.

Citations: CBC 1115B.8.1; ADAAG 4.26

Alternative No action is required at this time regarding the
Rec: replacement of grab bars in the restroom, unless major
(Where renovation occurs in the area.
Available)

Full Rec: Replace the side grab bar in the restroom with a 42 or 48-inch side grab bar complying with ADAAG 4.26 and CBC 1115B.8. The front end of the grab bar shall extend at least 54 inches from the back wall and the back end of the grab bar shall be mounted within 12 inches from the back wall. Grab bars must be able to support a point load of at least 250 pounds and shall be less than the allowable shear stress of the grab bar material.

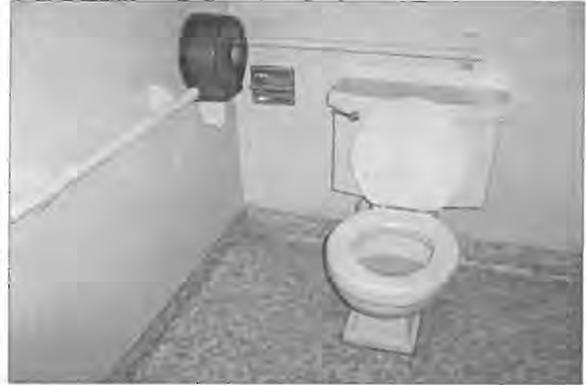
Women's Restroom Next to the Administrative Offices

Finding: The flush control on the toilet in the restroom is not on the wide (approach) side of the toilet.

Citations: ADAAG 4.16.5; ADAAG 4.27.4

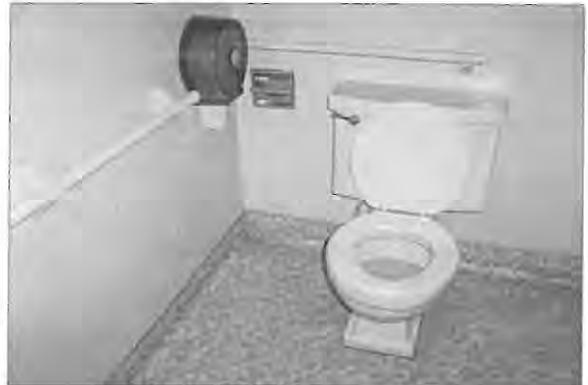
Women's Restroom Next to the Administrative Offices

Finding: The height of the toilet seat in the restroom is less than 17 inches above the finished floor.

Citations: ADAAG 4.16.3

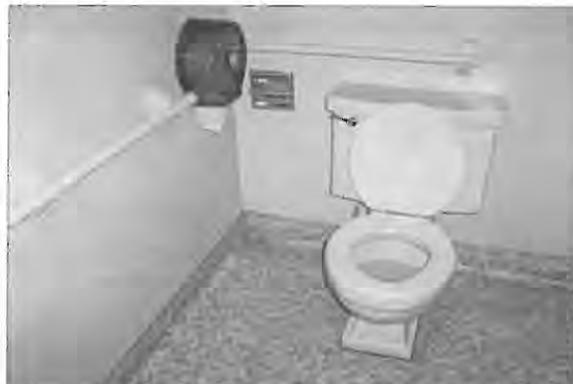
Women's Restroom Next to the Administrative Offices

Finding: The distance from the center of the toilet to the nearest side wall in the restroom is greater than 18 inches.

Citations: CBC 1115B; ADAAG 4.16; ADAAG Figure 28

Alternative Rec: No action is required at this time regarding adjusting the distance to the nearest side wall from the centerline of the toilet in the restroom, unless major renovation occurs in the area.

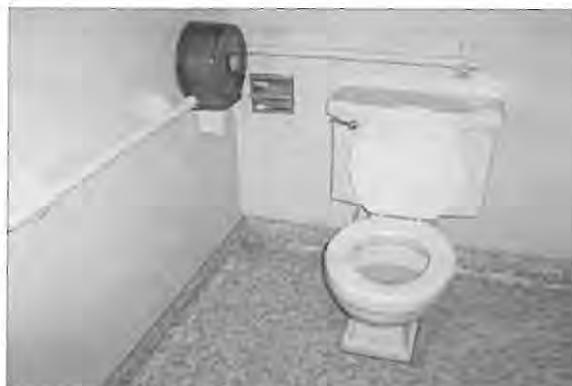
Women's Restroom Next to the Administrative Offices

Finding: The height of all operable parts of the seat cover dispenser in the restroom is greater than 40 inches.

Citations: CBC 1115B.9.2

Alternative Rec: No action is required at this time regarding lowering the seat cover dispenser in the restroom, unless major renovation occurs in the area.

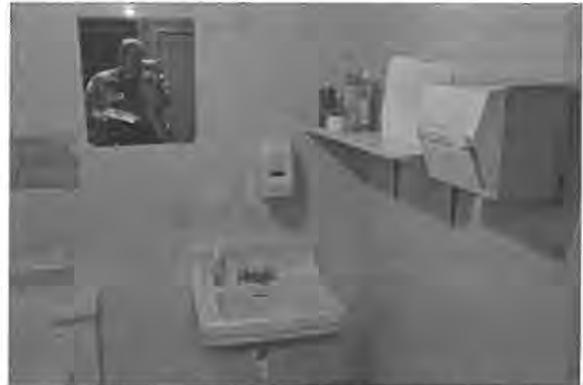
Women's Restroom Next to the Administrative Offices

Finding: The faucet controls on the lavatory in the restroom require tight grasping, pinching, or twisting of the wrist and are not accessible.

Citations: ADAAG 4.19.5

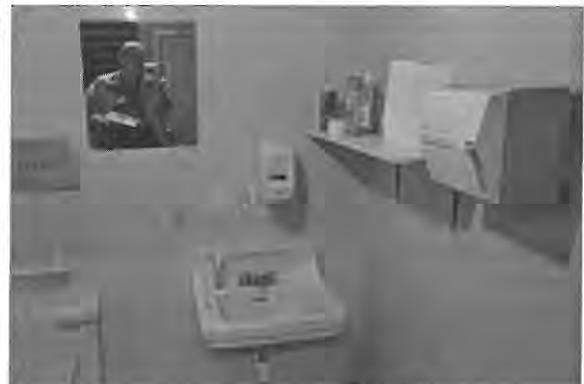
Women's Restroom Next to the Administrative Offices

Finding: The knee clearance space under the lavatory designated to be accessible in the restroom is less than 29 inches.

Citations: ADAAG 4.19.2

Full Rec: Raise or replace the lavatory designated to be accessible in the restroom to provide at least 29 inches of clear knee space between the finished floor and bottom of the lavatory apron and at least 27 inches of knee clearance under the lavatory bowl at a knee depth of 8 inches (see ADAAG 4.19.2). Make certain the height of the top of the lavatory does not exceed 34 inches above the finished floor.

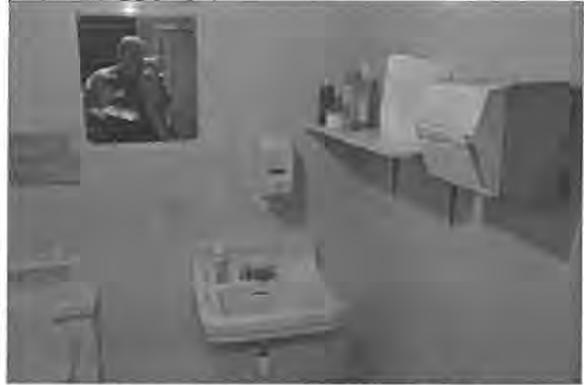
Women's Restroom Next to the Administrative Offices

Finding: The pipes under the lavatory in the restroom do not provide protection against contact.

Citations: ADAAG 4.19.4

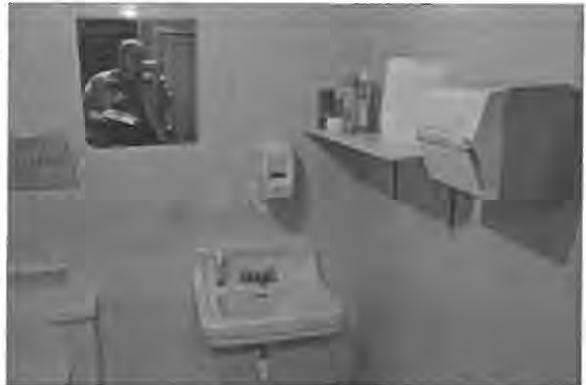
Women's Restroom Next to the Administrative Offices

Finding: The bottom edge of the reflecting surface of the mirror in the restroom is greater than 40 inches above the finished floor.

Citations: ADAAG A4.19.6; CBC 1115B.9.1.2; ADAAG 4.19.6

Full Rec: Lower the mirror in the restroom so that the bottom edge of the reflecting surface is no higher than 40 inches above the finished floor and the topmost portion of the reflecting surface extends at least 74 inches above the finished floor (see ADAAG A4.19.6). A single, full-length mirror is recommended since it can accommodate all people. Make certain to provide a minimum clear floor space in front of the mirror of 30 inches in width and 48 inches in length.

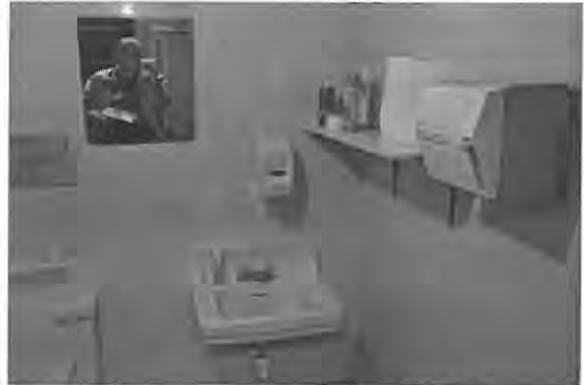
Women's Restroom Next to the Administrative Offices

Citations: CBC 1115B.9.2; ADAAG A4.27

Alternative Rec: No action is required at this time regarding the location of the soap dispenser in the restroom, unless major renovation occurs in the area.
(Where Available)

Full Rec: Relocate the soap dispenser in the restroom to a maximum height of 40 inches for all the controls and operating mechanisms (see CBC 1115B.9.2).

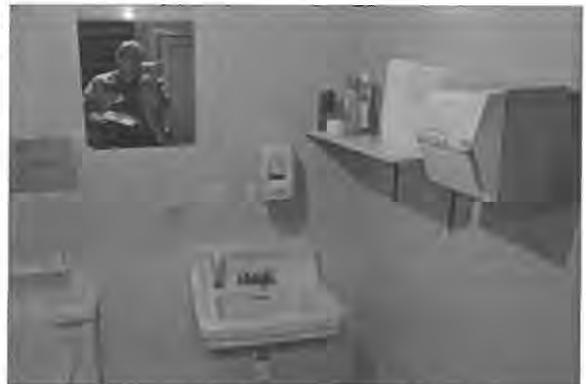
Women's Restroom Next to the Administrative Offices

Citations: CBC 1115B.9.2; ADAAG A4.27

Alternative Rec: No action is required at this time regarding the location of the paper towel dispenser in the restroom, unless major renovation occurs in the area.
(Where Available)

Full Rec: Relocate the paper towel dispenser in the restroom to a maximum height of 40 inches for all the controls and operating mechanisms (see CBC 1115B.9.2).

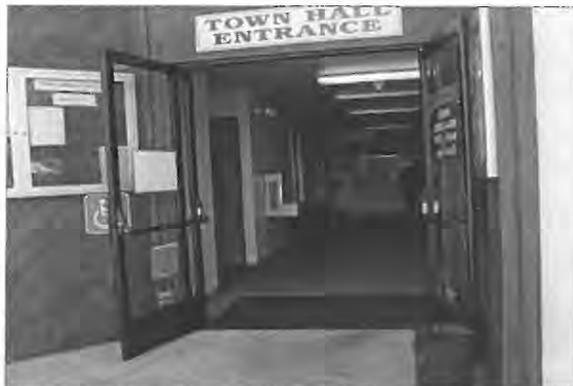
Drinking Fountain Next to the Main Entrance

Finding: There is less than 27 inches knee clearance height.

Alternative Rec: Provide students or teachers with disabilities who are unable to use a drinking fountain with their own personal drinking container, when appropriate. Other situations should be accommodated on a case-by-case basis.

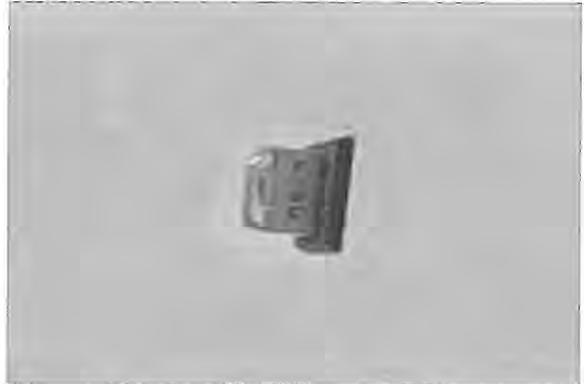
Finding: There are no visual warning devices at the facility.

Citations: CBC 1114B.2.4; ADAAG 4.1.3(14); ADAAG 4.28

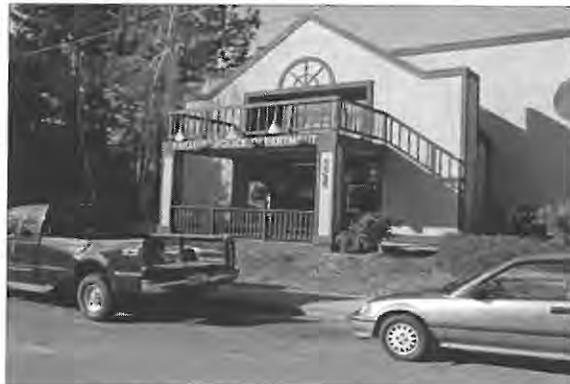
Finding: The Paradise Police Department is located in a two-story building at 5595 Black Olive Drive in Paradise. The facility was built in 1984. The facility was inspected by Disability Access Consultants, Inc., on January 15, 2002. It is noted that there have been permits issued for construction or renovation in this facility after January 26, 1992.

Full Rec: Any renovation or new construction that occurred after January 26, 1992, is subject to meet full code specifications for the California Building Code and ADAAG guidelines. All recommendations in this report that specify relocating Programs, Services or Activities, or make other allowances which avoid physical barrier removal as an alternative minimum compliance will have no effect or bearing on the non-compliant elements of newly constructed or renovated facilities. Consult with your Architect to determine which elements are affected by this requirement. It is recommended that Disability Access Consultants, Inc. is consulted for inspection of any new construction or renovation at the facility.

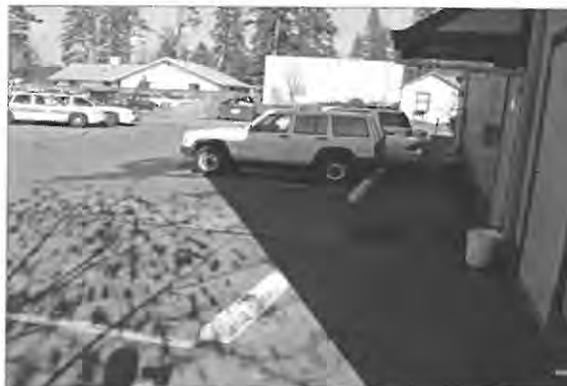
Parking Lot North and Northwest of the Facility

Finding: Paved parking is provided north and northwest of the facility. There are no accessible parking spaces designated out of 18 total parking spaces provided in the parking lot.

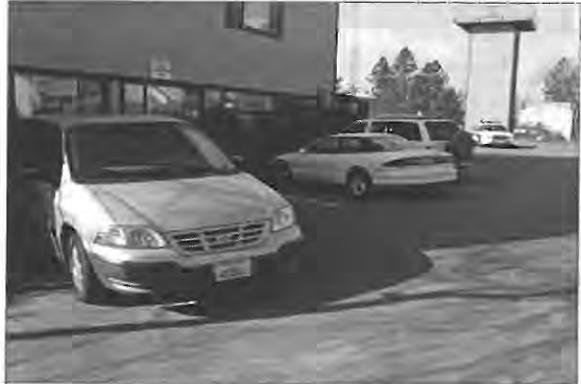
Parking Lot North and Northwest of the Facility

Finding: Each designated accessible parking space required in the parking lot shall provide a post-mounted sign showing the International Symbol of Accessibility.

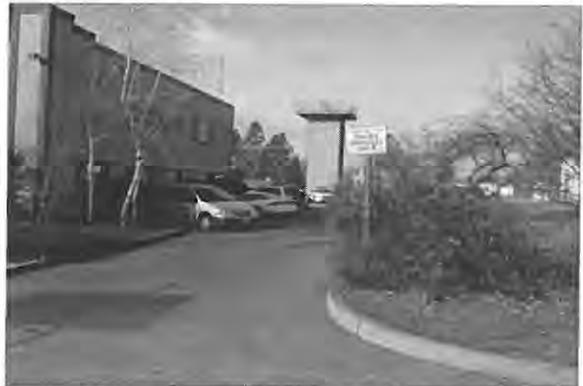
Parking Lot North and Northwest of the Facility

Finding: There is no warning signage posted regarding unauthorized use of accessible parking spaces in the parking lot.

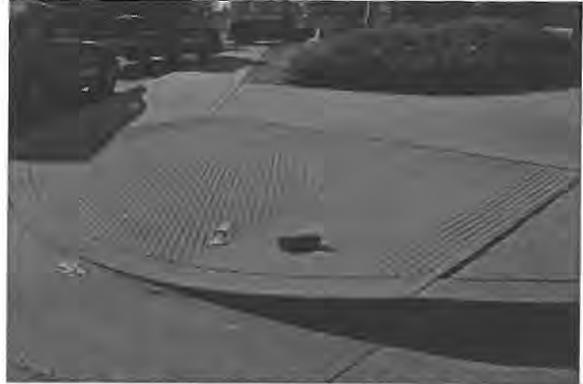
Curb Ramp at Black Olive Drive Entrance

Finding: The slope of the concrete curb-cut ramp is greater than 8.33%. The cross slope is greater than 2%. The slope at the top landing is greater than 2%.

Full Rec: Replace the concrete curb-cut ramp with a concrete curb-cut ramp at least 48 inches in width that provides a slope no greater than 8.33% and a cross slope no greater than 2%. The slope of the top landing shall not exceed 2% and shall provide at least 48 inches in length of maneuvering clearance. The bottom landing shall provide a smooth transition. The side flares shall be no greater in slope than 10%.

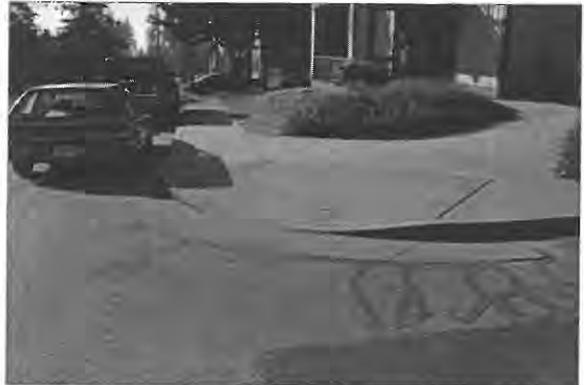
Curb Ramp at Black Olive Drive Entrance

Finding: The grooved border along the top and sides of the ramp measures less than 12 inches in width.

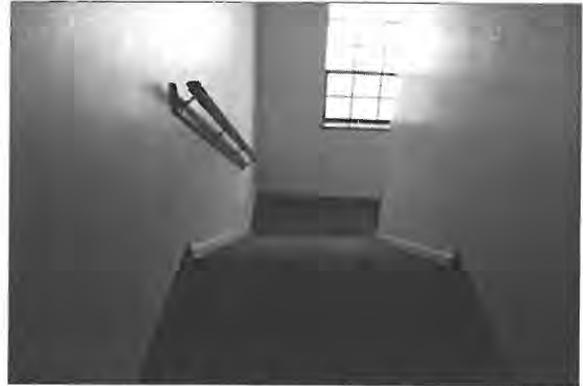
Accessible Path of Travel to the Upper Floor

Finding: There are only stairs to the primary functions provided on the upper floor of the facility, preventing access to individuals with mobility impairments.

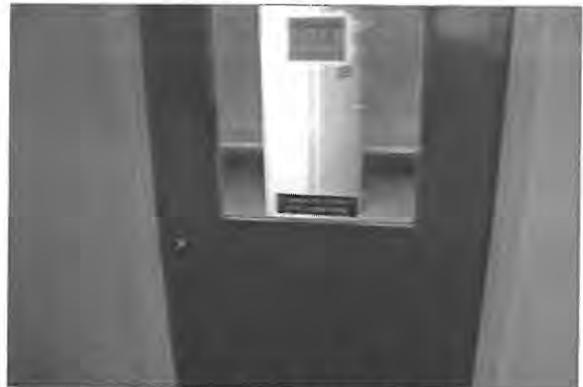
Holding Cells in the Facility

Finding: There are two holding cells next to the west entrance. Each holding cell has sanitary facilities.

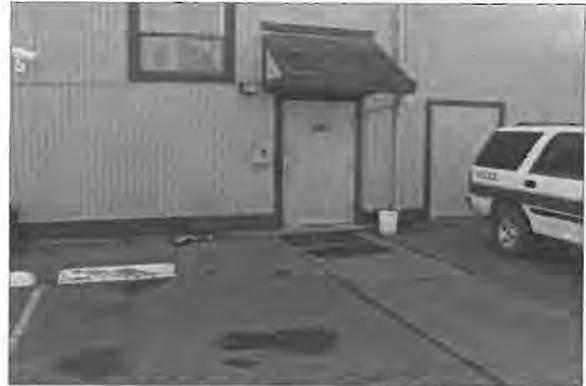
Path of Travel at the West Entrance

Finding: There is a step at the west entrance of the building, preventing access to individuals with mobility impairments. There is no signage posted directing individuals with disabilities to the accessible entrance.

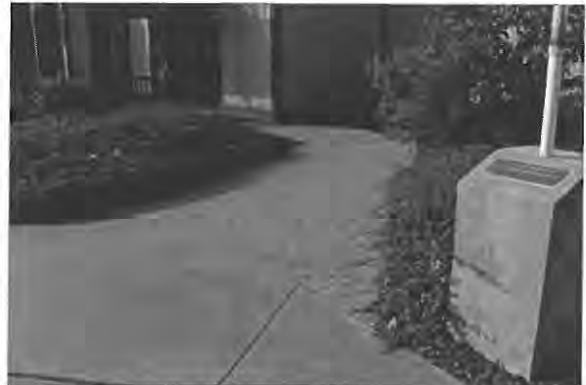
Path of Travel Outside of the Main Entrance

Finding: There are slopes greater than 5% on the primary path of travel outside of the main entrance to Black Olive Drive.

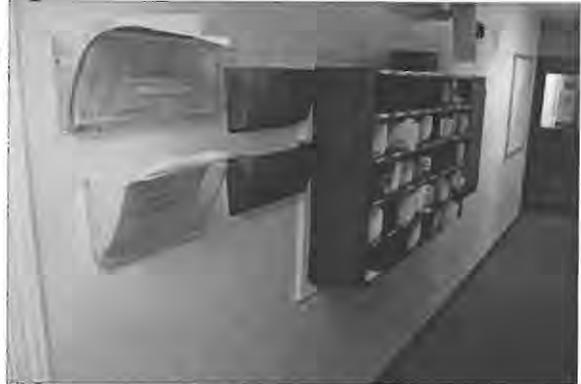
Protruding Object

Finding: The leading edge of the wall-mounted wood mail-box, in the main hallway on the west side of the building, is more than 4 inches from the wall and greater than 27 inches from the floor and protrudes into the primary path of travel.

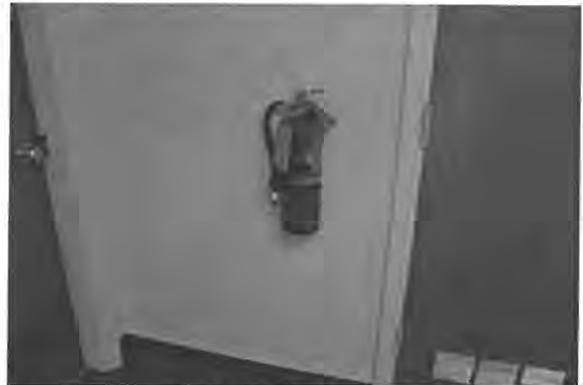
Protruding Object

Finding: The leading edge of the fire extinguisher, outside of the locker rooms, is more than 4 inches from the wall and greater than 27 inches from the floor and protrude into the primary path of travel.

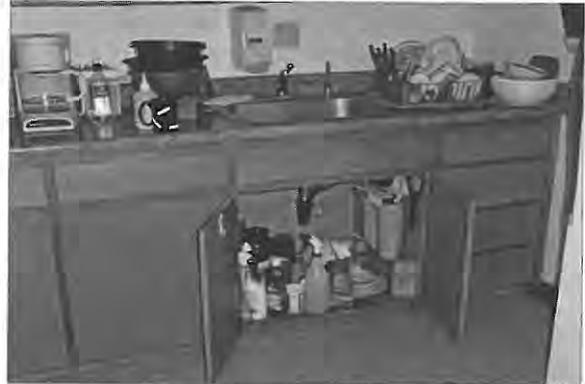
Sink in the Staff Lounge

Finding: The sink in the staff lounge is in an enclosed cabinet, thereby preventing an accessible forward approach.

Alternative Rec: No action is required at this time regarding the front approach clearance of the sink, unless major renovation occurs in the area.
(Where Available)

Full Rec: Sinks must provide clear floor space in front of the sink for an accessible forward approach and shall provide at least 27 inches clear knee space and a minimum of nine inches clear toe space (see ADAAG 4.19.2). If neither clear floor space and knee and toe clearance can be provided, remove the sink cabinet and replace with an accessible wall-mounted sink unit.

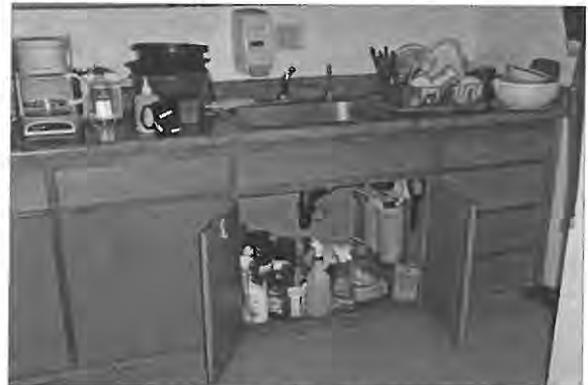
Sink in the Staff Lounge

Finding: The finger-pull on the cabinet enclosing the sink in the staff lounge, does not provide at least 1 1/2 inches of clearance.

Alternative Rec: No action is required at this time regarding the hardware on the cabinet enclosing the sink, unless major renovation occurs in the area.
(Where Available)

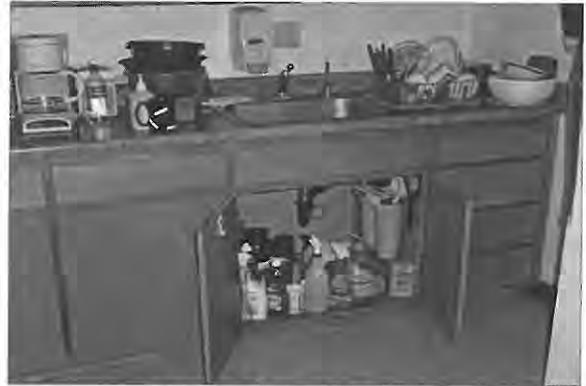
Sink in the Staff Lounge

Finding: The pipes under the sink in the staff lounge do not provide protection against contact.

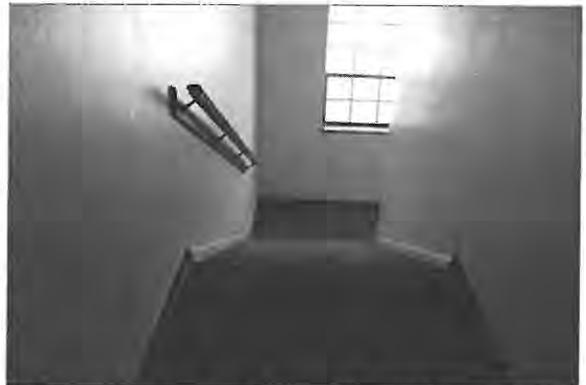
Accessible Path of Travel to the Upper Floor

Finding: There are programs, services and activities to staff and the public provided at this location. The interior stairways are the primary access with no other means to the area.

Alternative Rec: Since all programs, services and activities are required to be accessible, it is recommended that the program be relocated to an accessible area on an accessible level.
(Where Available) Otherwise, another means of access to the location will be required.

Full Rec: Since programs, services and activities to staff and the public are provided in this location, those programs, services and activities are required to be made accessible. It is recommended that an elevator be installed or other means of vertical access.

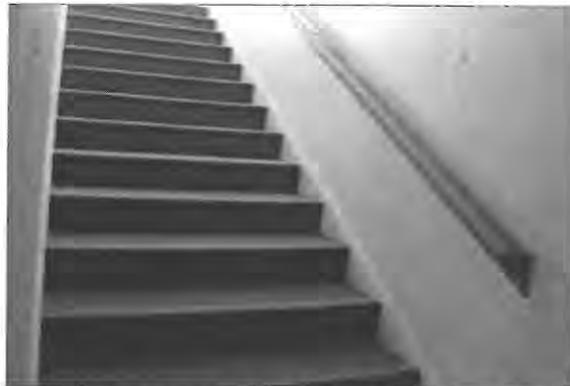
Interior Stairs to the Upper Floor, by the Captain's Office

Finding: There is no detectable striping on the top and bottom treads of the interior stairway.

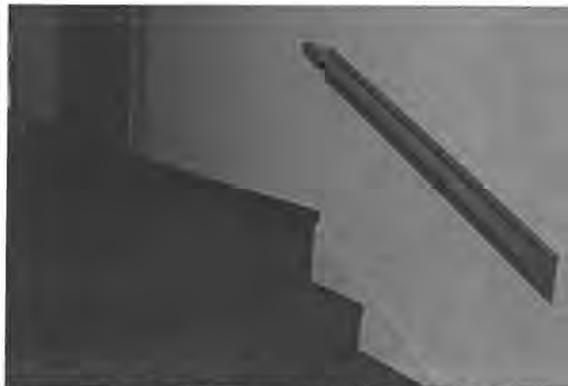
Interior Stairs to the Upper Floor, by the Captain's Office

Finding: There is only one handrail on the stairway. The handrail does not provide 12-inch extensions beyond the top and bottom treads and the ends of the handrail end abruptly. The diameter of the gripping surface is greater than 1 1/2 inches. The handrail is mounted at a height less than 34 inches.

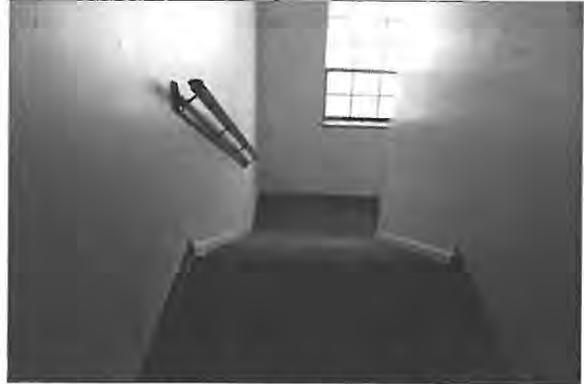
Interior Stairs to the Upper Floor, by the Holding Cell

Finding: There is no detectable striping on the top and bottom treads of the interior stairway.

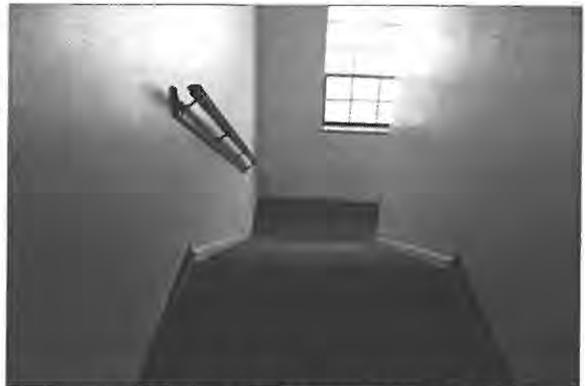
Interior Stairs to the Upper Floor, by the Holding Cell

Finding: There is only one handrail on the stairway. The handrail does not provide 12-inch extensions beyond the top and bottom treads and the ends of the handrail end abruptly. The diameter of the gripping surface is greater than 1 1/2 inches.

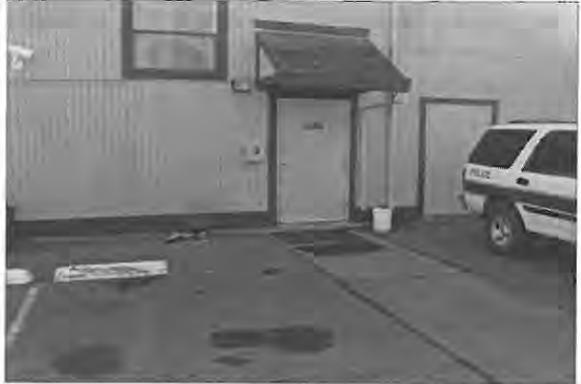
Exterior Door Hardware

Finding: The exterior passage door, at the west entrance, has a round doorknob, which requires twisting of the wrist to operate.

Full Rec: Replace the existing door hardware with accessible hardware (see ADAAG 4.13.9).

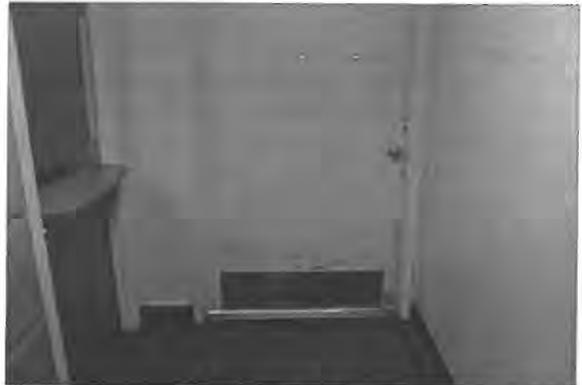
Exterior Doors

Finding: There is less than 12 inches of clearance on the latch side of the west entrance door from the push side.

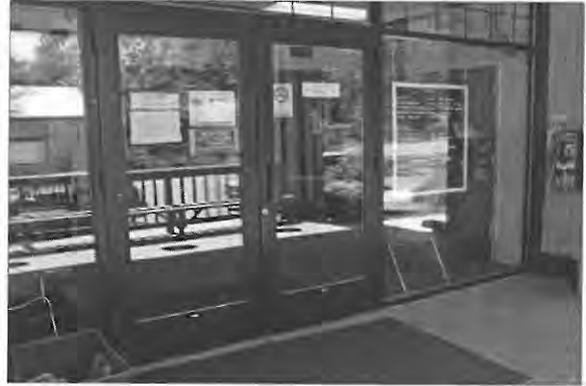
Exterior Doors

Finding: The door opening force for some exterior doors is greater than 8 1/2 pounds of force.

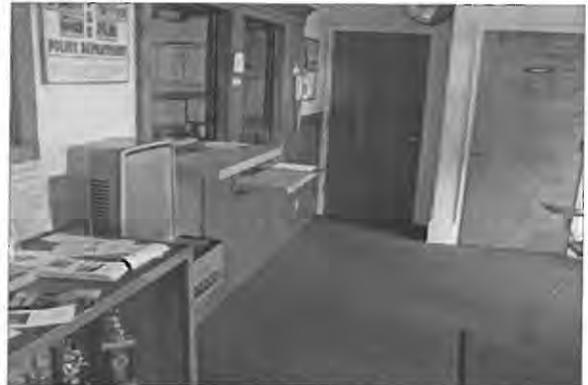
Interior Door Hardware

Finding: Interior passage doors, throughout the facility (except the communications center in the middle of the facility) have round doorknobs, which require twisting of the wrist to operate.

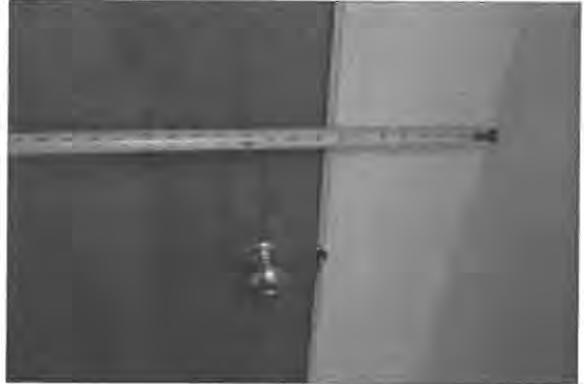
Interior Doors

Finding: The interior door, in the main lobby to the interior offices, is set in an alcove. There is less than 18 inches of clearance on the latch side of the interior entrance door from the pull side.

Alternative Rec: Provide assisted service for individuals with disabilities.
(Where Available)

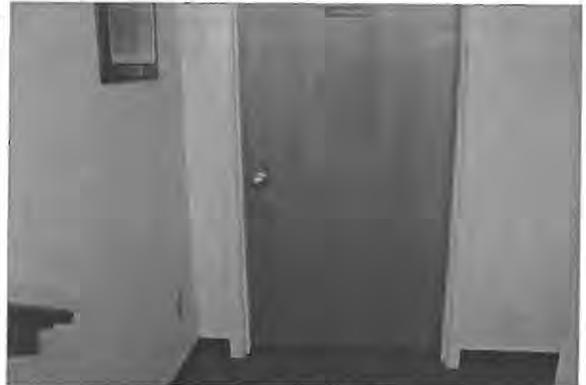
Interior Doors

Finding: The door opening force for some interior doors is greater than 5 pounds of force.

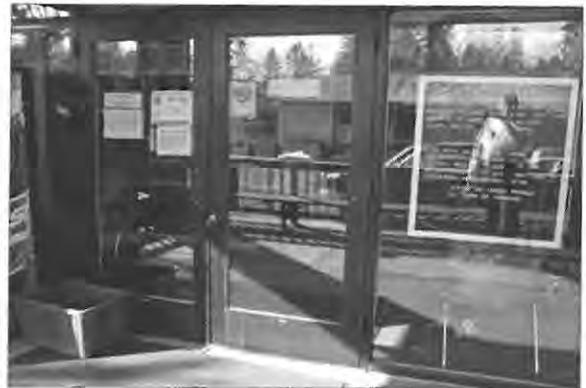
Directional Signage

Finding: There is no directional signage to the main entrance, E.O.C., communication center or other common use areas.

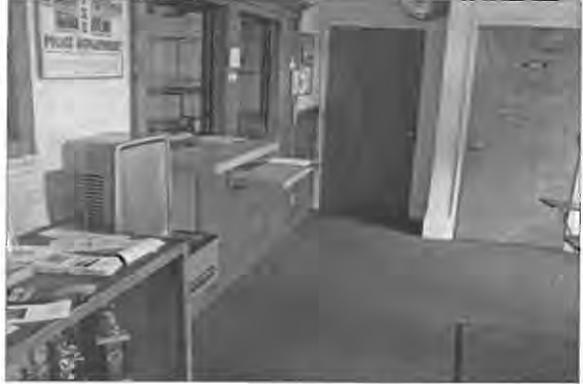
Facility Signage

Finding: The main entrance, communication center, E.O.C., interior offices and other common use rooms do not have accessible signage mounted on the wall adjacent to the latch side of the door.

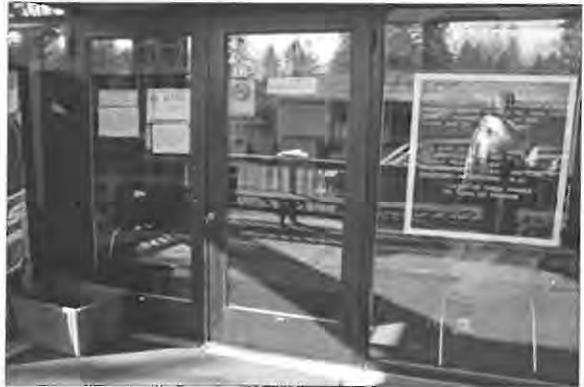
Facility Signage

Finding: There is no signage with the International Symbol of Accessibility on the entrance door to the facility designating it as accessible.

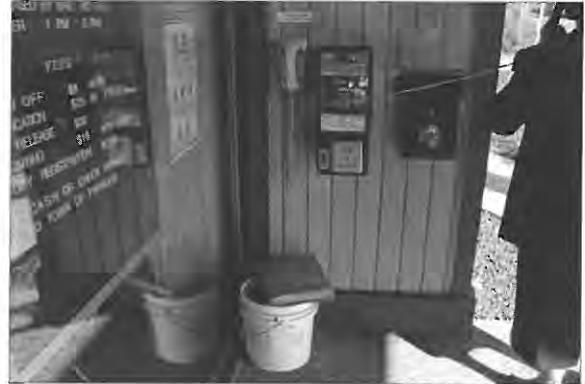
Pay Telephone

Finding: There is one pay telephone at the facility, located next to the main entrance.

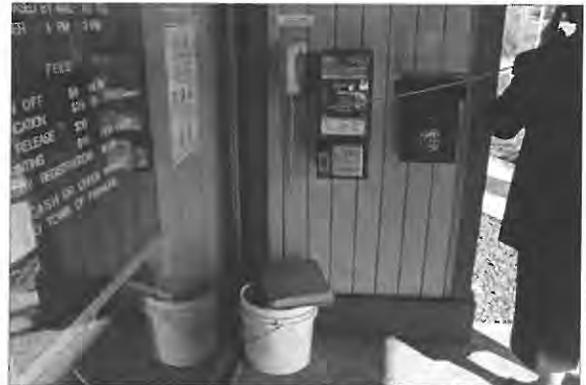
Pay Telephone

Finding: There is not sufficient clear floor space provided in front of the pay telephone, due to the sand filled bucket.

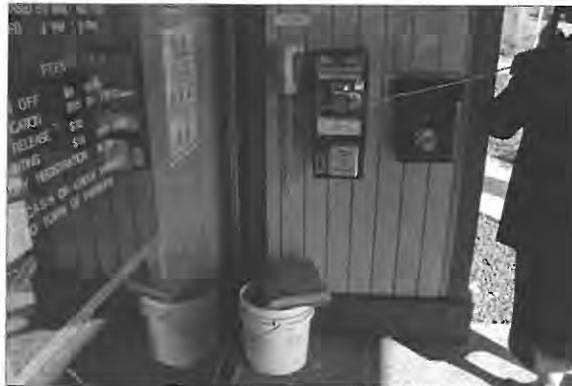
Public Assistance Phone

Finding: There is not sufficient clear floor space provided in front of the public assistance telephone, next to the main entrance.

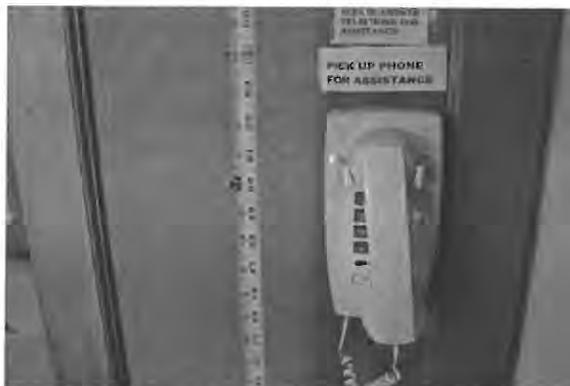
Public Assistance Phone

Finding: The highest operable part of the public assistance telephone, next to the main entrance, exceeds the forward reach range of 48 inches.

Full Rec: Lower or replace the public assistance telephone so that it has a reach height no greater than 48 inches above the finished floor (see CBC 1106B.4.2 and ADAAG 8.4).

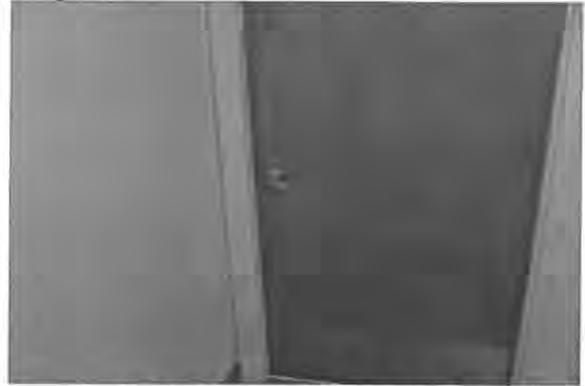
Men's Restroom in the Lobby

Finding: There is no signage indicating accessibility on the latch side of the entry door of the restroom.

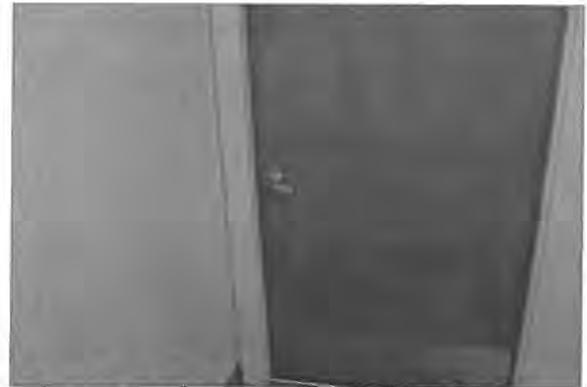
Men's Restroom in the Lobby

Finding: There is less than 12 inches on the latch side of the entrance door to the restroom from the push side.

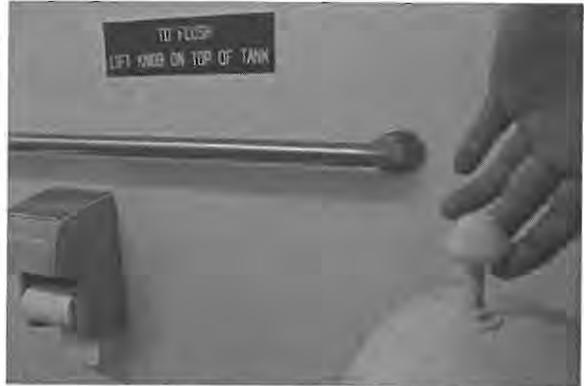
Men's Restroom in the Lobby

Finding: The flush control on the toilet in the restroom requires tight grasping, pinching, or twisting of the wrist and is not accessible.

Full Rec: Replace the flush control on the toilet in the restroom. Lever-operated, push-type, touch-type or electronically controlled mechanisms are acceptable elements (see ADAAG 4.19.5).

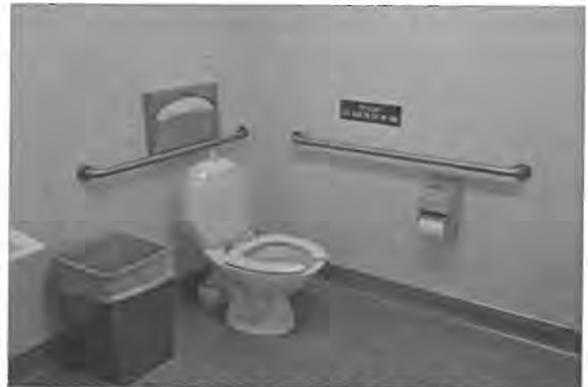
Men's Restroom in the Lobby

Finding: The height of the toilet seat in the restroom is less than 17 inches above the finished floor.

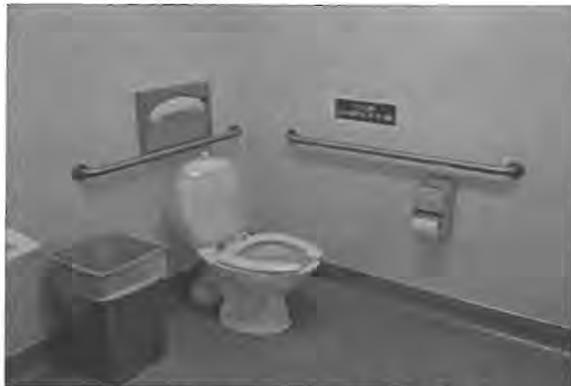
Men's Restroom in the Lobby

Finding: The distance from the center of the toilet to the nearest side wall in the restroom is greater than 18 inches.

Citations: CBC 1115B; ADAAG 4.16; ADAAG Figure 28

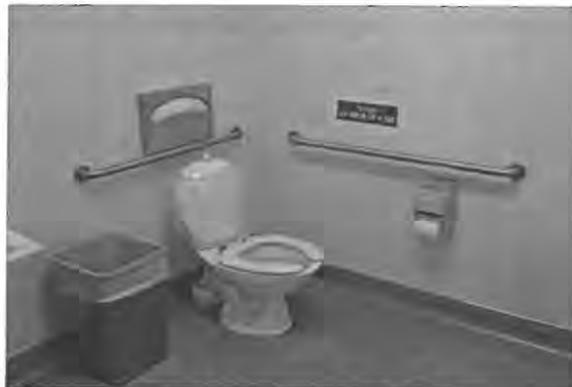
Men's Restroom in the Lobby

Finding: The height of all operable parts of the seat cover dispenser in the restroom is greater than 40 inches. The seat cover dispenser interferes with the use of the back grab bar.

Citations: CBC 1115B.9.2

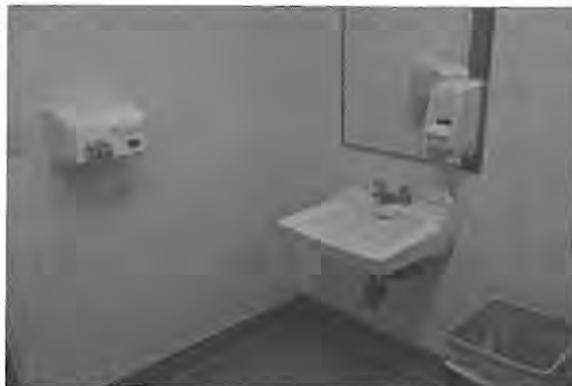
Men's Restroom in the Lobby

Finding: The knee clearance space under the lavatory designated to be accessible in the restroom is less than 29 inches.

Citations: ADAAG 4.19.2

Full Rec: Raise or replace the lavatory designated to be accessible in the restroom to provide at least 29 inches of clear knee space between the finished floor and bottom of the lavatory apron and at least 27 inches of knee clearance under the lavatory bowl at a knee depth of 8 inches (see ADAAG 4.19.2). Make certain the height of the top of the lavatory does not exceed 34 inches above the finished floor.
