Town of Paradise

ADA self-evaluation transition plan

June 2015

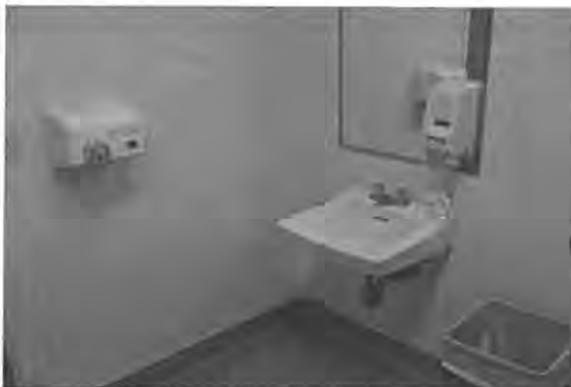
Men's Restroom in the Lobby

Finding: The pipes under the lavatory in the restroom do not provide protection against contact.

Citations: ADAAG 4.19.4

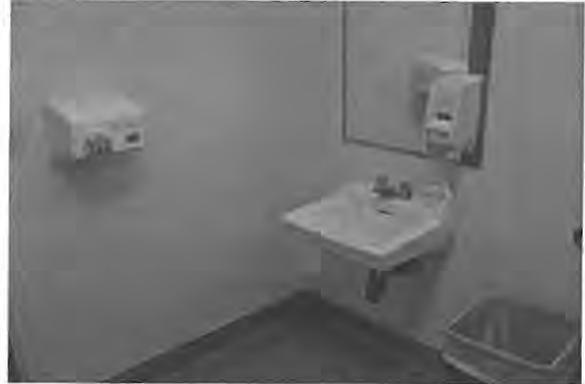
Men's Restroom in the Lobby

Finding: The height of the controls and operating mechanisms for the soap dispenser in the restroom is greater than 40 inches above the finished floor.

Citations: CBC 1115B.9.2; ADAAG A4.27

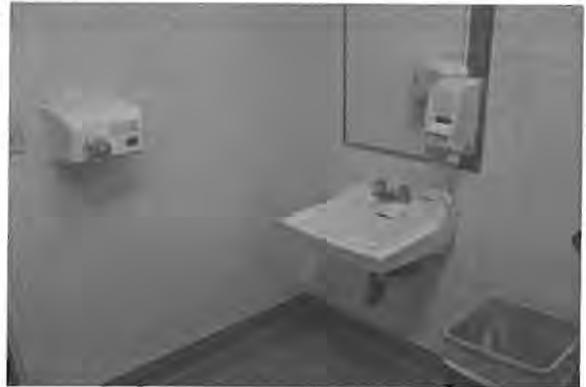
Men's Restroom in the Lobby

Finding: The height of the controls and operating mechanisms for the hand dryer in the restroom is greater than 40 inches above the finished floor.

Citations: CBC 1115B.9.2; ADAAG A4.27

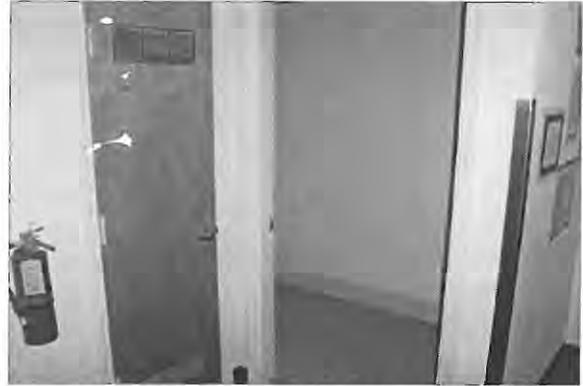
Men's Restroom in the Locker Room

Finding: This restroom is not located on an accessible level.

Citations: CBC 1104B.3; CBC 1115B.5; ADAAG 4.1.2(7); ADAAG 4.1.6(3)(e)

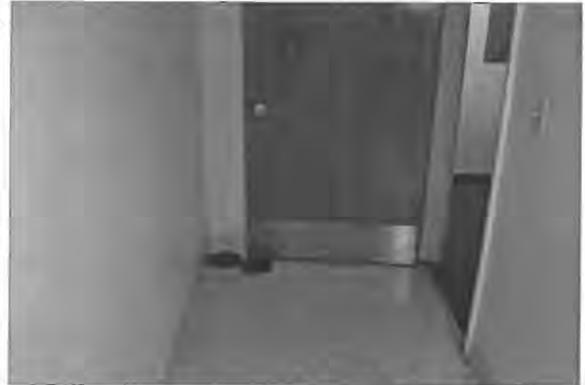
Men's Restroom in the Locker Room

Finding: The entrance door to the restroom has a round doorknob that requires tight grasping or twisting of the wrist to operate.

Citations: ADAAG 4.13.9

Full Rec: Replace the door hardware mounted on the restroom complying with ADAAG 4.13.9. Make certain accessible door hardware is mounted no higher than 48 inches above the finished floor.

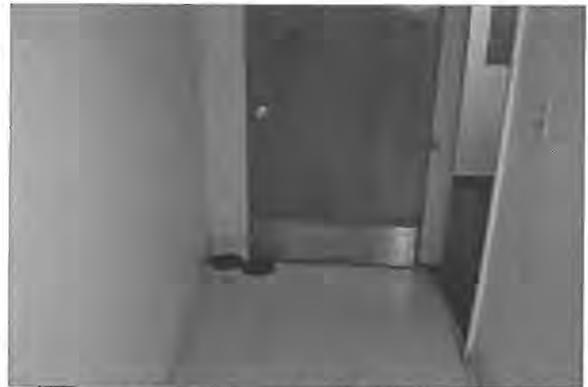
Men's Restroom in the Locker Room

Finding: The door landing at the entrance to the restroom does not provide at least 60 inches in the direction of the door swing.

Citations: ADAAG 4.13.6; CBC 1133B.2.4.2

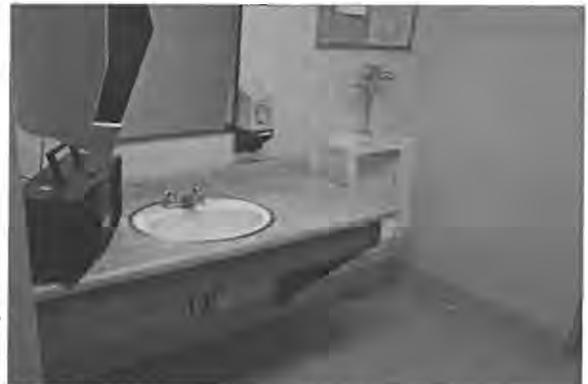
Men's Restroom in the Locker Room

Finding: The urinal in the restroom does not have a tapered, elongated rim. The urinal rim is greater than 17 inches above the finished floor. The flush control valve on the urinal is greater than 44 inches above the finished floor.

Citations: ADAAG 4.18.2

Alternative Rec: No action is required at this time regarding the replacement of the urinal designated to be accessible in the restroom, unless major renovation occurs in the area.
(Where Available)

Full Rec: Replace the urinal designated to be accessible in the restroom with a wall-mounted or stall-type tapered, elongated rim unit complying with ADAAG 4.18.2. The height of the rim surface of the urinal designated to be accessible shall not exceed 17 inches above the finished floor and the flush control valve shall not exceed a height of 44 inches above the finished floor.

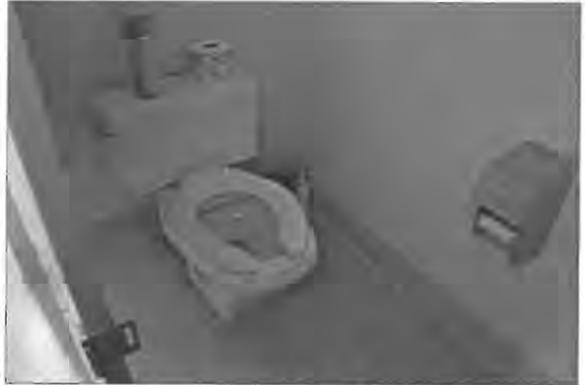
Men's Restroom in the Locker Room

Finding: There is insufficient clear floor space in the stall designated to be accessible in the restroom.

Citations: CBC 1115B; ADAAG 4.17.3; ADAAG A4.17.3

Alternative Rec: No action is required at this time regarding the modification or replacement of the stall designated to be accessible in the restroom, unless major renovation occurs in the area.

Full Rec: Modify or replace the stall designated to be accessible in the restroom so that it complies with ADAAG 4.17.3, CBC 1115B and CBC Figures 11B-1A and 1B. A standard accessible stall requires 60 inches in width with 56 inches depth for wall-mounted toilets or 59 inches depth for floor-mounted toilets to accommodate individuals in wheelchairs. The minimum width of a front-approach doorway shall provide at least 32 inches of a side-approach doorway shall provide at least 34 inches.

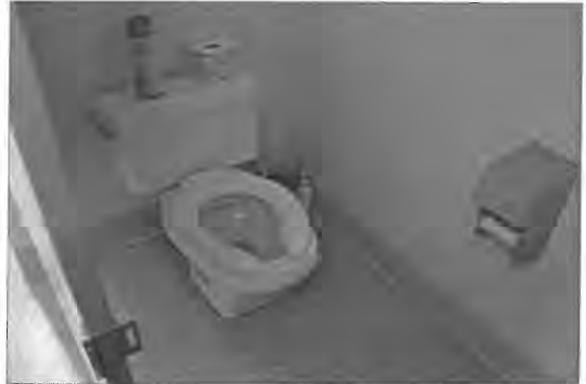
Men's Restroom in the Locker Room

Finding: There are no grab bars in the stall designated to be accessible in the restroom.

Citations: CBC 1115B.8; ADAAG 4.26

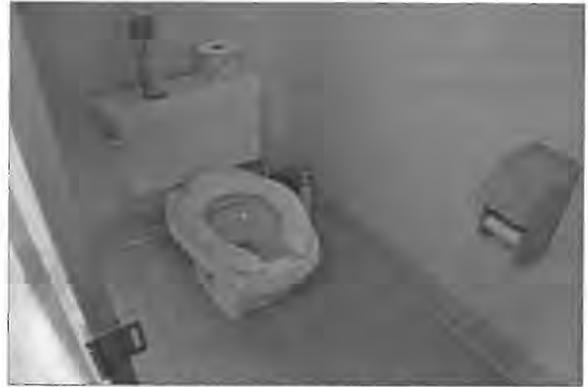
Men's Restroom in the Locker Room

Finding: The height of the toilet seat in the stall designated to be accessible in the restroom is less than 17 inches above the finished floor.

Citations: ADAAG 4.16.3

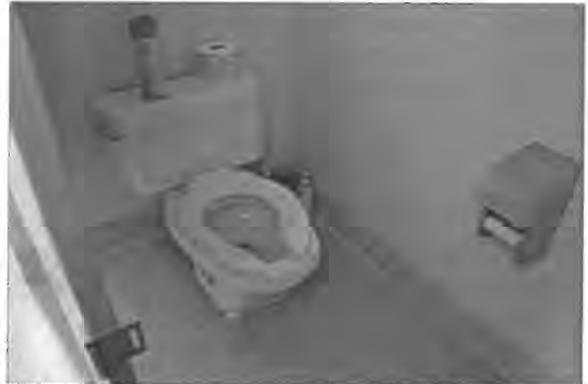
Men's Restroom in the Locker Room

Finding: The distance from the center of the toilet to the nearest side wall in the stall designated to be accessible in the restroom is less than 18 inches.

Citations: CBC 1115B; ADAAG 4.17; ADAAG Figure 28

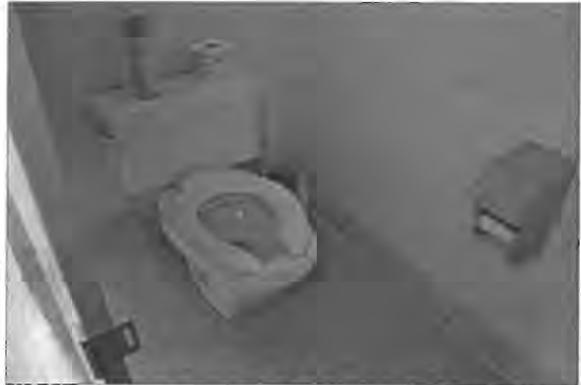
Men's Restroom in the Locker Room

Finding: The height of all operable parts of the seat cover dispenser in the stall designated to be accessible in the restroom is greater than 40 inches.

Citations: CBC 1115B.9.2

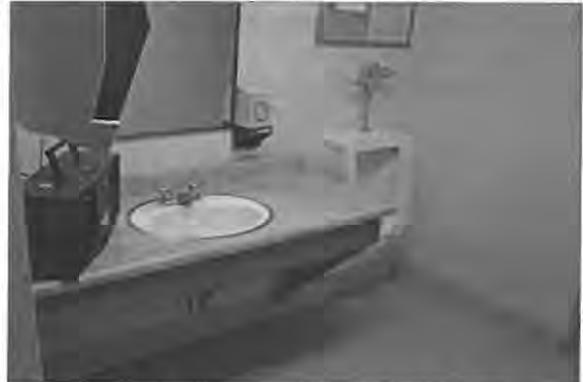
Men's Restroom in the Locker Room

Finding: The knee clearance space under the lavatory designated to be accessible in the restroom is less than 29 inches.

Citations: ADAAG 4.19.2

Full Rec: Raise or replace the lavatory designated to be accessible in the restroom to provide at least 29 inches of clear knee space between the finished floor and bottom of the lavatory apron and at least 27 inches of knee clearance under the lavatory bowl at a knee depth of 8 inches (see ADAAG 4.19.2). Make certain the height of the top of the lavatory does not exceed 34 inches above the finished floor.

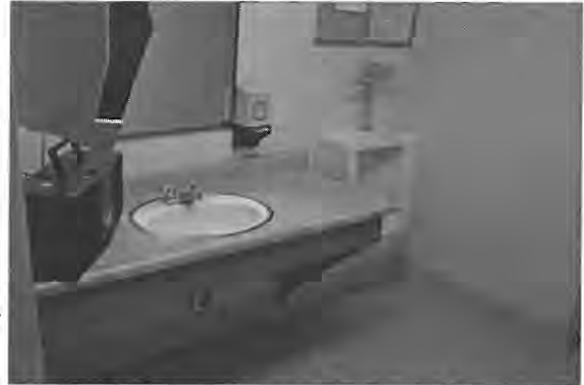
Men's Restroom in the Locker Room

Finding: The pipes under the lavatory in the restroom do not provide protection against contact.

Citations: ADAAG 4.19.4

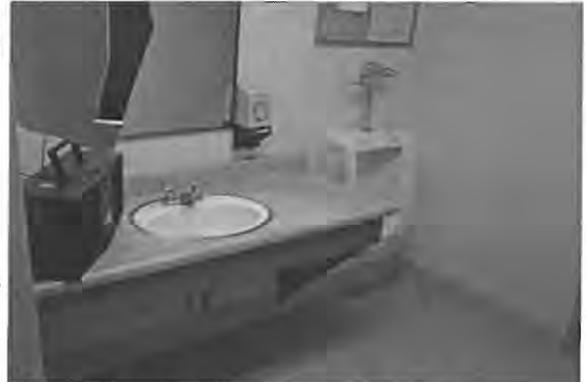
Men's Restroom in the Locker Room

Finding: The bottom edge of the reflecting surface of the mirror in the restroom is greater than 40 inches above the finished floor.

Citations: ADAAG A4.19.6; CBC 1115B.9.1.2; ADAAG 4.19.6

Full Rec: Lower the mirror in the restroom so that the bottom edge of the reflecting surface is no higher than 40 inches above the finished floor and the topmost portion of the reflecting surface extends at least 74 inches above the finished floor (see ADAAG A4.19.6). A single, full-length mirror is recommended since it can accommodate all people. Make certain to provide a minimum clear floor space in front of the mirror of 30 inches in width and 48 inches in length.

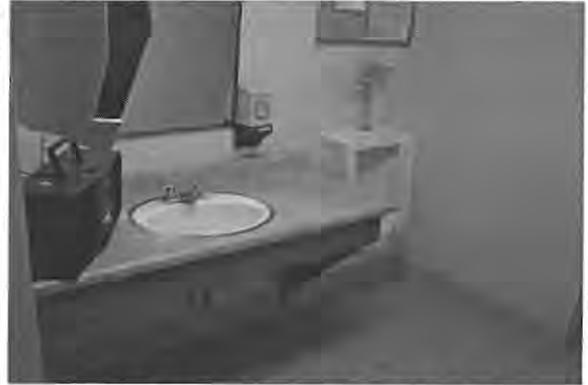
Men's Restroom in the Locker Room

Finding: The height of the controls and operating mechanisms for the paper towel dispenser in the restroom is greater than 40 inches above the finished floor.

Citations: CBC 1115B.9.2; ADAAG A4.27

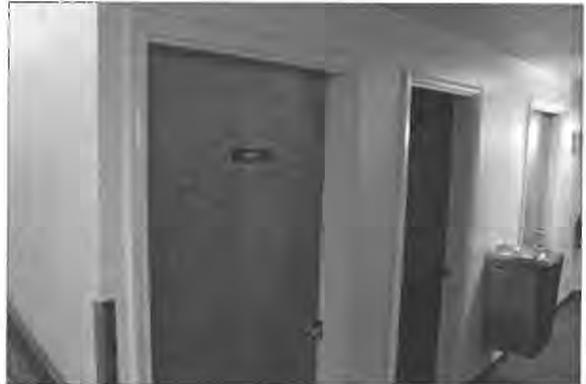
Men's Restroom Next to the Staff Lounge

Finding: There is no signage at the restroom directing individuals to accessible restrooms.

Citations: CBC 1115B.5; ADAAG 4.1.2(7); ADAAG 4.1.6(3)(e)

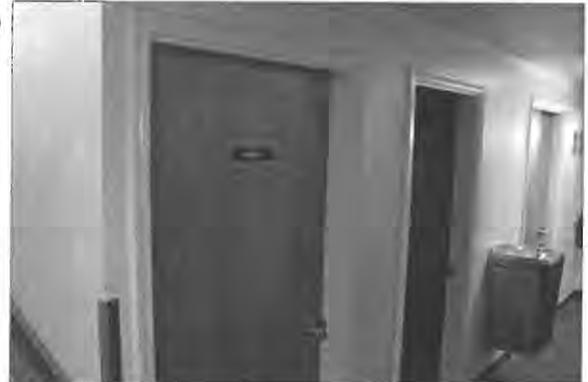
Men's Restroom Next to the Staff Lounge

Finding: The entrance door to the restroom has a round doorknob that requires tight grasping or twisting of the wrist to operate.

Citations: ADAAG 4.13.9

Full Rec: Replace the door hardware mounted on the restroom complying with ADAAG 4.13.9. Make certain accessible door hardware is mounted no higher than 48 inches above the finished floor.

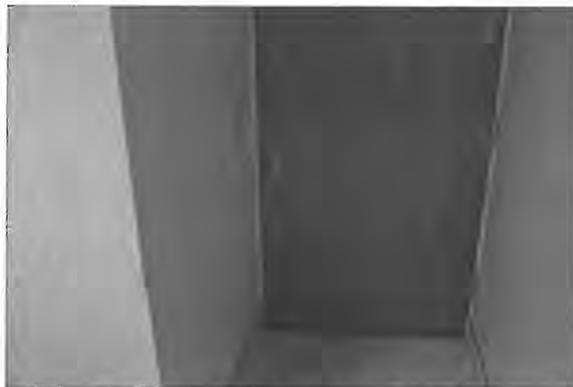
Men's Restroom Next to the Staff Lounge

Finding: There is less than 18 inches of clearance on the latch side of the entrance door to the restroom from the pull side.

Citations: ADAAG 4.13.6; CBC 1133B.2.4.2

Alternative Rec: No action is required at this time regarding the latch side clearance at the entrance door to the restroom unless major renovation occurs in the area.
(Where Available)

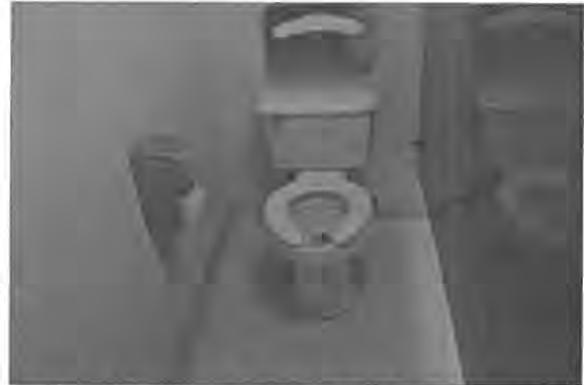
Men's Restroom Next to the Staff Lounge

Finding: There is insufficient clear floor space in the stall designated to be accessible in the restroom.

Citations: CBC 1115B; ADAAG 4.17.3; ADAAG A4.17.3

Full Rec: Modify or replace the stall designated to be accessible in the restroom so that it complies with ADAAG 4.17.3, CBC 1115B and CBC Figures 11B-1A and 1B. A standard accessible stall requires 60 inches in width with 56 inches depth for wall-mounted toilets or 59 inches depth for floor-mounted toilets to accommodate individuals in wheelchairs. The minimum width of a front-approach doorway shall provide at least 32 inches of a side-approach doorway shall provide at least 34 inches.

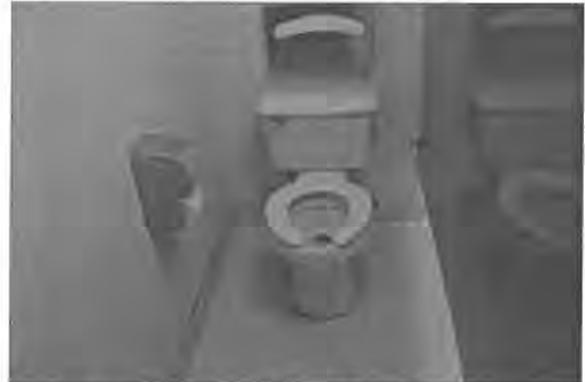
Men's Restroom Next to the Staff Lounge

Finding: There are no grab bars in the stall designated to be accessible in the restroom.

Citations: CBC 1115B.8; ADAAG 4.26

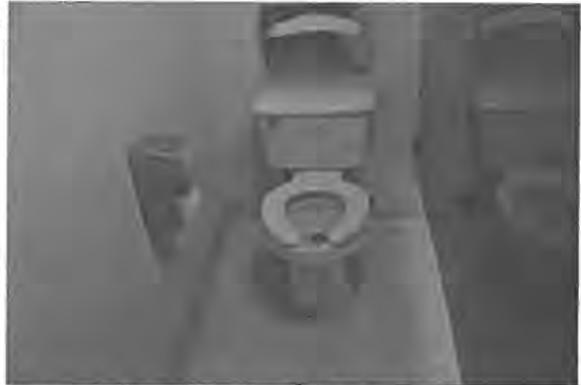
Men's Restroom Next to the Staff Lounge

Finding: The flush control on the toilet in the stall designated to be accessible in the restroom is not on the wide (approach) side of the toilet.

Citations: ADAAG 4.16.5; ADAAG 4.27.4

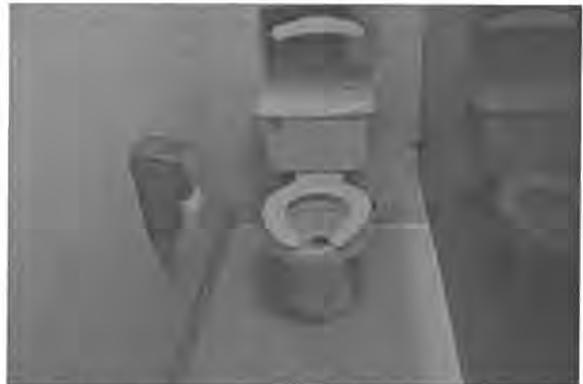
Men's Restroom Next to the Staff Lounge

Finding: The distance from the center of the toilet to the nearest side wall in the stall designated to be accessible in the restroom is less than 18 inches.

Citations: CBC 1115B; ADAAG 4.17; ADAAG Figure 28

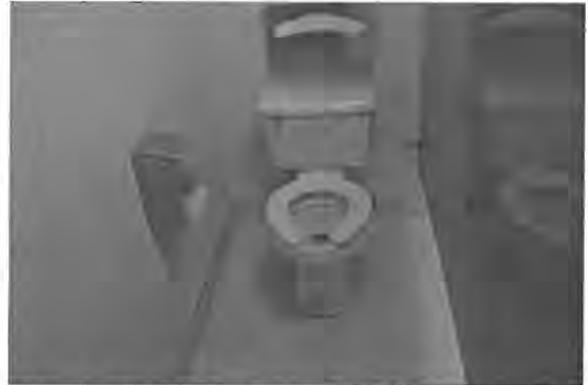
Men's Restroom Next to the Staff Lounge

Finding: The height of all operable parts of the seat cover dispenser in the stall designated to be accessible in the restroom is greater than 40 inches.

Citations: CBC 1115B.9.2

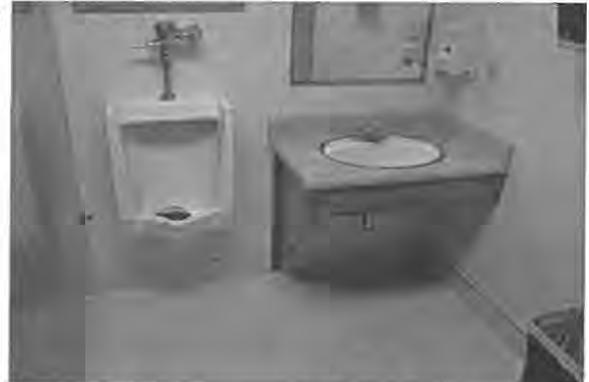
Men's Restroom Next to the Staff Lounge

Finding: The knee clearance space under the lavatory designated to be accessible in the restroom is less than 29 inches.

Citations: ADAAG 4.19.2

Full Rec: Raise or replace the lavatory designated to be accessible in the restroom to provide at least 29 inches of clear knee space between the finished floor and bottom of the lavatory apron and at least 27 inches of knee clearance under the lavatory bowl at a knee depth of 8 inches (see ADAAG 4.19.2). Make certain the height of the top of the lavatory does not exceed 34 inches above the finished floor.

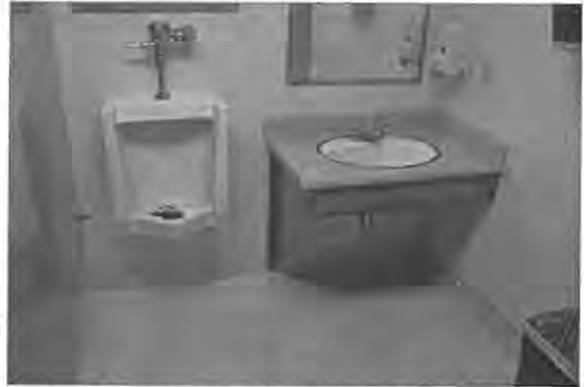
Men's Restroom Next to the Staff Lounge

Citations: ADAAG 4.19.4

Alternative Rec: No action is required at this time regarding insulating the pipes under the lavatory designated to be accessible in the restroom, unless major renovation occurs in the area.
(Where Available)

Full Rec: Insulate or otherwise configure pipes under the lavatory designated to be accessible in the restroom to protect against contact (see ADAAG 4.19.4). Make certain there are no sharp or abrasive surfaces under the lavatory.

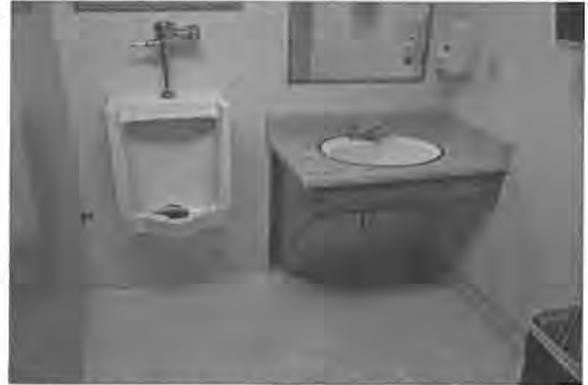
Men's Restroom Next to the Staff Lounge

Finding: The height of the controls and operating mechanisms for the soap dispenser in the restroom is greater than 40 inches above the finished floor.

Citations: CBC 1115B.9.2; ADAAG A4.27

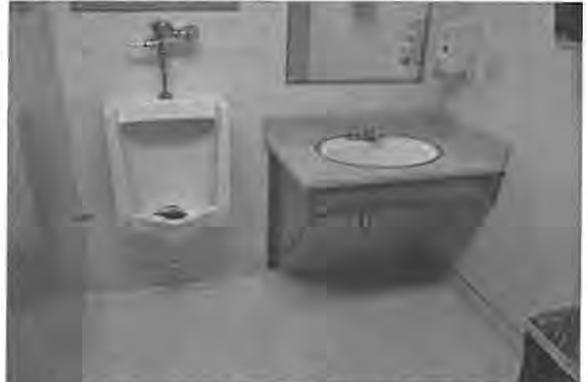
Men's Restroom Next to the Staff Lounge

Finding: The height of the controls and operating mechanisms for the paper towel dispenser in the restroom is greater than 40 inches above the finished floor.

Citations: CBC 1115B.9.2; ADAAG A4.27

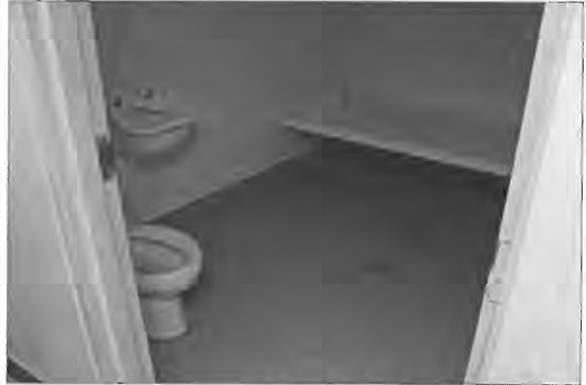
Typical Restroom in One of the Holding Cells

Finding: There is no signage indicating accessibility on the latch side of the entry door of the restroom.

Citations: CBC 1115B.5; ADAAG 4.1.2(7); ADAAG 4.1.6(3)(e)

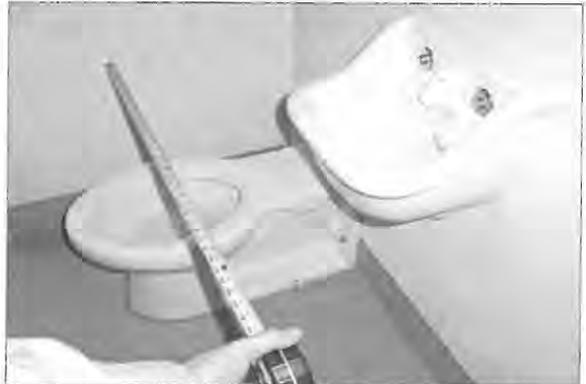
Typical Restroom in One of the Holding Cells

Finding: This restroom is not accessible and cannot be easily altered. There is not sufficient clear floor space in the restroom to accommodate an individual in a wheelchair. There is less than 28 inches between the toilet and the sink.

Citations: CBC 1115B.7.2; ADAAG 4.16.2

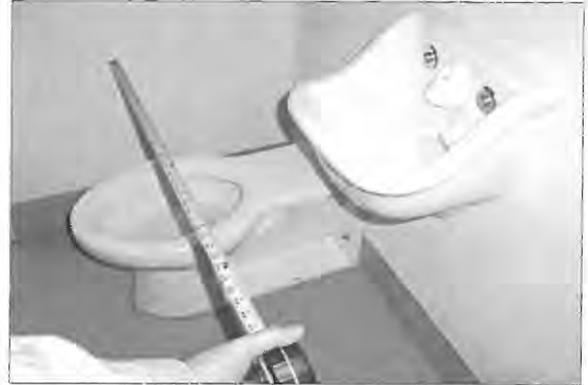
Finding: There are no grab bars in the restroom.

Typical Restroom in One of the Holding Cells
Citations: CBC 1115B.8; ADAAG 4.17.6; ADAAG 4.26.3

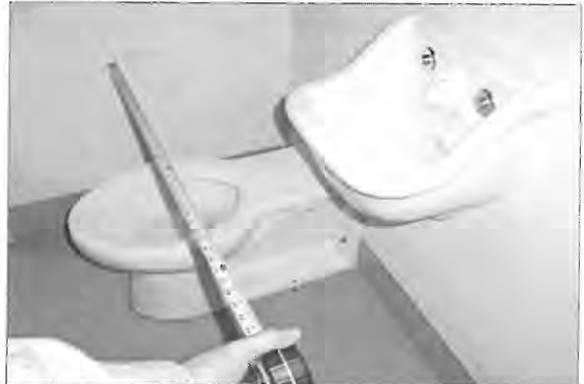
Finding: The height of the toilet seat in the restroom is less than 17 inches above the finished floor.

Typical Restroom in One of the Holding Cells
Citations: ADAAG 4.16.3

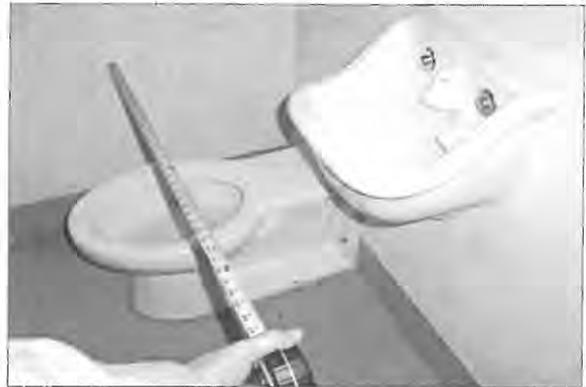
Typical Restroom in One of the Holding Cells

Finding: The distance from the center of the toilet to the nearest side wall in the restroom is less than 18 inches.

Citations: CBC 1115B; ADAAG 4.16; ADAAG Figure 28

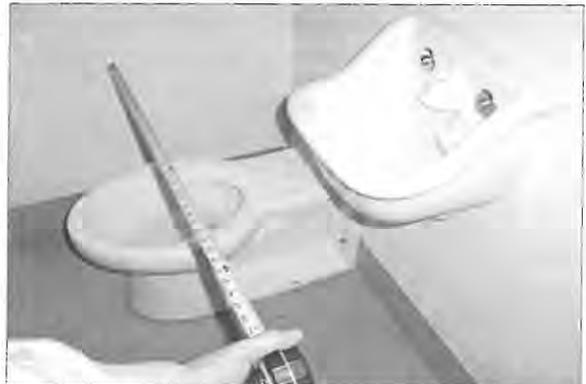
Typical Restroom in One of the Holding Cells

Finding: The knee clearance space under the lavatory designated to be accessible in the restroom is less than 29 inches.

Citations: ADAAG 4.19.2

Full Rec: Raise or replace the lavatory designated to be accessible in the restroom to provide at least 29 inches of clear knee space between the finished floor and bottom of the lavatory apron and at least 27 inches of knee clearance under the lavatory bowl at a knee depth of 8 inches (see ADAAG 4.19.2). Make certain the height of the top of the lavatory does not exceed 34 inches above the finished floor.

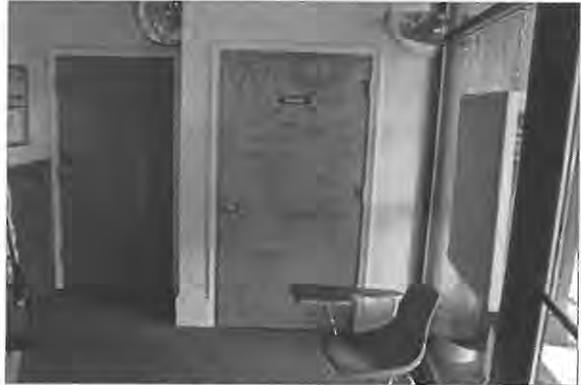
Women's Restroom in the Lobby

Finding: There is no signage indicating accessibility on the latch side of the entry door of the restroom.

Citations: CBC 1115B.5; ADAAG 4.1.2(7); ADAAG 4.1.6(3)(e)

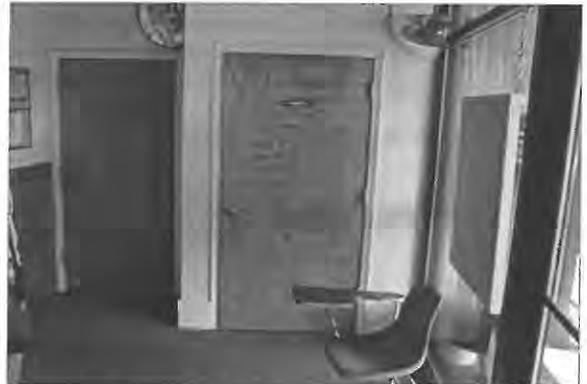
Women's Restroom in the Lobby

Finding: There is less than 12 inches on the latch side of the entrance door to the restroom from the push side.

Citations: ADAAG 4.13.6; CBC 1133B.2.4.2

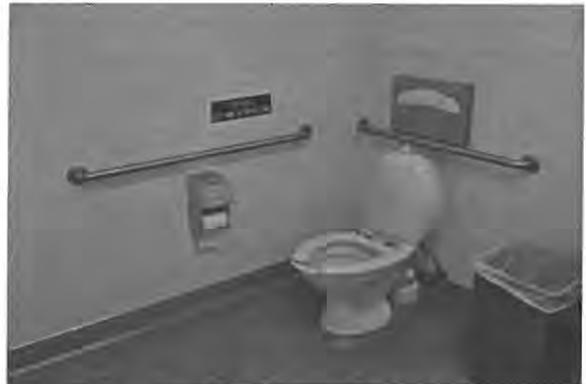
Finding: The height of the toilet seat in the restroom is less than 17 inches above the finished floor.

Full Rec: Adjust or modify the toilet in the restroom so that the seat height is between 17 inches and 19 inches above the finished floor (see ADAAG 4.16.3).

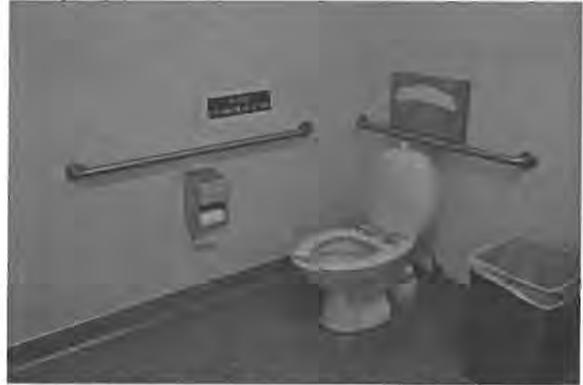
Women's Restroom in the Lobby

Finding: The distance from the center of the toilet to the nearest side wall in the restroom is greater than 18 inches.

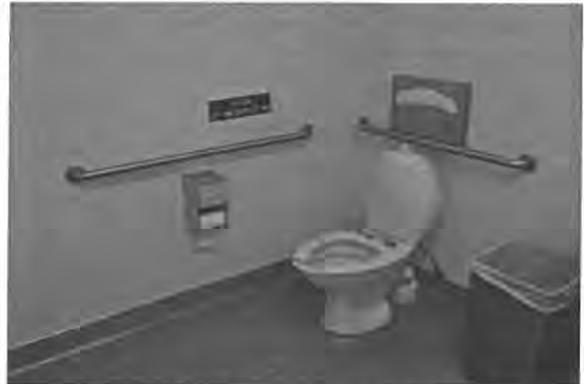
Women's Restroom in the Lobby

Finding: The height of all operable parts of the seat cover dispenser in the restroom is greater than 40 inches. The seat cover dispenser interferes with the use of the back grab bar.

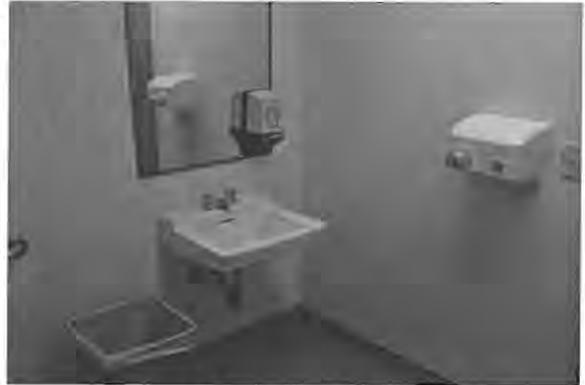
Women's Restroom in the Lobby

Finding: The knee clearance space under the lavatory designated to be accessible in the restroom is less than 29 inches.

Full Rec: Raise or replace the lavatory designated to be accessible in the restroom to provide at least 29 inches of clear knee space between the finished floor and bottom of the lavatory apron and at least 27 inches of knee clearance under the lavatory bowl at a knee depth of 8 inches (see ADAAG 4.19.2). Make certain the height of the top of the lavatory does not exceed 34 inches above the finished floor.

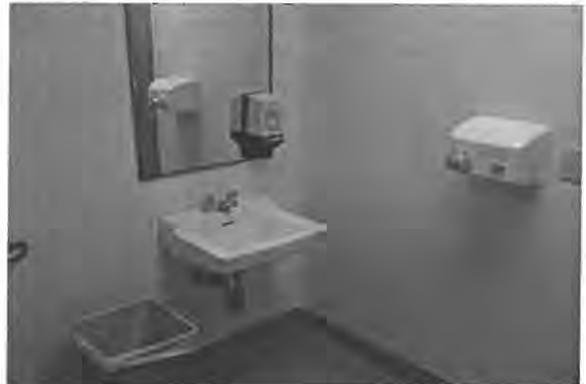
Women's Restroom in the Lobby

Finding: The pipes under the lavatory in the restroom do not provide protection against contact.

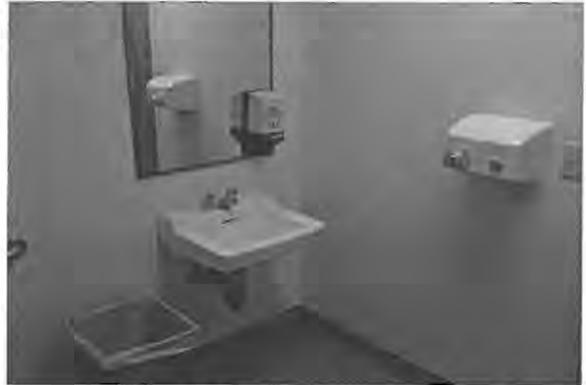
Women's Restroom in the Lobby

Finding: The height of the controls and operating mechanisms for the hand dryer in the restroom is greater than 40 inches above the finished floor.

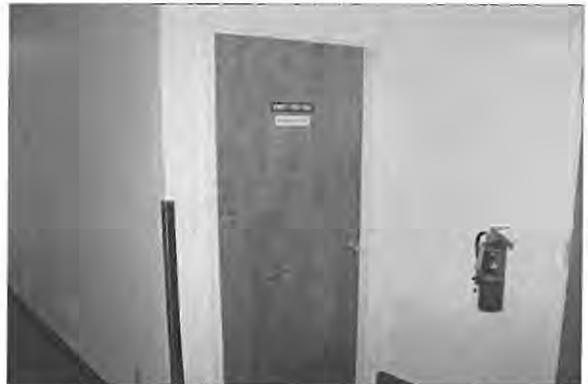
Women's Restroom in the Locker Room

Finding: This restroom is not located on an accessible level.

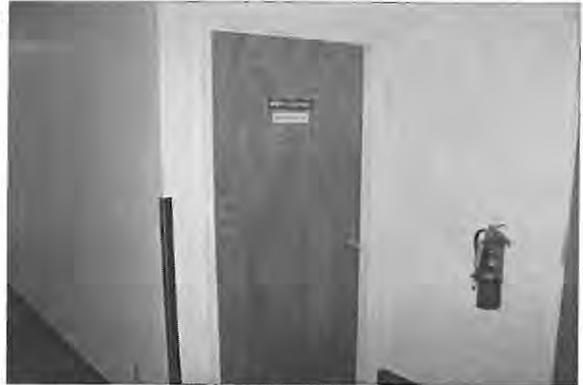
Women's Restroom in the Locker Room

Finding: The entrance door to the restroom has a round doorknob that requires tight grasping or twisting of the wrist to operate.

Full Rec: Replace the door hardware mounted on the restroom complying with ADAAG 4.13.9. Make certain accessible door hardware is mounted no higher than 48 inches above the finished floor.

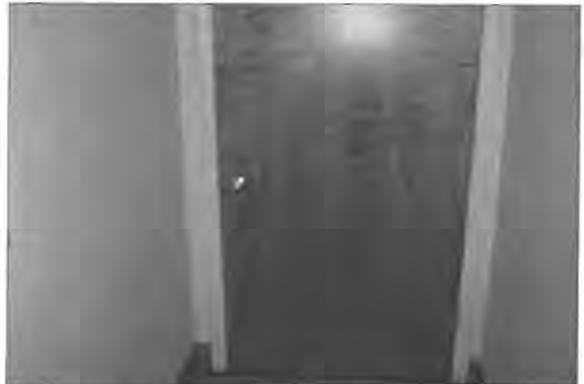
Women's Restroom in the Locker Room

Finding: There is less than 18 inches of clearance on the latch side of the entrance door to the restroom from the pull side.

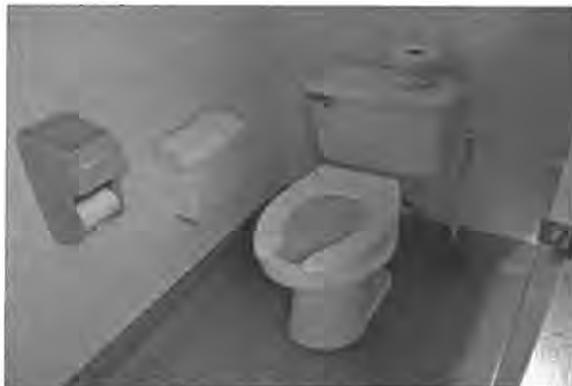
Women's Restroom in the Locker Room

Finding: There are no grab bars in the stall designated to be accessible in the restroom.

Alternative Rec: No action is required at this time regarding the installation of grab bars in the stall designated to be accessible in the restroom, unless major renovation occurs in the area.

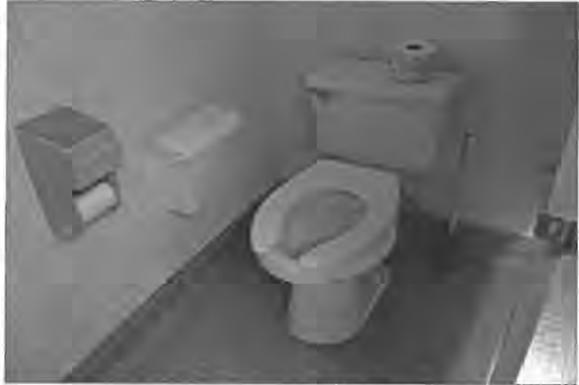
Women's Restroom in the Locker Room

Finding: The flush control on the toilet in the stall designated to be accessible in the restroom is not on the wide (approach) side of the toilet.

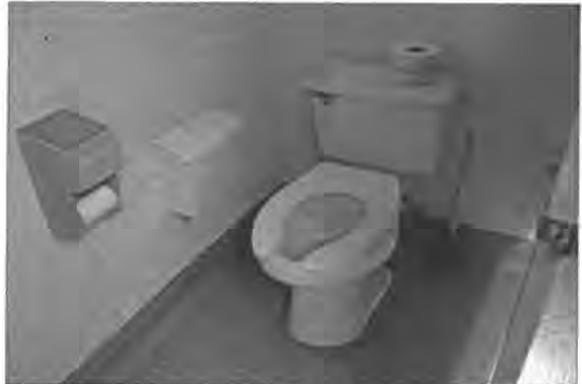
Women's Restroom in the Locker Room

Finding: The height of all operable parts of the seat cover dispenser in the stall designated to be accessible in the restroom is greater than 40 inches.

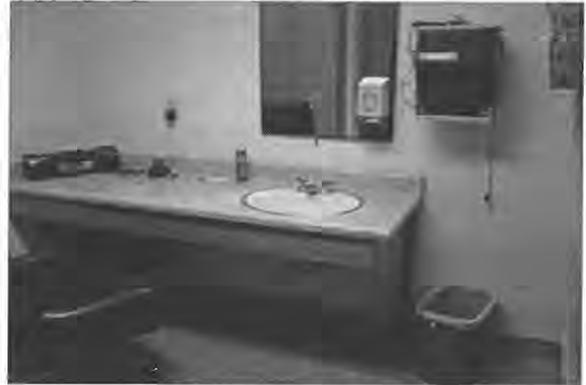
Women's Restroom in the Locker Room

Finding: The knee clearance space under the lavatory designated to be accessible in the restroom is less than 29 inches.

Full Rec: Raise or replace the lavatory designated to be accessible in the restroom to provide at least 29 inches of clear knee space between the finished floor and bottom of the lavatory apron and at least 27 inches of knee clearance under the lavatory bowl at a knee depth of 8 inches (see ADAAG 4.19.2). Make certain the height of the top of the lavatory does not exceed 34 inches above the finished floor.

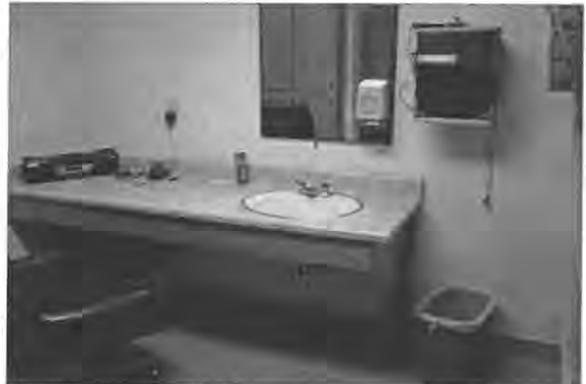
Women's Restroom in the Locker Room

Finding: The pipes under the lavatory in the restroom do not provide protection against contact.

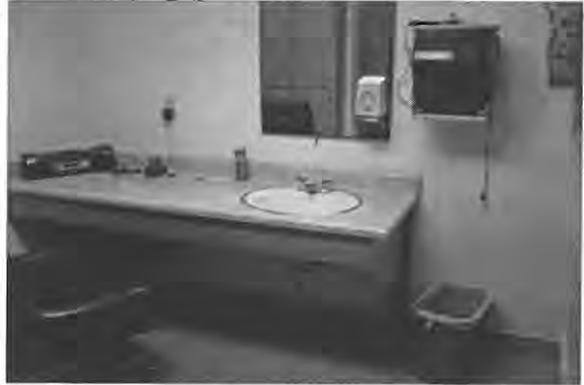
Women's Restroom in the Locker Room

Finding: The height of the controls and operating mechanisms for the soap dispenser in the restroom is greater than 40 inches above the finished floor.

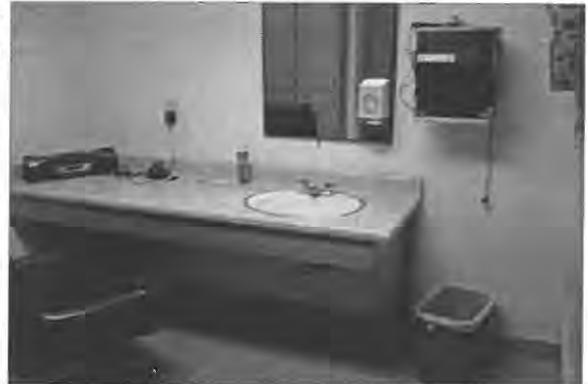
Women's Restroom in the Locker Room

Finding: The height of the controls and operating mechanisms for the paper towel dispenser in the restroom is greater than 40 inches above the finished floor.

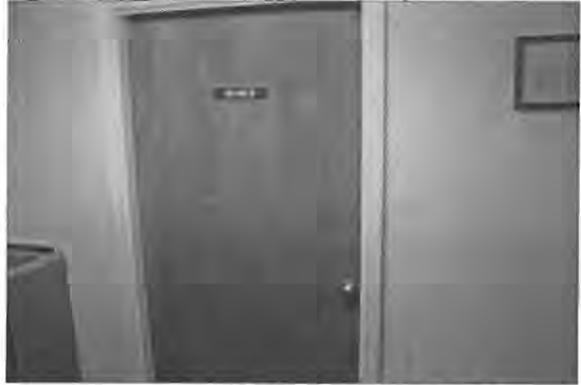
Women's Restroom Next to the Staff Lounge

Finding: There is no signage at the restroom directing individuals to accessible restrooms.

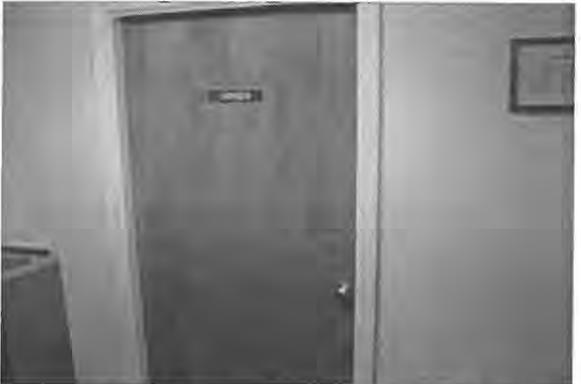
Women's Restroom Next to the Staff Lounge

Finding: The entrance door to the restroom has a round doorknob that requires tight grasping or twisting of the wrist to operate.

Full Rec: Replace the door hardware mounted on the restroom complying with ADAAG 4.13.9. Make certain accessible door hardware is mounted no higher than 48 inches above the finished floor.

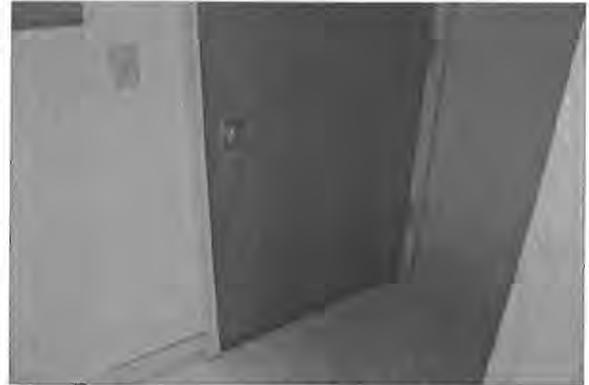
Finding: The door landing at the entrance to the restroom does not provide at least 60 inches in the direction of the door swing.

Alternative Rec: No action is required at this time regarding the door landing at the entrance door to the restroom unless major renovation occurs in the area.
(Where Available)

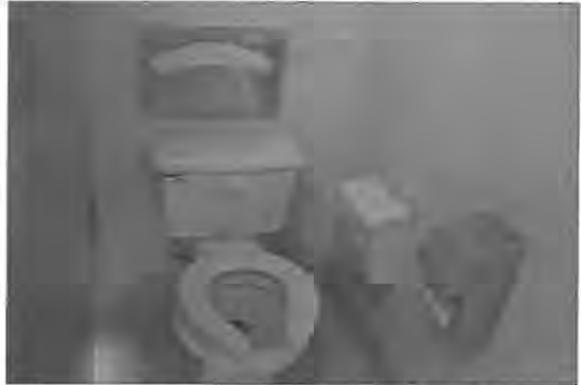
Women's Restroom Next to the Staff Lounge

Finding: There are no grab bars in the stall designated to be accessible in the restroom.

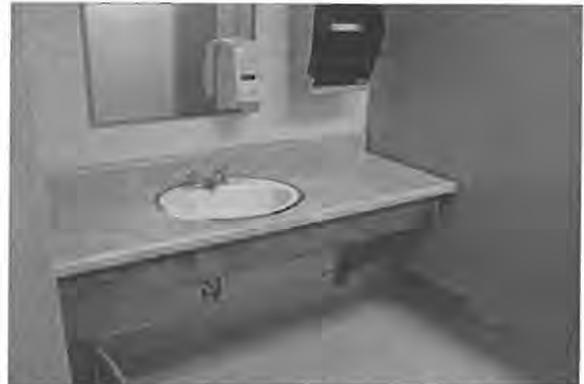
Women's Restroom Next to the Staff Lounge

Finding: The knee clearance space under the lavatory designated to be accessible in the restroom is less than 29 inches.

Full Rec: Raise or replace the lavatory designated to be accessible in the restroom to provide at least 29 inches of clear knee space between the finished floor and bottom of the lavatory apron and at least 27 inches of knee clearance under the lavatory bowl at a knee depth of 8 inches (see ADAAG 4.19.2). Make certain the height of the top of the lavatory does not exceed 34 inches above the finished floor.

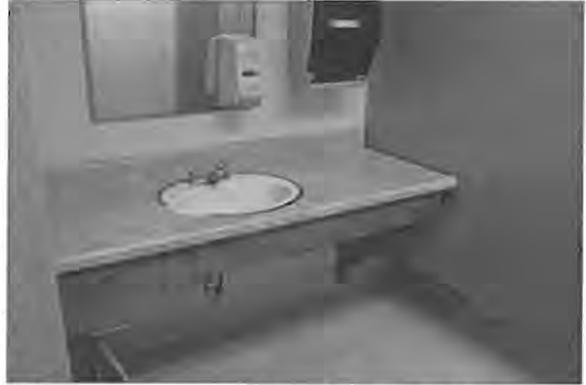
Women's Restroom Next to the Staff Lounge

Finding: The pipes under the lavatory in the restroom do not provide protection against contact.

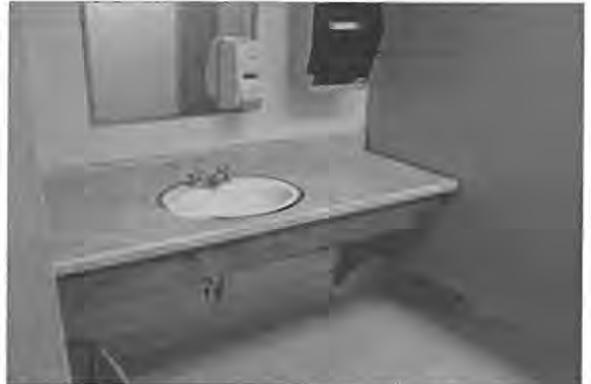
Women's Restroom Next to the Staff Lounge

Finding: The height of the controls and operating mechanisms for the paper towel dispenser in the restroom is greater than 40 inches above the finished floor.

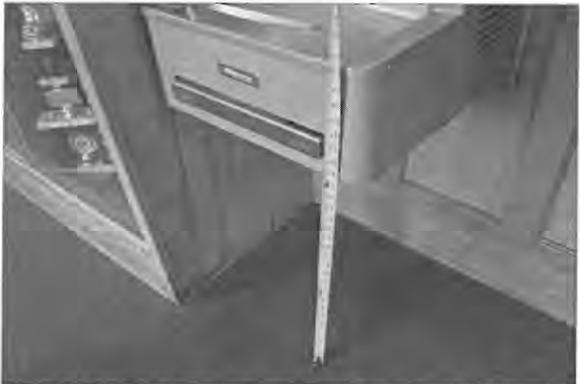
Drinking Fountain in the Main Lobby

Finding: There is insufficient clear floor space in front of the drinking fountain. There is less than 27 inches knee clearance height.

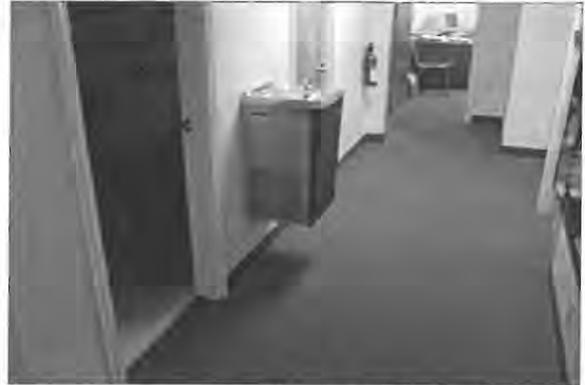
Drinking Fountain Next to the Staff Lounge

Finding: The spout outlet height is greater than 36 inches. There is less than 27 inches knee clearance height. There is less than 18 inches fountain clearance depth.

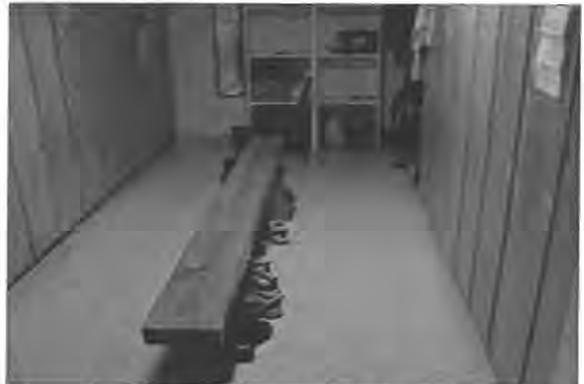
Men's and Women's Locker Rooms

Finding: Lockers are available for use in both the men's and women's locker rooms.

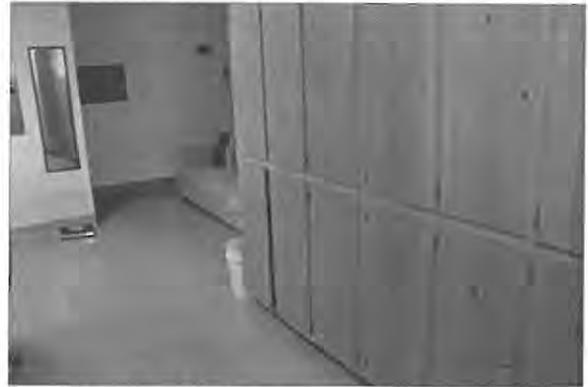
Men's and Women's Locker Rooms

Finding: There are no benches in the women's locker room.

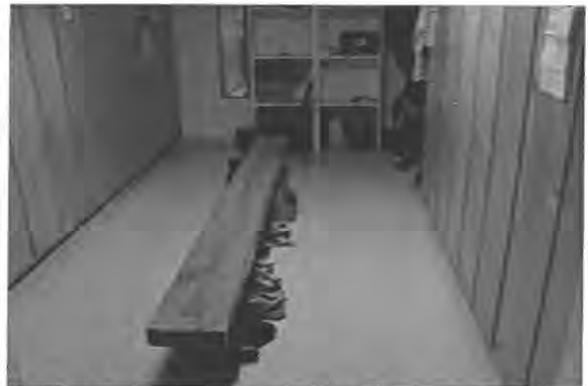
Men's and Women's Locker Rooms

Finding: The width of the bench in the men's locker room is less than 24 inches. The bench is not fixed to the wall along the longer dimension.

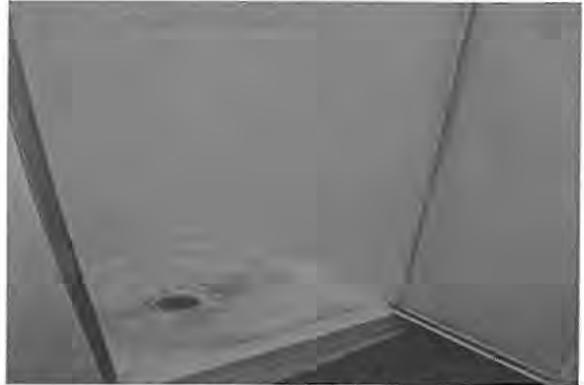
Men's and Women's Locker Rooms

Finding: There is a shower stall in both the men's and women's locker rooms.

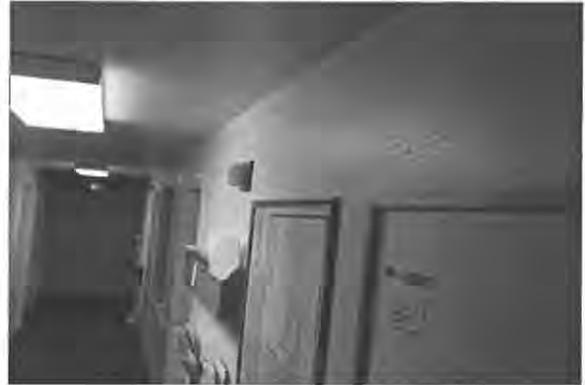
Finding: There is a visual warning device in the hallway on the south side of the facility, though no visual warning devices are located elsewhere in the facility.

Alternative Rec: Altering a facility's programs, or addressing higher priority barriers can reduce or eliminate the need for an area of rescue assistance, such as making certain that an individual with a disability participates in programs located near an already accessible exit. Otherwise creating an accessible exit can provide an acceptable alternative to providing an area of rescue assistance.

Full Rec: Install visual warning devices integrated with the facility's alarm system complying with CBC 1114B.2.5, ADAAG 4.1.3(14) and ADAAG 4.28 throughout the facility.

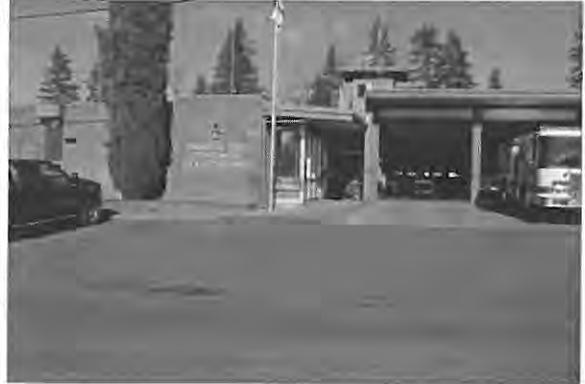
Finding: The Paradise Fire Department is located in a single-story building, built in 1965, at 767 Birch Street in Paradise. The facility was inspected by Disability Access Consultants, Inc., on July 26, 2001. It is noted that there have been permits issued for construction or renovation in this facility after January 26, 1992.

Full Rec: Any renovation or new construction that occurred after January 26, 1992, is subject to meet full code specifications for the California Building Code and ADAAG guidelines. All recommendations in this report that specify relocating Programs, Services or Activities, or make other allowances which avoid physical barrier removal as an alternative minimum compliance will have no effect or bearing on the non-compliant elements of newly constructed or renovated facilities. Consult with your Architect to determine which elements are affected by this requirement. It is recommended that Disability Access Consultants, Inc. is consulted for inspection of any new construction or renovation at the facility.

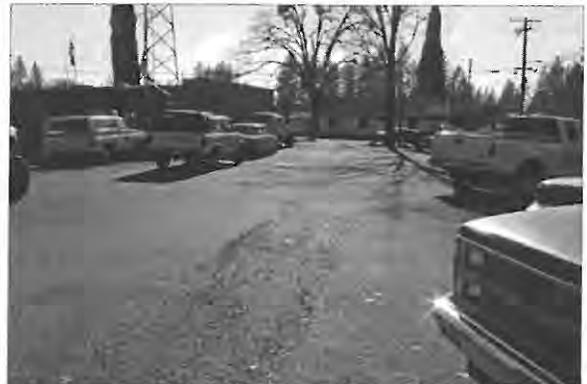
Parking North and West of the Facility

Finding: Paved parking is provided north and west of the facility. There are no accessible parking spaces designated out of 17 total parking spaces provided in the parking lot.

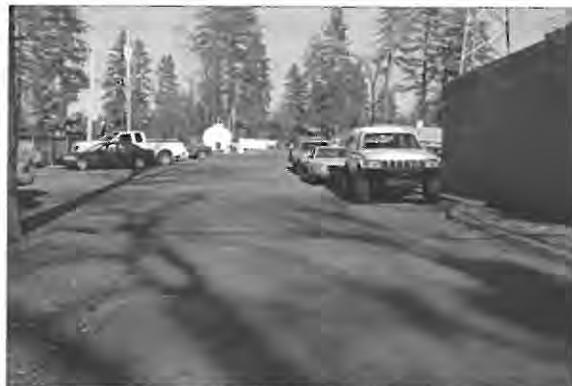
Parking North and West of the Facility

Finding: Each designated accessible parking space required in the parking lot shall provide a post-mounted sign showing the International Symbol of Accessibility.

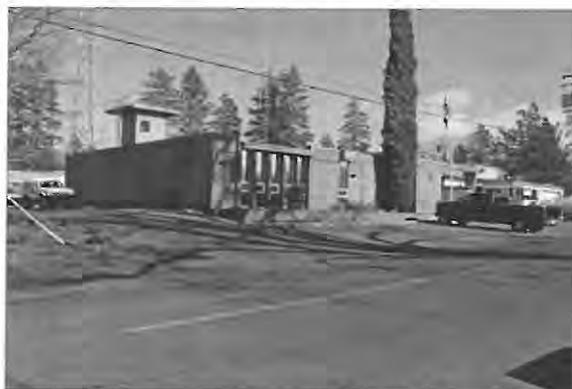
Parking North and West of the Facility

Finding: There is no warning signage posted regarding unauthorized use of accessible parking spaces in the parking lot.

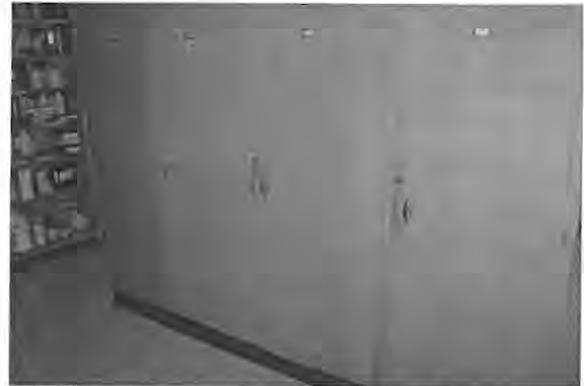
Lockers in the Dormitory

Finding: Lockers are available for use in the dormitory. The hardware on the lockers does not provide at least 1 1/2 inches of clearance between the hardware and the locker.

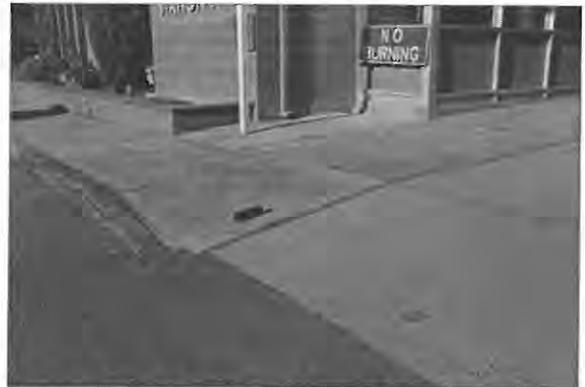
Path of Travel in Front of the Facility

Finding: There is a curb and slopes greater than 5% on the primary path of travel from the parking, off Birch Street, to the main entrance.

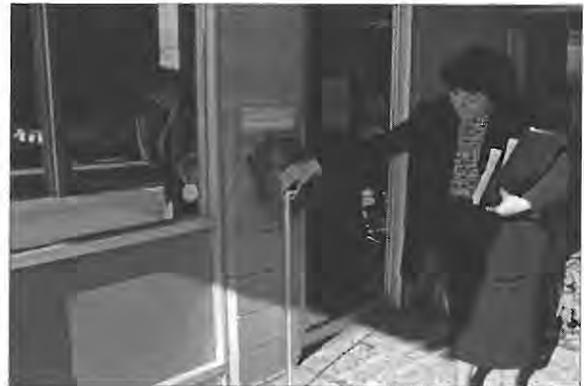
Protruding Object

Finding: The leading edge of the wall-mounted emergency call box, outside of the main entrance, is more than 4 inches from the wall and greater than 27 inches from the floor and protrudes into the primary path of travel.
