Town of Paradise

ADA self-evaluation transition plan

June 2015

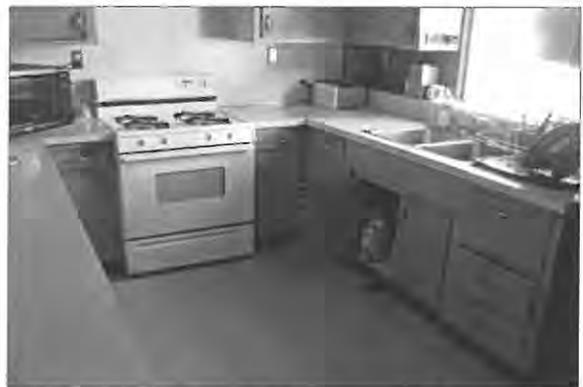
Sinks in the Facility: Kitchen and Apparatus Room

Finding: Each sink in the facility: in the kitchen and apparatus room, is in an enclosed cabinet, thereby preventing an accessible forward approach.

Full Rec: Sinks must provide clear floor space in front of the sink for an accessible forward approach and shall provide at least 27 inches clear knee space and a minimum of nine inches clear toe space (see ADAAG 4.19.2). If neither clear floor space and knee and toe clearance can be provided, remove the sink cabinet and replace with an accessible wall-mounted sink unit.

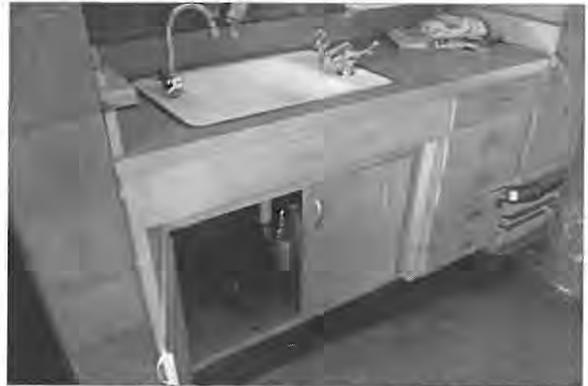
Sinks in the Facility: Kitchen and Apparatus Room

Finding: The hardware on the cabinet enclosing each sink in the facility, does not provide at least 1 1/2 inches of clearance between the hardware and the cabinet.

Citations: ADAAG 4.19.9

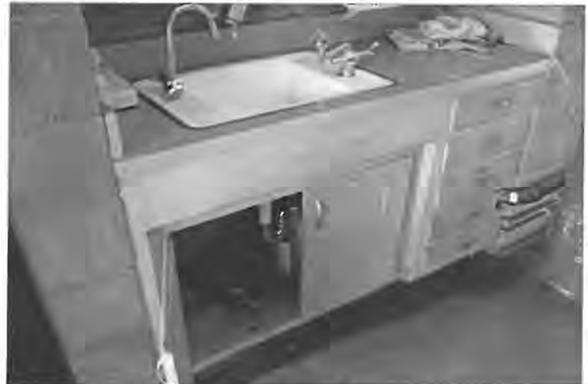
Sinks in the Facility: Kitchen and Apparatus Room

Finding: The pipes under each sink in the facility do not provide protection against contact.

Citations: ADAAG 4.19.4

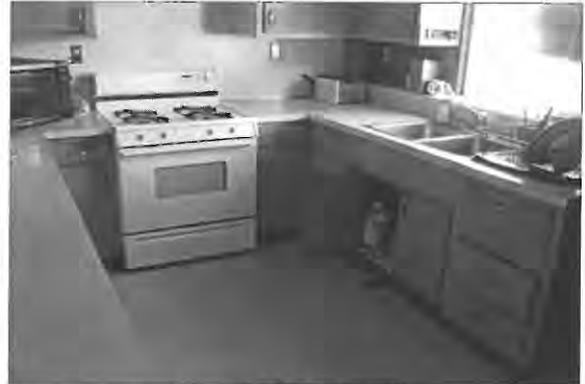
Sinks in the Facility: Kitchen and Apparatus Room

Finding: The height of the counter surface of each sink in the facility is greater than 34 inches above the finished floor.

Citations: ADAAG 4.19.2

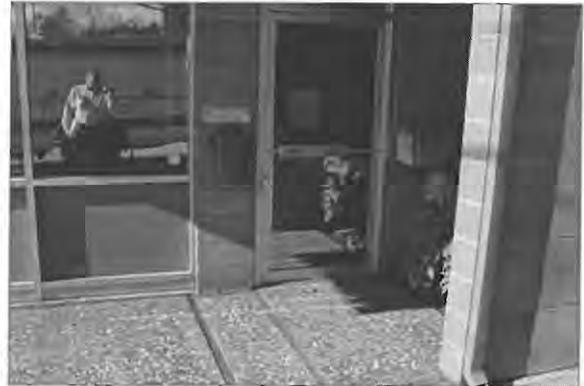
Entrance Doors

Finding: The door landing at the main entrance door has slopes greater than 2%.

Citations: CBC 1133B.2.4.2; ADAAG 4.13.6, Figure 25.

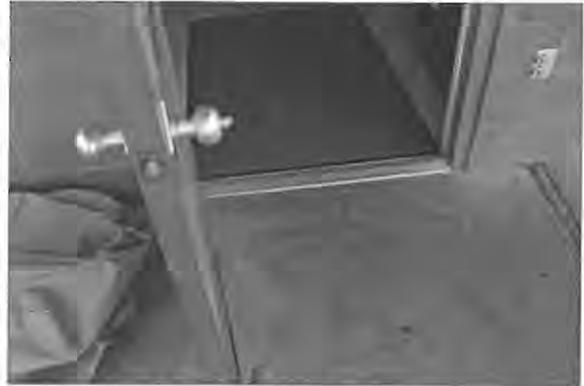
Exterior Door Threshold

Finding: The height of the threshold at each entrance door, at the north entrance, south entrance, west entrance and between the dormitory and apparatus room, is greater than 1/2 inch.

Citations: CBC 1133B.2.4.1; ADAAG 4.1.6(3)(d)(ii); ADAAG 4.5.2

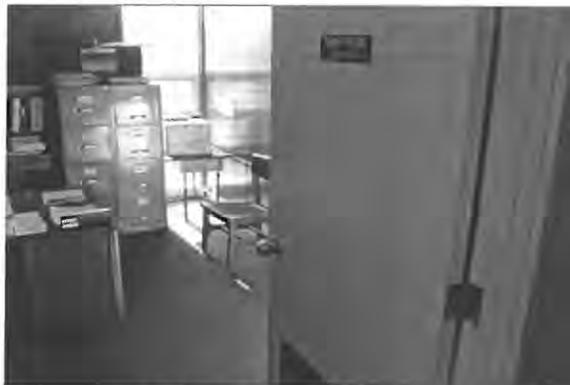
Interior Door Hardware

Finding: Interior passage doors, except to the conference room, have round doorknobs, which require twisting of the wrist to operate. The conference room provides accessible hardware.

Citations: ADAAG 4.13.9

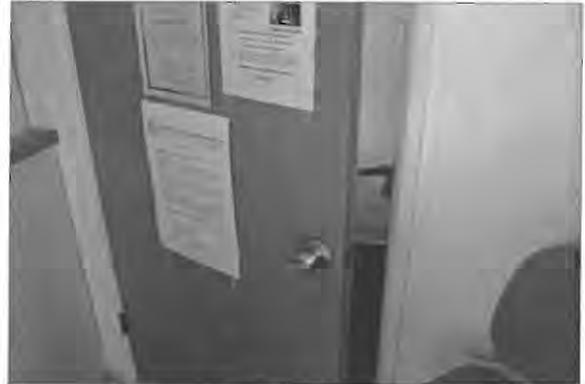
Interior Doors

Finding: The clear opening width of the interior door, leading to the interior rooms, is less than 32 inches.

Citations: CBC 1133B.2.3.1; ADAAG 4.13.5

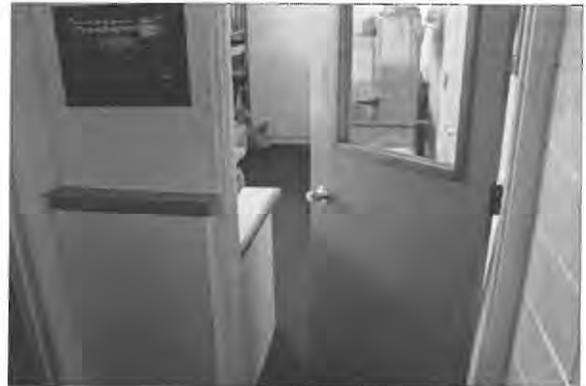
Interior Doors

Finding: The clear opening width of the door to the interior office just inside the hall entrance, is less than 32 inches.

Citations: CBC 1133B.2.3.1; ADAAG 4.13.5

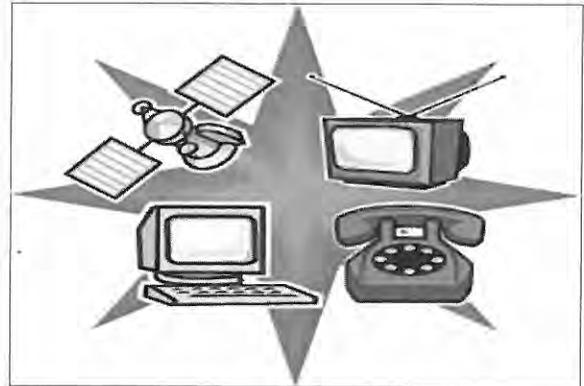
Finding: The facility does not provide information at the main office about accessible services, such as TDD/TTY machines, assistive listening systems (ALS), and alternative formats of facility materials.

Citations: CBC 1117B.2.9.3; CBC 1104B.2.4; ADAAG 4.30

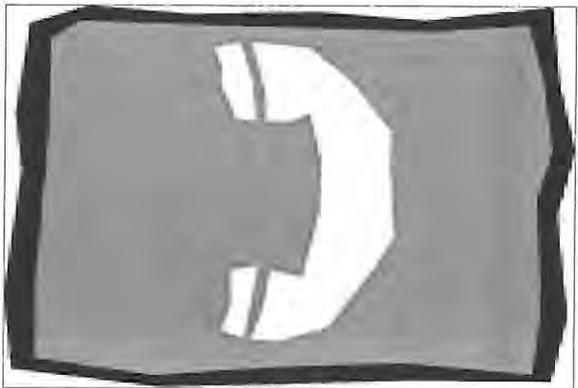
Finding: Hearing aid compatibility and handset amplification decibel range for telephones available for use by the public (for example, in the main office) could not be determined by visual inspection.

Citations: CBC 1117B.2.8

Full Rec: Determine whether telephones available for use by the public are hearing aid compatible or are equipped with handset amplification. If they are not, modify or replace them with appropriate peripheral devices.

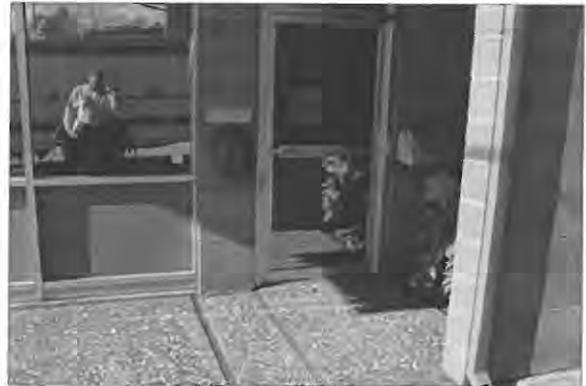
Facility Signage

Finding: The main entrance, interior offices and other common use rooms do not have accessible signage mounted on the wall adjacent to the latch side of the door.

Citations: CBC 1117B.5; ADAAG 4.30

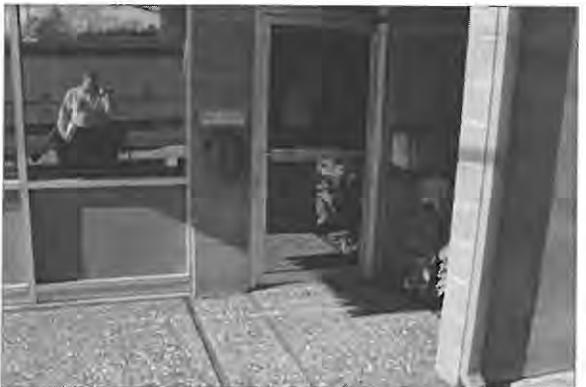
Facility Signage

Finding: There is no signage with the International Symbol of Accessibility on the entrance door to the facility designating it as accessible.

Citations: CBC 1117B.5.1

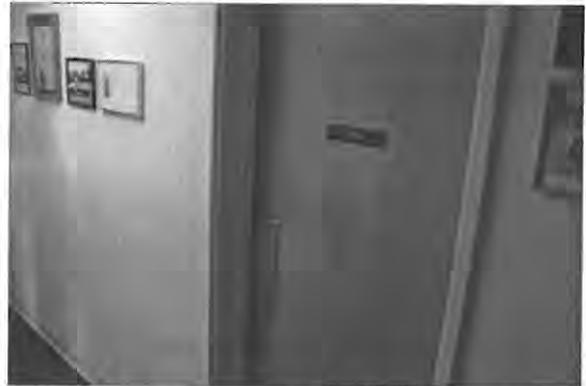
Men's Restroom in the Main Hallway

Finding: There is no signage indicating accessibility on the latch side of the entry door of the restroom.

Citations: CBC 1115B.5; ADAAG 4.1.2(7); ADAAG 4.1.6(3)(e)

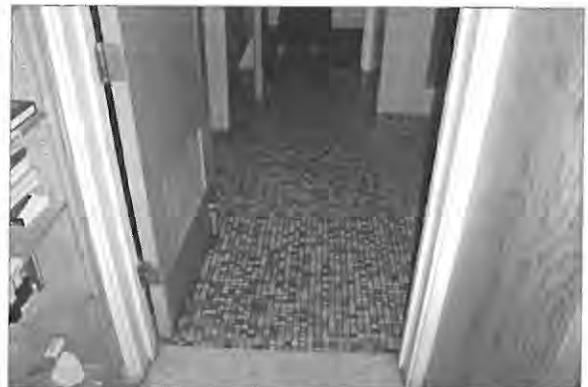
Men's Restroom in the Main Hallway

Finding: There is less than 12 inches on the latch side of the entrance door to the restroom from the dormitory on the push side.

Citations: ADAAG 4.13.6; CBC 1133B.2.4.2

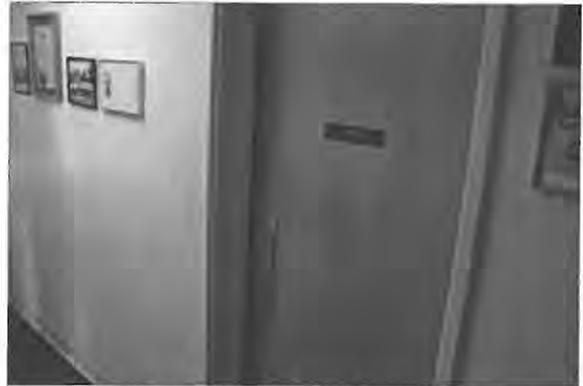
Men's Restroom in the Main Hallway

Finding: The clear opening width of the entrance doorway to the restroom is less than 32 inches.

Citations: ADAAG 4.13.5

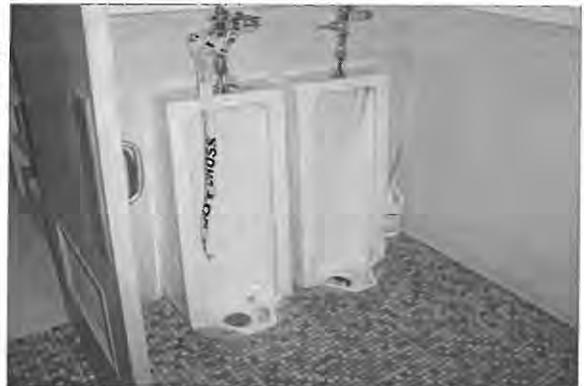
Men's Restroom in the Main Hallway

Finding: The urinal in the restroom is floor mounted and does not provide a tapered, elongated rim. The flush control valve on the urinal is greater than 44 inches above the finished floor.

Citations: ADAAG 4.18.2

Full Rec: Replace the urinal designated to be accessible in the restroom with a wall-mounted or stall-type tapered, elongated rim unit complying with ADAAG 4.18.2. The height of the rim surface of the urinal designated to be accessible shall not exceed 17 inches above the finished floor and the flush control valve shall not exceed a height of 44 inches above the finished floor.

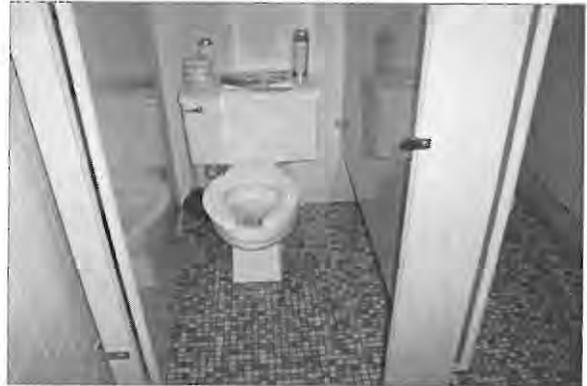
Men's Restroom in the Main Hallway

Finding: There is insufficient clear floor space in the stall designated to be accessible in the restroom.

Citations: CBC 1115B; ADAAG 4.17.3; ADAAG A4.17.3

Full Rec: Modify or replace the stall designated to be accessible in the restroom so that it complies with ADAAG 4.17.3, CBC 1115B and CBC Figures 11B-1A and 1B. Standard accessible stalls require 60 inches in width with 56 inches depth for wall-mounted toilets or 59 inches depth for floor-mounted toilets to accommodate individuals in wheelchairs. A minimum 48 inches of clear space shall be provided in front of the toilet. Door shall swing outward, close automatically and provide accessible hardware.

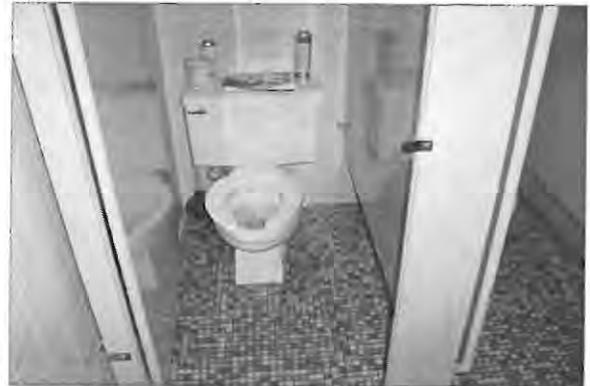
Men's Restroom in the Main Hallway

Finding: There are no grab bars in the stall designated to be accessible in the restroom.

Citations: CBC 1115B.8; ADAAG 4.26

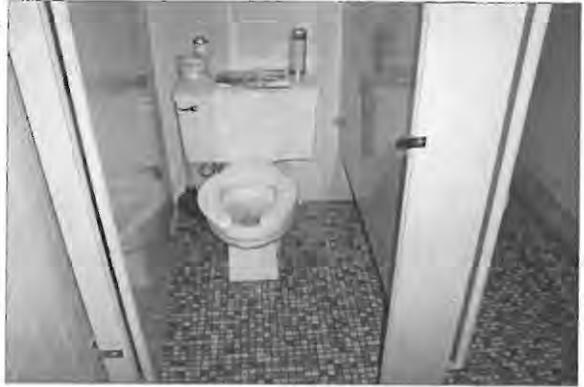
Men's Restroom in the Main Hallway

Finding: The flush control on the toilet in the stall designated to be accessible in the restroom is not on the wide (approach) side of the toilet.

Citations: ADAAG 4.16.5; ADAAG 4.27.4

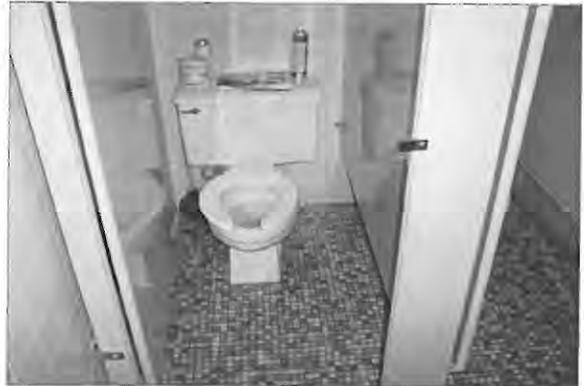
Men's Restroom in the Main Hallway

Finding: The height of the toilet seat in the stall designated to be accessible in the restroom is less than 17 inches above the finished floor.

Citations: ADAAG 4.16.3

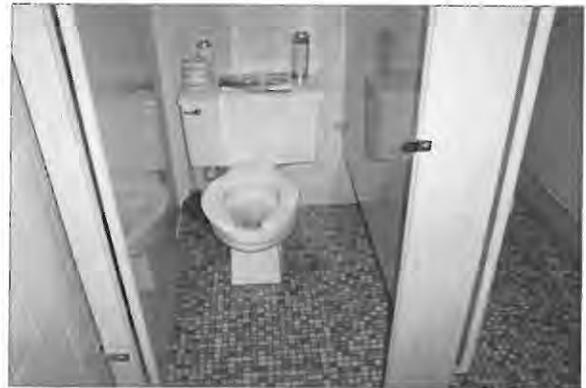
Men's Restroom in the Main Hallway

Finding: The distance from the center of the toilet to the nearest side wall in the stall designated to be accessible in the restroom is less than 18 inches.

Citations: CBC 1115B; ADAAG 4.17; ADAAG Figure 28

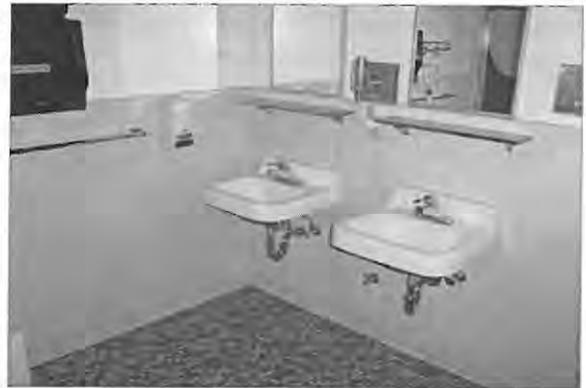
Men's Restroom in the Main Hallway

Finding: The knee clearance space under the lavatory designated to be accessible in the restroom is less than 29 inches.

Citations: ADAAG 4.19.2

Full Rec: Raise or replace the lavatory designated to be accessible in the restroom to provide at least 29 inches of clear knee space between the finished floor and bottom of the lavatory apron and at least 27 inches of knee clearance under the lavatory bowl at a knee depth of 8 inches (see ADAAG 4.19.2). Make certain the height of the top of the lavatory does not exceed 34 inches above the finished floor.

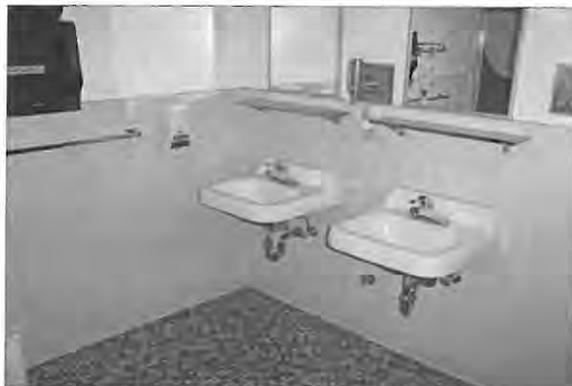
Men's Restroom in the Main Hallway

Finding: The pipes under the lavatory in the restroom do not provide protection against contact.

Citations: ADAAG 4.19.4

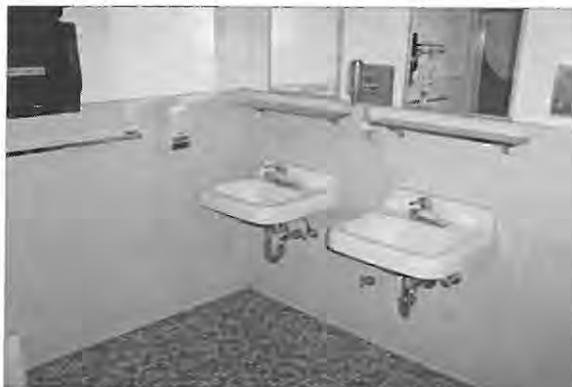
Men's Restroom in the Main Hallway

Finding: The bottom edge of the reflecting surface of the mirror in the restroom is greater than 40 inches above the finished floor.

Citations: ADAAG A4.19.6; CBC 1115B.9.1.2; ADAAG 4.19.6

Full Rec: Lower the mirror in the restroom so that the bottom edge of the reflecting surface is no higher than 40 inches above the finished floor and the topmost portion of the reflecting surface extends at least 74 inches above the finished floor (see ADAAG A4.19.6). A single, full-length mirror is recommended since it can accommodate all people. Make certain to provide a minimum clear floor space in front of the mirror of 30 inches in width and 48 inches in length.

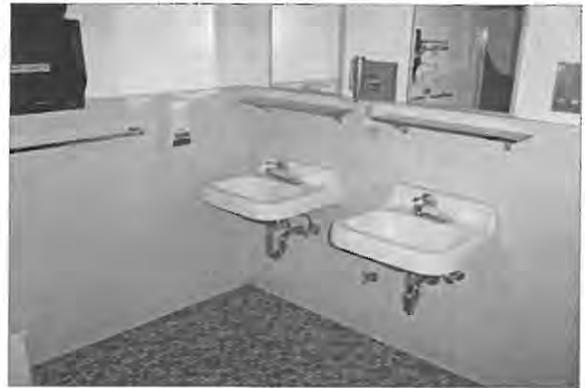
Men's Restroom in the Main Hallway

Finding: The height of the controls and operating mechanisms for the paper towel dispenser in the restroom is greater than 40 inches above the finished floor.

Citations: CBC 1115B.9.2; ADAAG A4.27

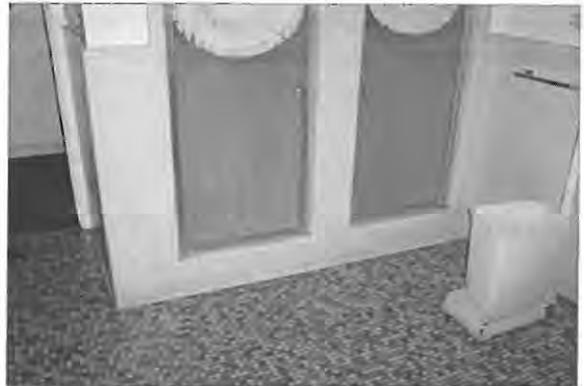
Men's Restroom in the Main Hallway

Finding: The men's restroom provides private shower stalls. There is no accessible shower stall.

Citations: CBC 1115B.6.2; ADAAG 4.21

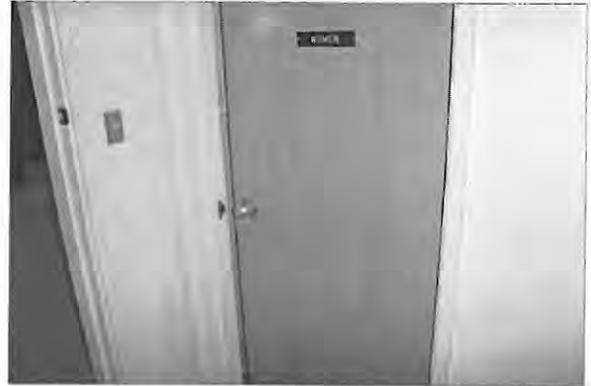
Women's Restroom in the Main Hallway

Finding: The clear opening width of the entrance doorway to the restroom is less than 32 inches.

Citations: ADAAG 4.13.5

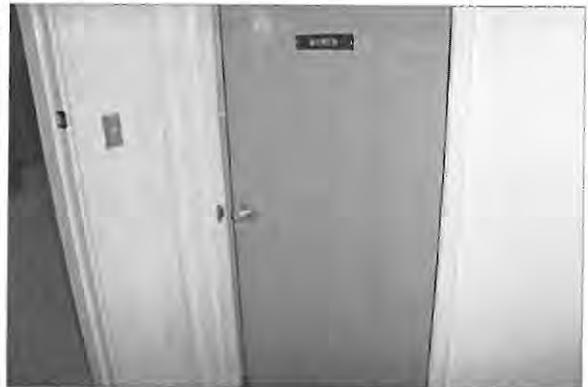
Women's Restroom in the Main Hallway

Finding: The entrance door to the restroom has a round doorknob that requires tight grasping or twisting of the wrist to operate.

Citations: ADAAG 4.13.9

Full Rec: Replace the door hardware mounted on the restroom complying with ADAAG 4.13.9. Make certain accessible door hardware is mounted no higher than 48 inches above the finished floor.

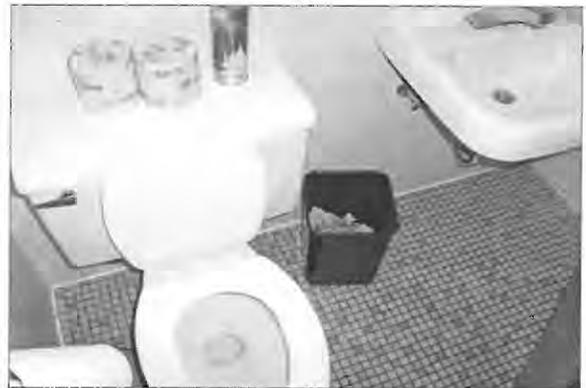
Women's Restroom in the Main Hallway

Finding: This restroom is not accessible and cannot be easily altered. There is not sufficient clear floor space in the restroom to accommodate an individual in a wheelchair.

Citations: CBC 1115B.7.2; ADAAG 4.16.2

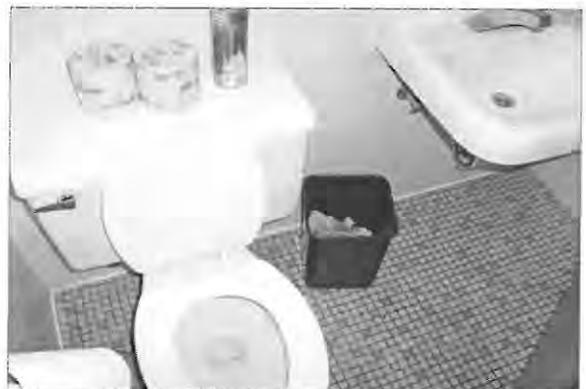
Women's Restroom in the Main Hallway

Finding: There are no grab bars in the restroom.

Citations: CBC 1115B.8; ADAAG 4.17.6; ADAAG 4.26.3

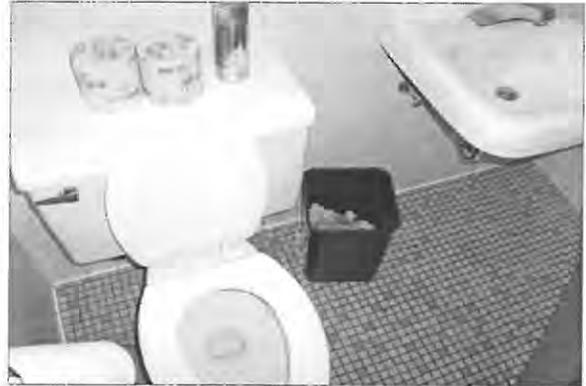
Women's Restroom in the Main Hallway

Finding: The flush control on the toilet in the restroom is not on the wide (approach) side of the toilet.

Citations: ADAAG 4.16.5; ADAAG 4.27.4

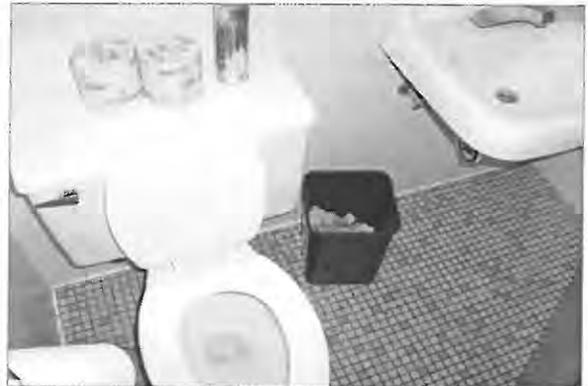
Women's Restroom in the Main Hallway

Finding: The height of the toilet seat in the restroom is less than 17 inches above the finished floor.

Citations: ADAAG 4.16.3

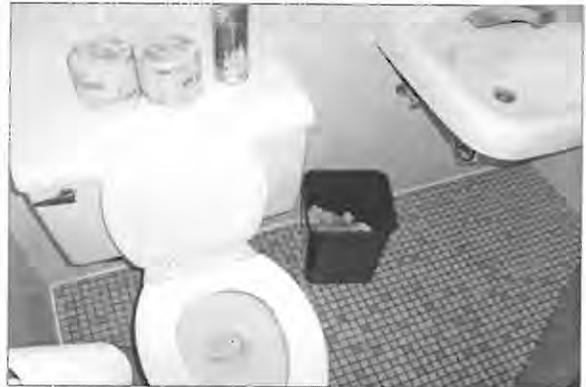
Women's Restroom in the Main Hallway

Finding: The distance from the center of the toilet to the nearest side wall in the restroom is less than 18 inches.

Citations: CBC 1115B; ADAAG 4.16; ADAAG Figure 28

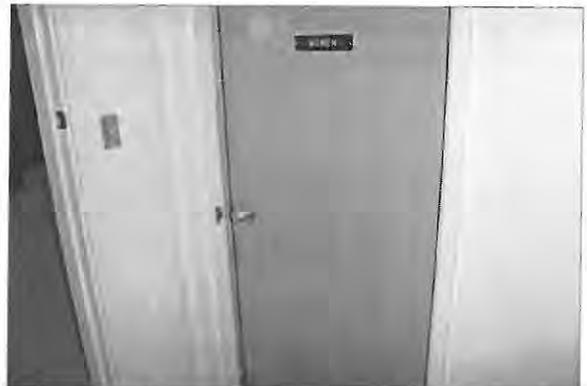
Women's Restroom in the Main Hallway

Finding: There is no signage indicating accessibility on the latch side of the entry door of the restroom.

Citations: CBC 1115B.5; ADAAG 4.1.2(7); ADAAG 4.1.6(3)(e)

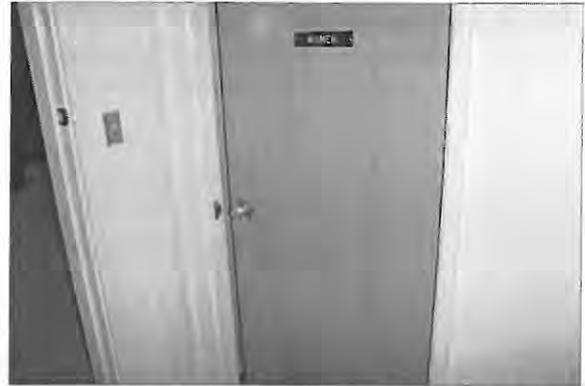
Women's Restroom in the Main Hallway

Finding: There is less than 12 inches on the latch side of the entrance door to the restroom from the push side.

Citations: ADAAG 4.13.6; CBC 1133B.2.4.2

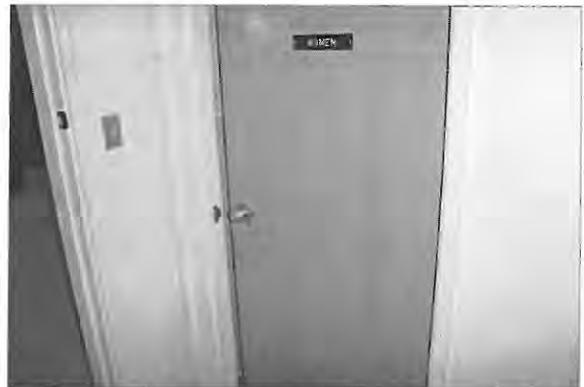
Women's Restroom in the Main Hallway

Finding: The clear opening width of the entrance doorway to the restroom is less than 32 inches.

Citations: ADAAG 4.13.5

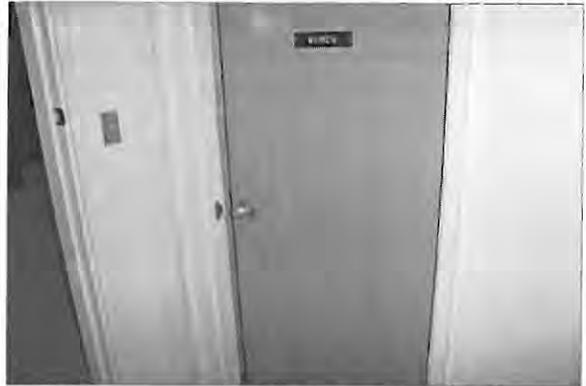
Women's Restroom in the Main Hallway

Finding: The entrance door to the restroom has a round doorknob that requires tight grasping or twisting of the wrist to operate.

Citations: ADAAG 4.13.9

Full Rec: Replace the door hardware mounted on the restroom complying with ADAAG 4.13.9. Make certain accessible door hardware is mounted no higher than 48 inches above the finished floor.

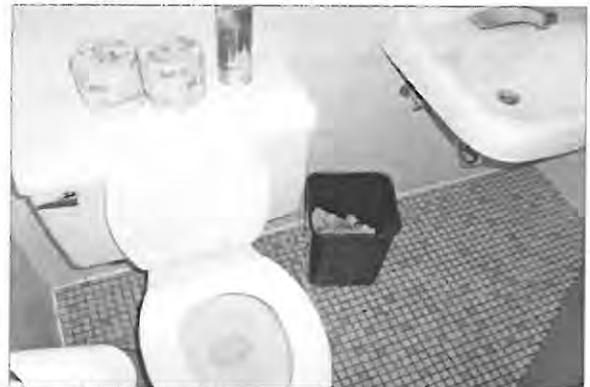
Women's Restroom in the Main Hallway

Finding: This restroom is not accessible and cannot be easily altered. There is not sufficient clear floor space in the restroom to accommodate an individual in a wheelchair.

Citations: CBC 1115B.7.2; ADAAG 4.16.2

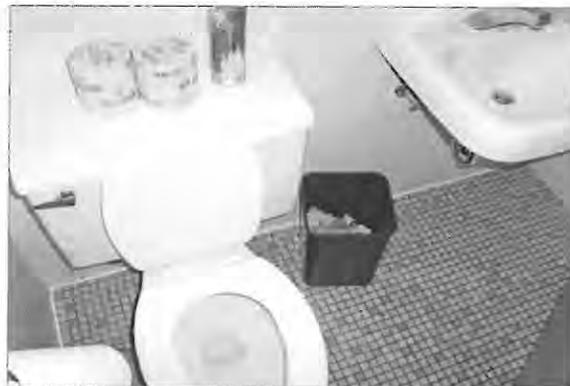
Women's Restroom in the Main Hallway

Finding: There are no grab bars in the restroom.

Citations: CBC 1115B.8; ADAAG 4.17.6; ADAAG 4.26.3

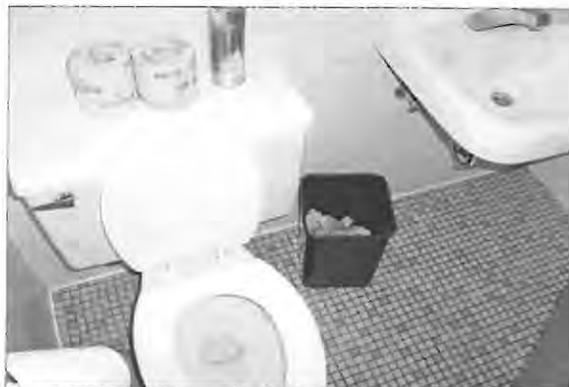
Women's Restroom in the Main Hallway

Finding: The flush control on the toilet in the restroom is not on the wide (approach) side of the toilet.

Citations: ADAAG 4.16.5; ADAAG 4.27.4

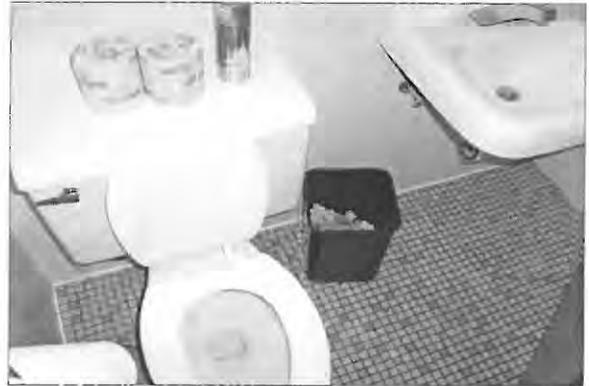
Women's Restroom in the Main Hallway

Finding: The height of the toilet seat in the restroom is less than 17 inches above the finished floor.

Citations: ADAAG 4.16.3

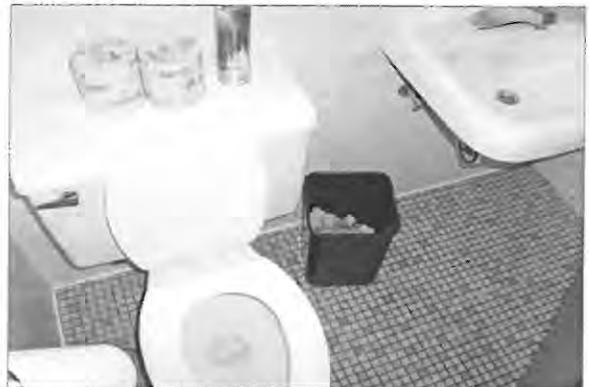
Women's Restroom in the Main Hallway

Finding: The distance from the center of the toilet to the nearest side wall in the restroom is less than 18 inches.

Citations: CBC 1115B; ADAAG 4.16; ADAAG Figure 28

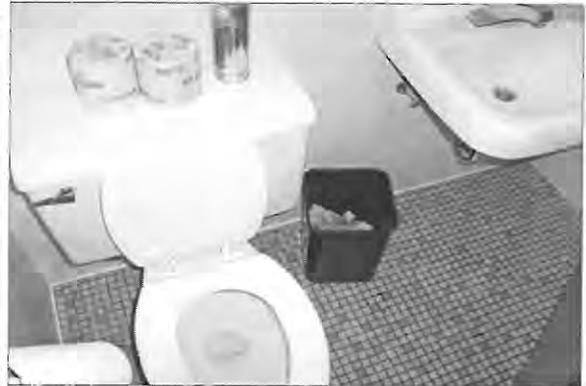
Women's Restroom in the Main Hallway

Finding: The knee clearance space under the lavatory designated to be accessible in the restroom is less than 29 inches.

Citations: ADAAG 4.19.2

Full Rec: Raise or replace the lavatory designated to be accessible in the restroom to provide at least 29 inches of clear knee space between the finished floor and bottom of the lavatory apron and at least 27 inches of knee clearance under the lavatory bowl at a knee depth of 8 inches (see ADAAG 4.19.2). Make certain the height of the top of the lavatory does not exceed 34 inches above the finished floor.

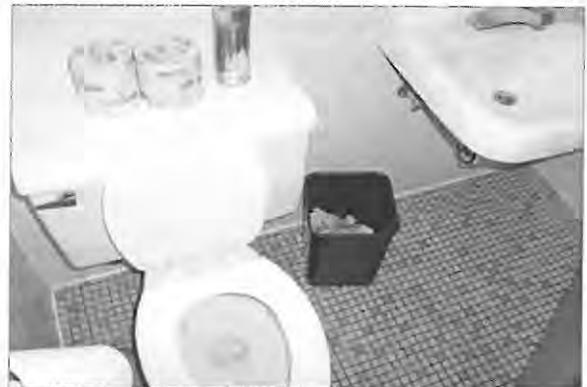
Women's Restroom in the Main Hallway

Finding: The pipes under the lavatory in the restroom do not provide protection against contact.

Citations: ADAAG 4.19.4

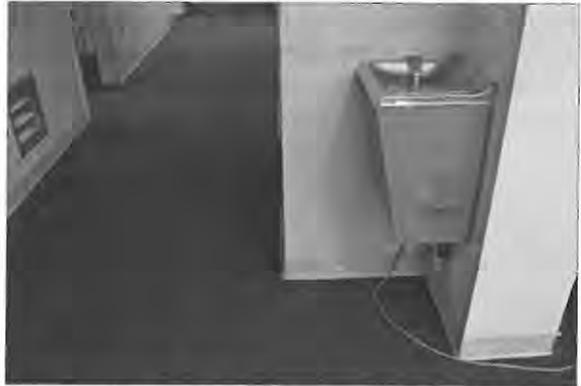
Drinking Fountain in the Main Hallway

Finding: The spout outlet height is greater than 36 inches. The water trajectory is diagonal to the front of the unit. There is less than 27 inches knee clearance height. There is less than 18 inches fountain clearance depth.

Citations: CBC 1117B.1; ADAAG 4.15

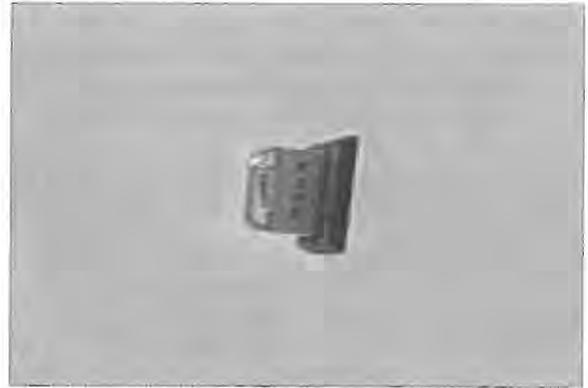
Finding: There are no visual warning devices at the facility.

Alternative Rec: Altering a facility's programs, or addressing higher priority barriers can reduce or eliminate the need for an area of rescue assistance, such as making certain that an individual with a disability participates in programs located near an already accessible exit. Otherwise creating an accessible exit can provide an acceptable alternative to providing an area of rescue assistance.

Full Rec: Install visual warning devices integrated with the facility's alarm system complying with CBC 1114B.2.5, ADAAG 4.1.3(14) and ADAAG 4.28 in all common areas such as hallways, classrooms and general use rooms, and in accessible restrooms and other accessible rooms.

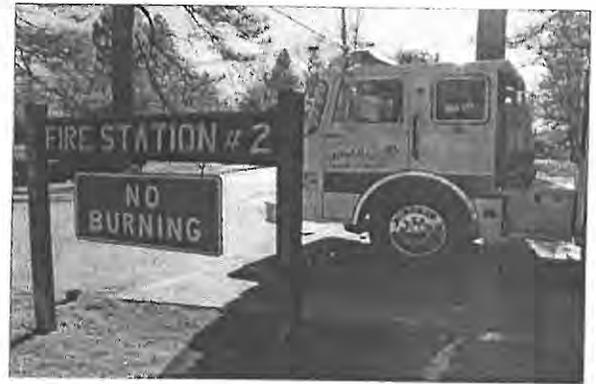
Finding: The Paradise Fire Department, Station 2, is located in a single story structure at 5545 S. Libby in Paradise. The facility was built in the 1950's. The facility was inspected by Disability Access Consultants, Inc., on January 15, 2002. It is noted that there have been permits issued for construction or renovation in this facility after January 26, 1992.

Full Rec Any renovation or new construction that occurred after January 26, 1992, is subject to meet full code specifications for the California Building Code and ADAAG guidelines. All recommendations in this report that specify relocating Programs, Services or Activities, or make other allowances which avoid physical barrier removal as an alternative minimum compliance will have no effect or bearing on the non-compliant elements of newly constructed or renovated facilities. Consult with your Architect to determine which elements are affected by this requirement. It is recommended that Disability Access Consultants, Inc. is consulted for inspection of any new construction or renovation at the facility.

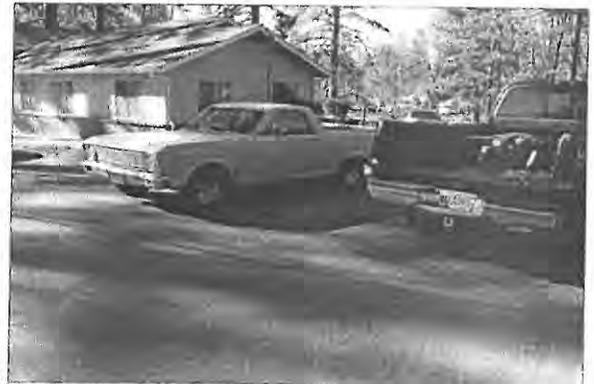
Parking Lot North of the Facility

Finding: Paved parking is provided north of the facility. There are no striped parking spaces in the parking lot. There are approximately three parking spaces in the parking lot. There are no accessible parking spaces designated out of the approximate three parking spaces provided in the parking lot.

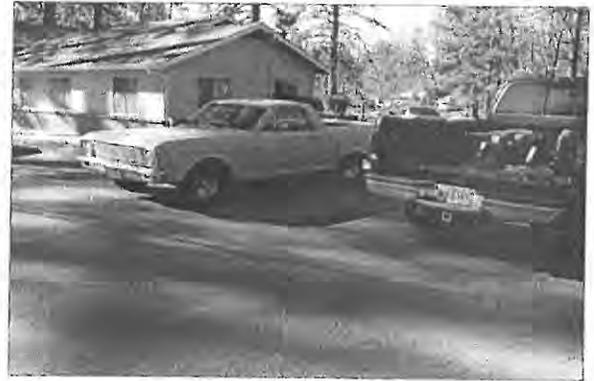
Parking Lot North of the Facility

Finding: Each designated accessible parking space required in the parking lot shall provide a post-mounted sign showing the International Symbol of Accessibility.

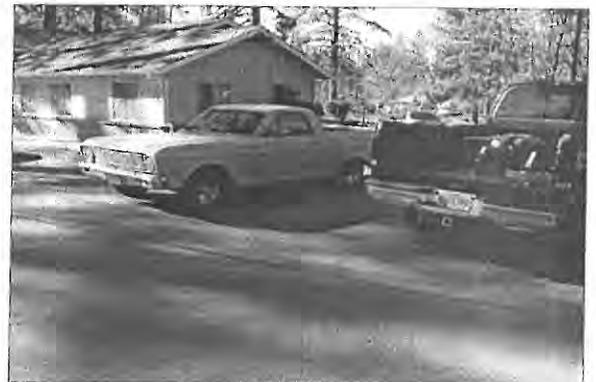
Parking Lot North of the Facility

Finding: There is no warning signage posted regarding unauthorized use of accessible parking spaces in the parking lot.

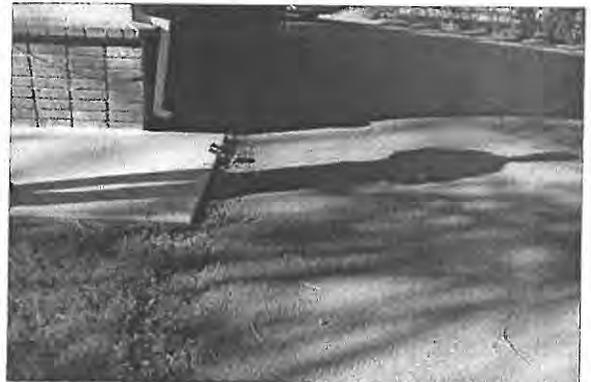
Path of Travel Between Parking and the Main Entrance

Finding: There is a change in elevation greater than 1/2 inch on the primary path of travel from the parking lot north of the facility to the main entrance at the asphalt to concrete transition point.

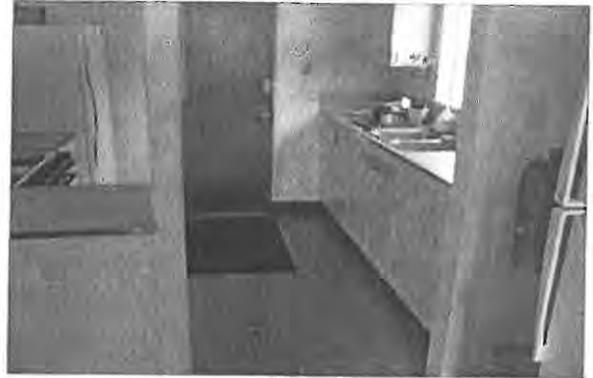
Sink in the Kitchen

Finding: The sink in the kitchen is in an enclosed cabinet, thereby preventing an accessible forward approach.

Alternative Rec: (Where Available) No action is required at this time regarding the front approach clearance of the sink, unless major renovation occurs in the area.

Full Rec Sinks must provide clear floor space in front of the sink for an accessible forward approach and shall provide at least 27 inches clear knee space and a minimum of nine inches clear toe space (see ADAAG 4.19.2). If neither clear floor space and knee and toe clearance can be provided, remove the sink cabinet and replace with an accessible wall-mounted sink unit.

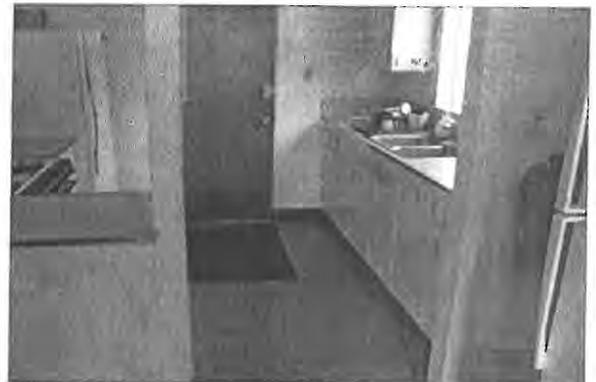
Sink in the Kitchen

Finding: The hardware on the cabinet enclosing the sink in the kitchen, does not provide at least 1 1/2 inches of clearance between the hardware and the cabinet.

Alternative Rec: (Where Available) No action is required at this time regarding the hardware on the cabinet enclosing the sink, unless major renovation occurs in the area.

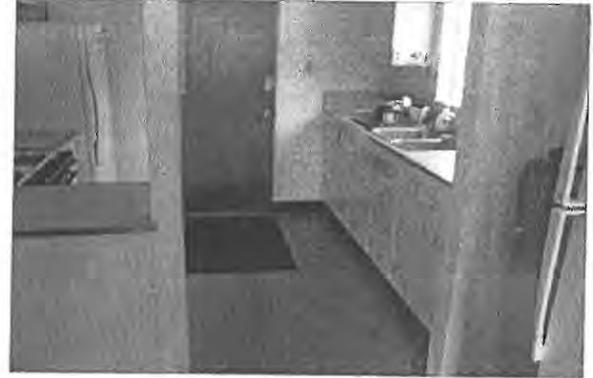
Sink in the Kitchen

Finding: The pipes under the sink in the kitchen do not provide protection against contact.

Alternative Rec: (Where Available) No action is required at this time regarding the pipes under the sink, unless major renovation occurs in the area.

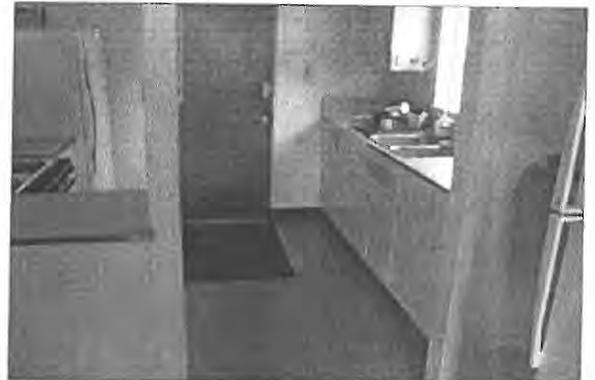
Sink in the Kitchen

Finding: The height of the counter surface of the sink in the kitchen is greater than 34 inches above the finished floor.

Alternative Rec: (Where Available) No action is required at this time regarding the height of the rim surface of the sink, unless major renovation occurs in the area.

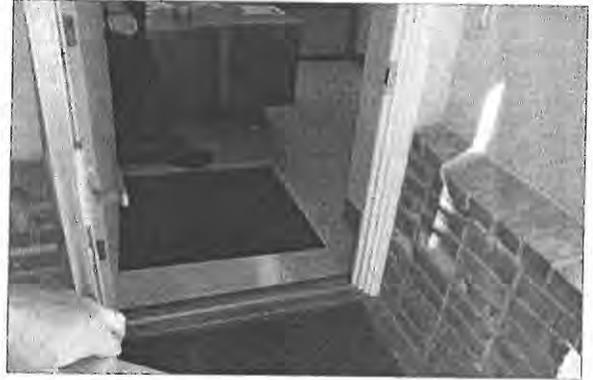
Entrance Doors

Finding: There is less than 12 inches of clearance on the latch side of the main entrance door from the push side.

Alternative Rec: Provide assisted service for individuals with disabilities.
(Where Available)

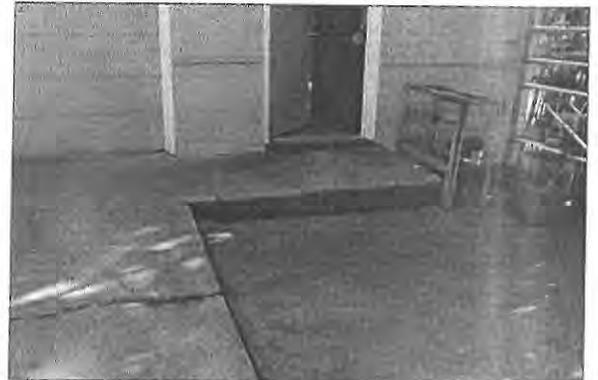
Entrance Doors

Finding: There is less than 12 inches of clearance on the latch side of the west entrance to the apparatus room door from the push side.

Alternative Rec: Provide assisted service for individuals with disabilities.
(Where Available)

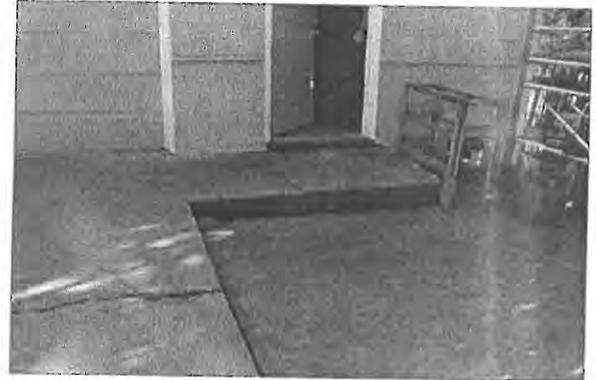
Exterior Door Hardware

Finding: Exterior passage doors, at the main entrance, kitchen, west entrance to the apparatus room, have round doorknobs, which require twisting of the wrist to operate.

Full Rec Replace the existing door hardware with accessible hardware (see ADAAG 4.13.9).

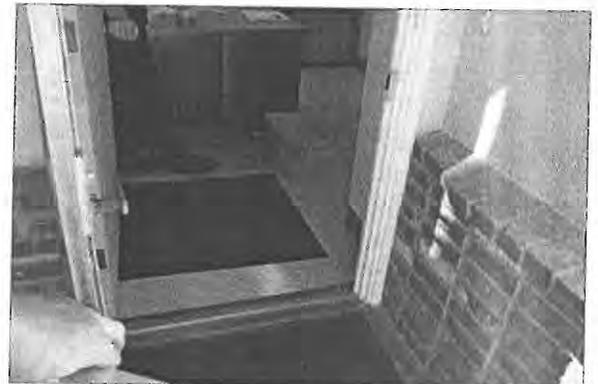
Exterior Door Threshold

Finding: The height of the threshold at the main entrance and the kitchen entrance, is greater than 1/4 inch but does not exceed 1/2 inch.

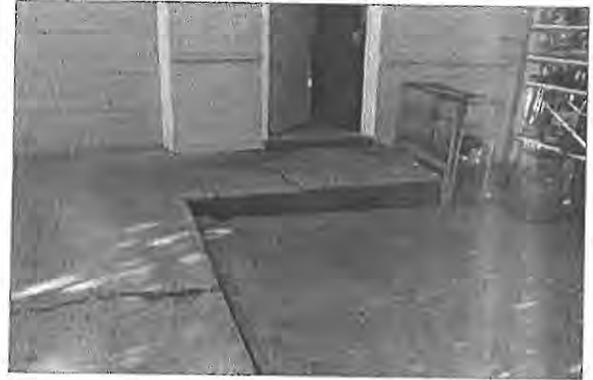
Exterior Door Threshold

Finding: The height of the threshold at the west entrance door to the apparatus room door is greater than 1/2 inch.

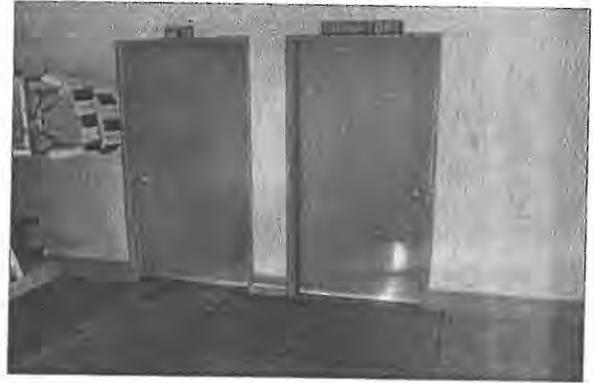
Interior Door Hardware

Finding: Interior passage doors, throughout the facility, have round doorknobs, which require twisting of the wrist to operate.

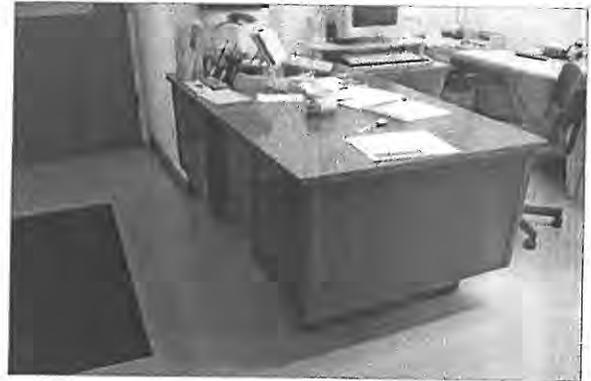
Reception Desk

Finding: The reception desk, by the main entrance, was inspected and was found to comply with height and length requirements.

Alternative Rec: (Where Available) No action needs to be taken at this time regarding the reception desk.

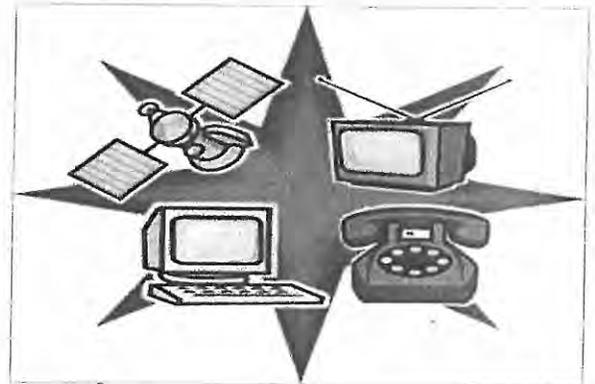
Finding: The facility does not provide information at the office about accessible services, such as TDD/TTY machines, assistive listening systems (ALS), and alternative formats of facility materials.

Full Rec Provide information at the facility office concerning accessible services such as TDD/TTY machines (see CBC 1117B.2.9.3), assistive listening systems (ALS) (see CBC 1104B.2.4), and alternative formats of facility materials. Request forms for auxiliary aids (such as large print materials, signers at public events, etc.), should also be kept at the main office. A large-print sign with wording similar to the following should be displayed at the office counter; "Access to individuals with disabilities is provided to programs, services and activities. Please inquire if assistance is needed."

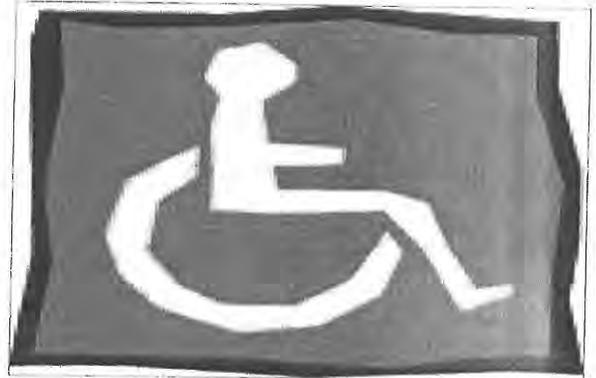
Facility Signage

Finding: There is no signage with the International Symbol of Accessibility on the entrance door to the facility designating it as accessible.

Full Rec The International Symbol of Accessibility shall be the standard used to identify facilities that are accessible to and usable by physically disabled persons (see CBC 1117B.5.1). All building entrances that are accessible to and usable by persons with disabilities shall be identified with an ISA symbol (see CBC 1117B.5.7).

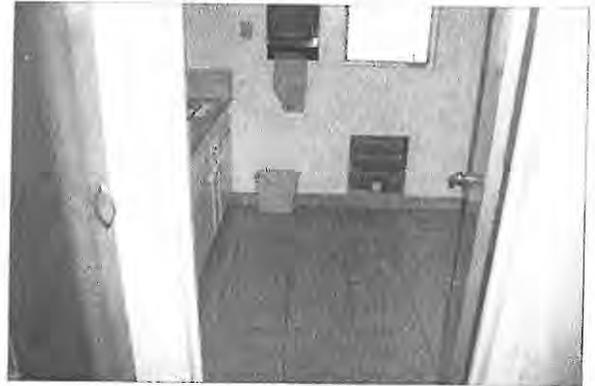
Men's Restroom Next to the Dormitory

Finding: There is no signage indicating accessibility on the latch side of the entry door of the restroom.

Full Rec At least one accessible set of restrooms shall be provided for adults. The restroom should be made an accessible restroom for the facility. Post signage centered 60 inches above the floor on the latch side of the entrance door identifying the restroom as accessible upon completion of the following items (see CBC 1115B.5, ADAAG 4.1.2(7) and ADAAG 4.1.6(3)(e)). Signage shall include Braille and raised lettering, the gender or unisex use symbol and the ISA symbol.

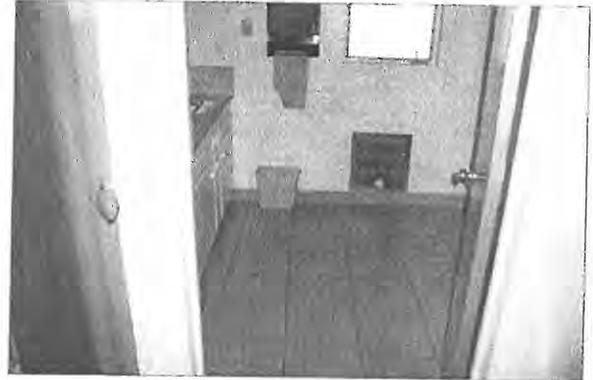
Men's Restroom Next to the Dormitory

Finding: The clear opening width of the entrance doorway to the restroom is less than 32 inches.

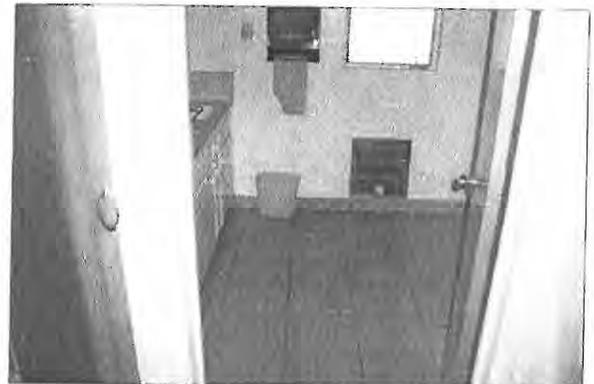
Men's Restroom Next to the Dormitory

Finding: The entrance door to the restroom has a round doorknob that requires tight grasping or twisting of the wrist to operate.

Full Rec Replace the door hardware mounted on the restroom complying with ADAAG 4.13.9. Make certain accessible door hardware is mounted no higher than 48 inches above the finished floor.

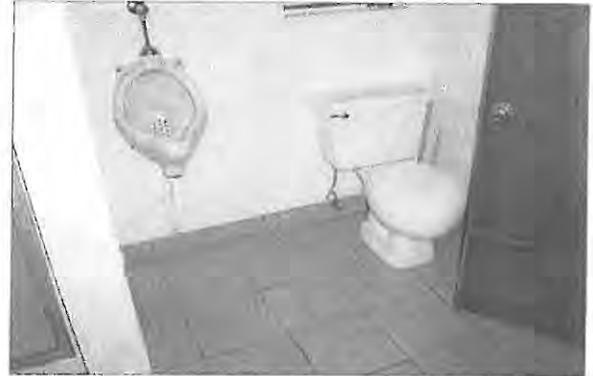
Men's Restroom Next to the Dormitory

Finding: This restroom is not accessible and cannot be easily altered. There is not sufficient clear floor space in the restroom. The inward swing of the entrance door reduces the clear floor space in the restroom.

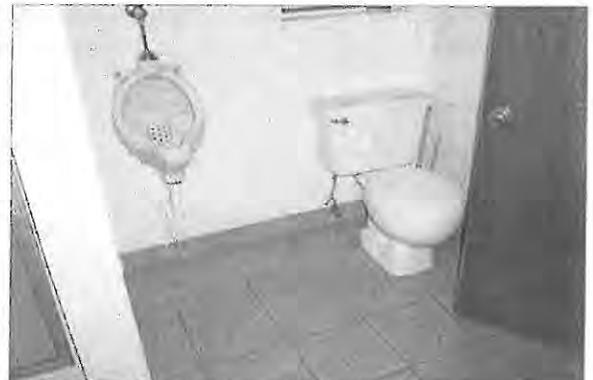
Men's Restroom Next to the Dormitory

Finding: The urinal in the restroom does not provide a tapered, elongated rim. The height of the urinal rim is greater than 17 inches above the finished floor. The flush control valve on the urinal is greater than 44 inches above the finished floor.

Full Rec Replace the urinal designated to be accessible in the restroom with a wall-mounted or stall-type tapered, elongated rim unit complying with ADAAG 4.18.2. The height of the rim surface of the urinal designated to be accessible shall not exceed 17 inches above the finished floor and the flush control valve shall not exceed a height of 44 inches above the finished floor.

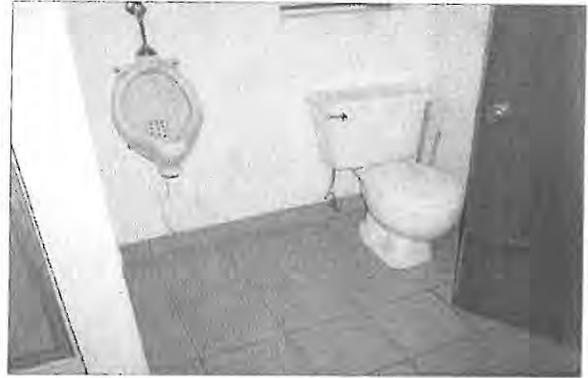
Men's Restroom Next to the Dormitory

Finding: There are no grab bars in the restroom.

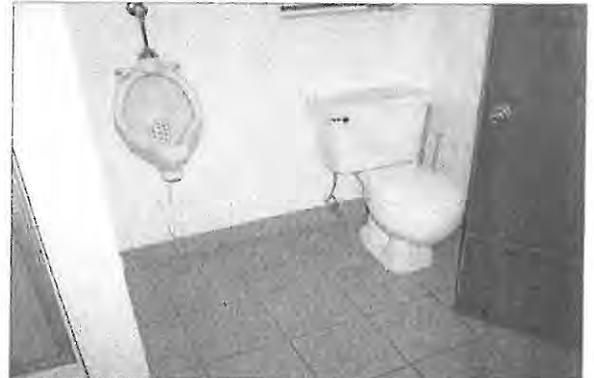
Men's Restroom Next to the Dormitory

Finding: The height of the toilet seat in the restroom is less than 17 inches above the finished floor.

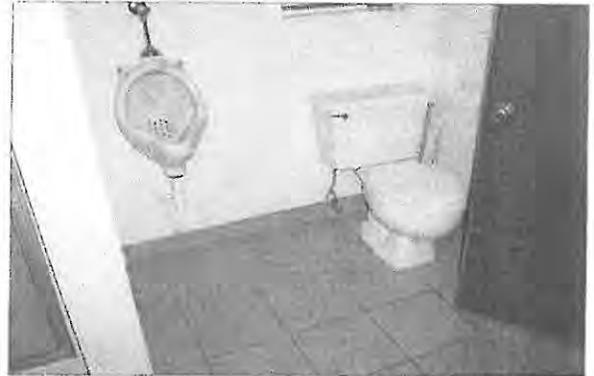
Men's Restroom Next to the Dormitory

Finding: The distance from the center of the toilet to the nearest side wall in the restroom is less than 18 inches.
