Town of Paradise

ADA self-evaluation transition plan

June 2015

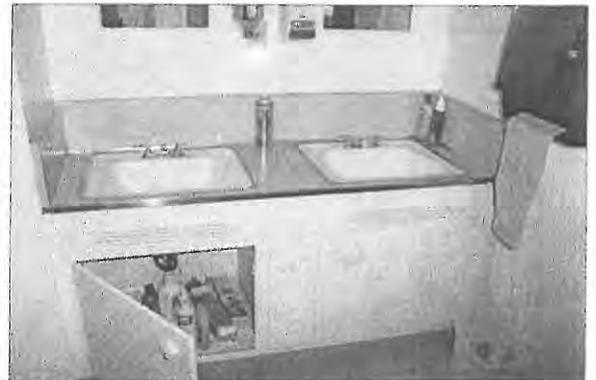
Men's Restroom Next to the Dormitory

Finding: The lavatory in the restroom is in an enclosed cabinet, thereby preventing an accessible forward approach.

Full Rec Lavatories in restrooms must provide clear floor space in front of the lavatory for an accessible forward approach and shall provide at least 29 inches clear knee space and a minimum of nine inches clear toe space (see ADAAG 4.19.2). If neither clear floor space and knee and toe clearance can be provided, remove the lavatory cabinet and replace with an accessible wall-mounted lavatory unit.

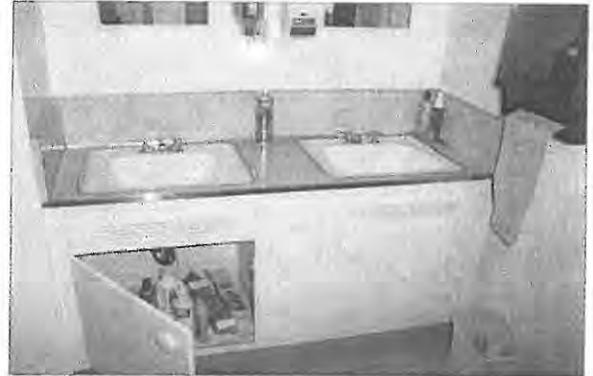
Men's Restroom Next to the Dormitory

Finding: The bottom edge of the reflecting surface of the mirror in the restroom is greater than 40 inches above the finished floor.

Full Rec Lower the mirror in the restroom so that the bottom edge of the reflecting surface is no higher than 40 inches above the finished floor and the topmost portion of the reflecting surface extends at least 74 inches above the finished floor (see ADAAG A4.19.6). A single, full-length mirror is recommended since it can accommodate all people. Make certain to provide a minimum clear floor space in front of the mirror of 30 inches in width and 48 inches in length.

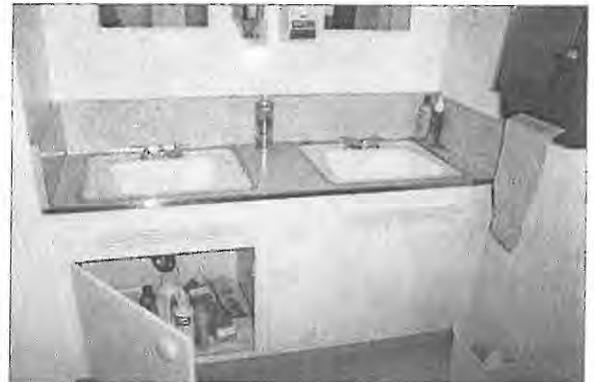
Men's Restroom Next to the Dormitory

Finding: The height of the controls and operating mechanisms for the soap dispenser in the restroom is greater than 40 inches above the finished floor.

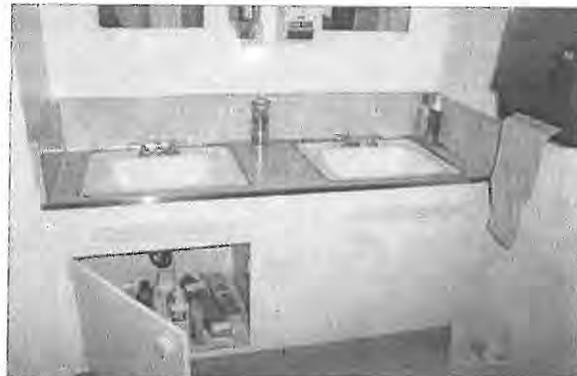
Men's Restroom Next to the Dormitory

Finding: The height of the controls and operating mechanisms for the paper towel dispenser in the restroom is greater than 40 inches above the finished floor.

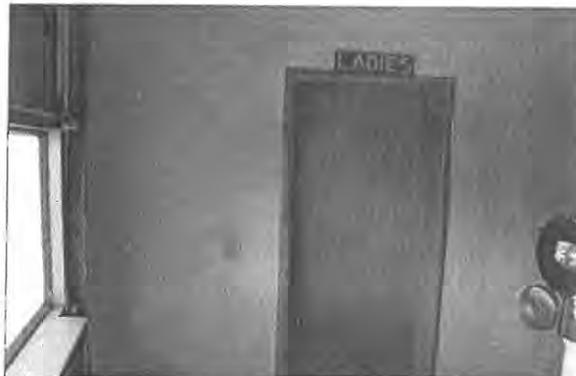
Women's Restroom Next to the Apparatus Room

Finding: There is no signage indicating accessibility on the latch side of the entry door of the restroom.

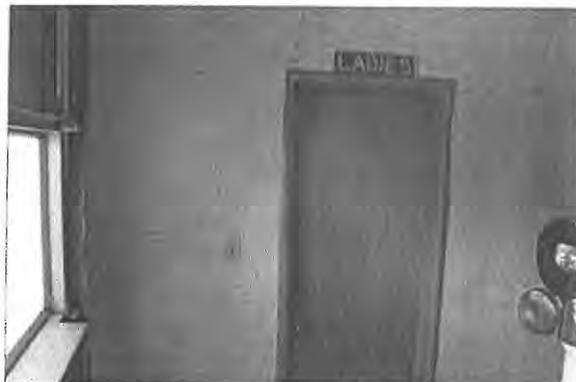
Women's Restroom Next to the Apparatus Room

Finding: The clear opening width of the entrance doorway to the restroom is less than 32 inches.

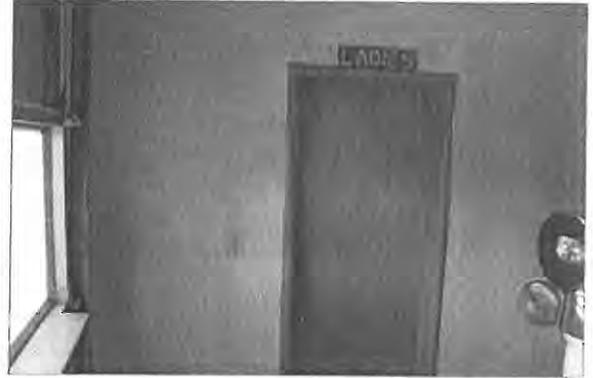
Women's Restroom Next to the Apparatus Room

Finding: The entrance door to the restroom has a round doorknob that requires tight grasping or twisting of the wrist to operate.

Full Rec Replace the door hardware mounted on the restroom complying with ADAAG 4.13.9. Make certain accessible door hardware is mounted no higher than 48 inches above the finished floor.

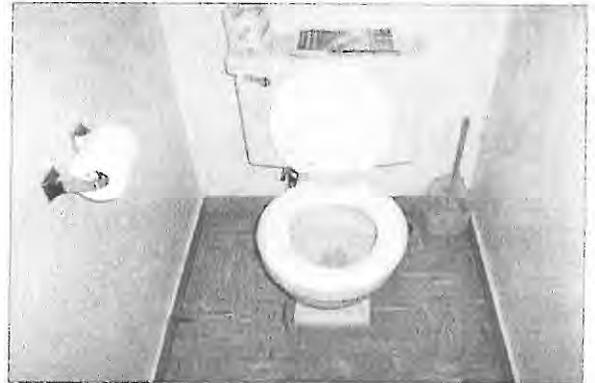
Women's Restroom Next to the Apparatus Room

Finding: This restroom is not accessible and cannot be easily altered. There is not sufficient clear floor space in the restroom to accommodate an individual in a wheelchair.

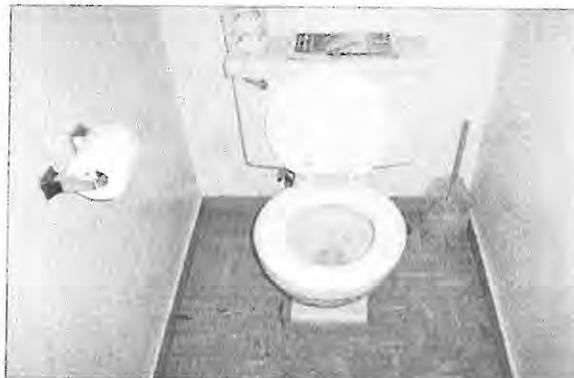
Women's Restroom Next to the Apparatus Room

Finding: There are no grab bars in the restroom.

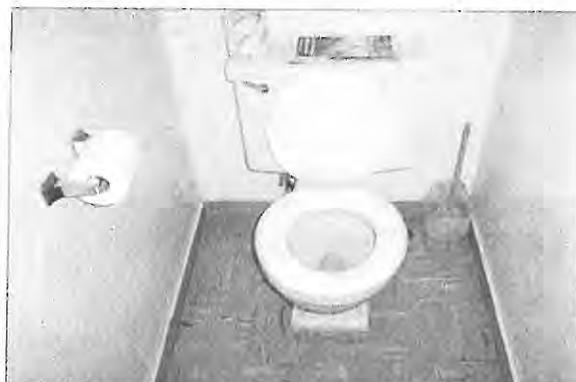
Women's Restroom Next to the Apparatus Room

Finding: The flush control on the toilet in the restroom is not on the wide (approach) side of the toilet.

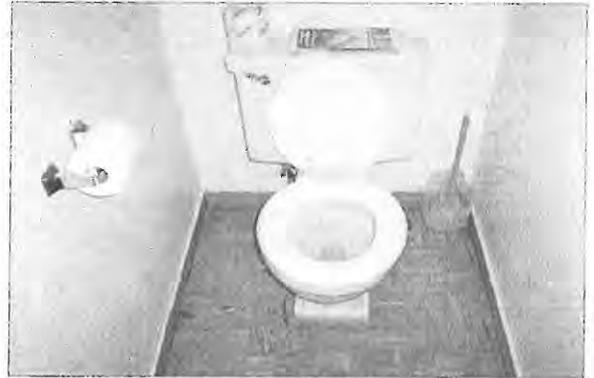
Women's Restroom Next to the Apparatus Room

Finding: The height of the toilet seat in the restroom is less than 17 inches above the finished floor.

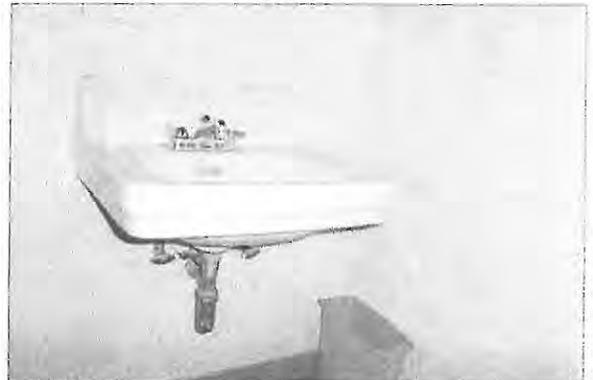
Women's Restroom Next to the Apparatus Room

Finding: The knee clearance space under the lavatory designated to be accessible in the restroom is less than 29 inches.

Full Rec Raise or replace the lavatory designated to be accessible in the restroom to provide at least 29 inches of clear knee space between the finished floor and bottom of the lavatory apron and at least 27 inches of knee clearance under the lavatory bowl at a knee depth of 8 inches (see ADAAG 4.19.2). Make certain the height of the top of the lavatory does not exceed 34 inches above the finished floor.

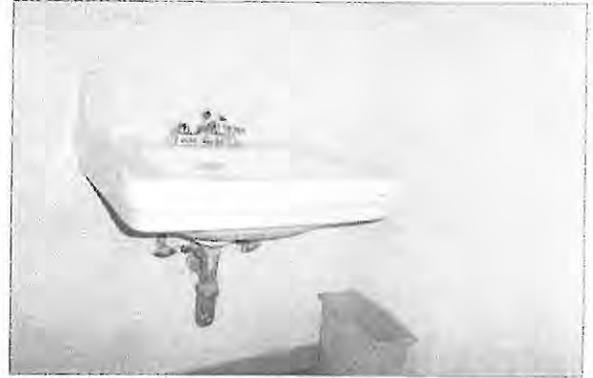
Women's Restroom Next to the Apparatus Room

Finding: The pipes under the lavatory in the restroom do not provide protection against contact.

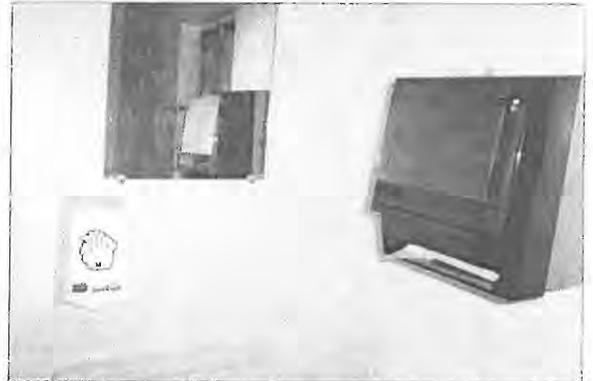
Women's Restroom Next to the Apparatus Room

Finding: The bottom edge of the reflecting surface of the mirror in the restroom is greater than 40 inches above the finished floor.

Full Rec Lower the mirror in the restroom so that the bottom edge of the reflecting surface is no higher than 40 inches above the finished floor and the topmost portion of the reflecting surface extends at least 74 inches above the finished floor (see ADAAG A4.19.6). A single, full-length mirror is recommended since it can accommodate all people. Make certain to provide a minimum clear floor space in front of the mirror of 30 inches in width and 48 inches in length.

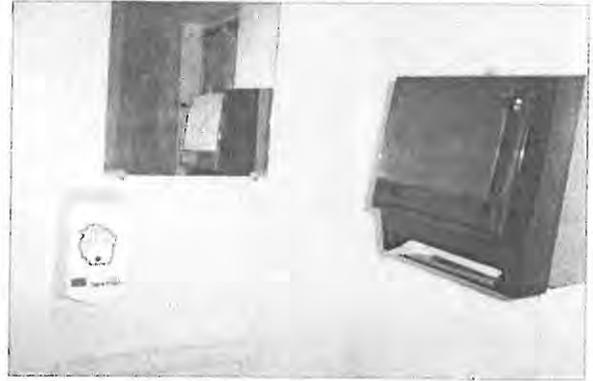
Women's Restroom Next to the Apparatus Room

Finding: The height of the controls and operating mechanisms for the soap dispenser in the restroom is greater than 40 inches above the finished floor.

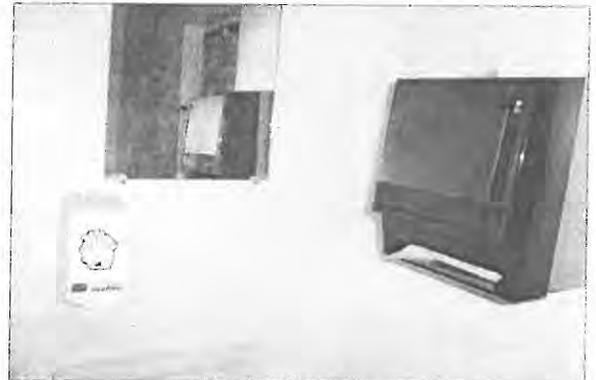
Women's Restroom Next to the Apparatus Room

Finding: The height of the controls and operating mechanisms for the paper towel dispenser in the restroom is greater than 40 inches above the finished floor.

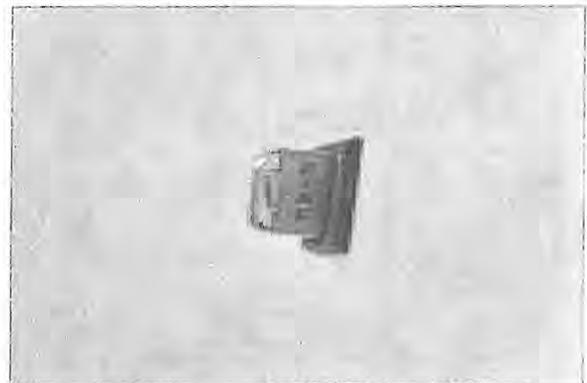
Finding: There are no visual warning devices at the facility.

Alternative Rec: (Where Available) Altering a facility's programs, or addressing higher priority barriers can reduce or eliminate the need for an area of rescue assistance, such as making certain that an individual with a disability participates in programs located near an already accessible exit. Otherwise creating an accessible exit can provide an acceptable alternative to providing an area of rescue assistance.

Full Rec Install visual warning devices integrated with the facility's alarm system complying with CBC 1114B.2.5, ADAAG 4.1.3(14) and ADAAG 4.28 in all common areas such as hallways, classrooms and general use rooms, and in accessible restrooms and other accessible rooms.

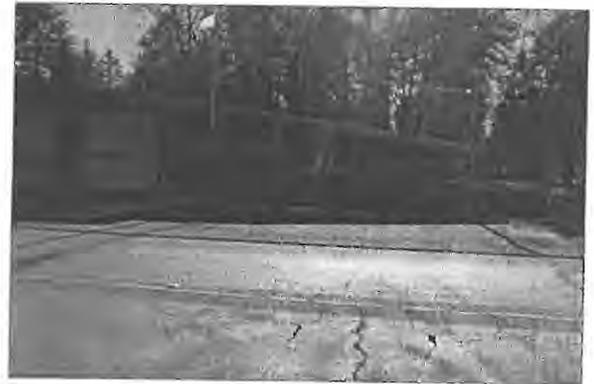
Finding: The Paradise Fire Department, Station 3, is a single story structure located at 1250 Wagstaff in Paradise. The fire station was built in 1965. The facility was inspected by Disability Access Consultants, Inc., on January 15, 2002. It is noted that there have been permits issued for construction or renovation in this facility after January 26, 1992.

Full Rec Any renovation or new construction that occurred after January 26, 1992, is subject to meet full code specifications for the California Building Code and ADAAG guidelines. All recommendations in this report that specify relocating Programs, Services or Activities, or make other allowances which avoid physical barrier removal as an alternative minimum compliance will have no effect or bearing on the non-compliant elements of newly constructed or renovated facilities. Consult with your Architect to determine which elements are affected by this requirement. It is recommended that Disability Access Consultants, Inc. is consulted for inspection of any new construction or renovation at the facility.

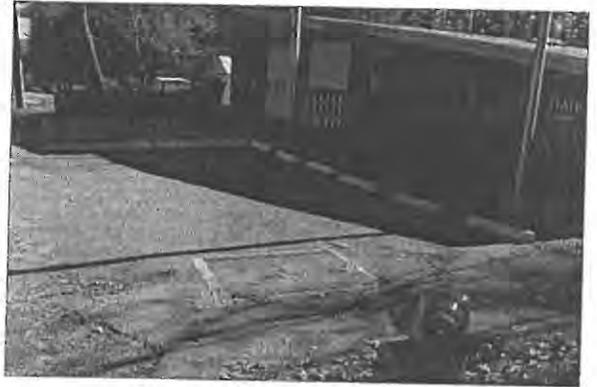
Parking Lot in Front of the Facility

Finding: The surface of the parking lot has a slope greater than 2%.

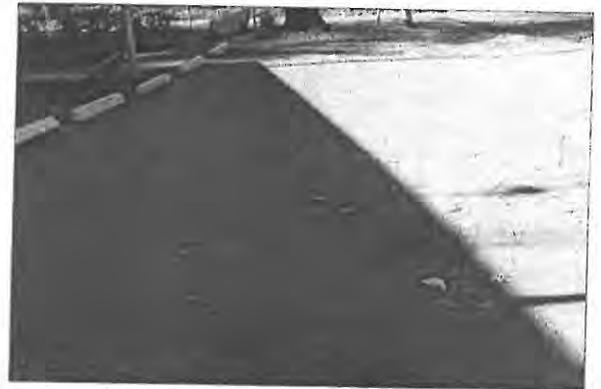
Parking Lot in Front of the Facility

Finding: There are no marked parking spaces in the parking lot. There are approximately five parking spaces in the parking lot. There are no accessible parking spaces designated out of the five approximate parking spaces provided in the parking lot.

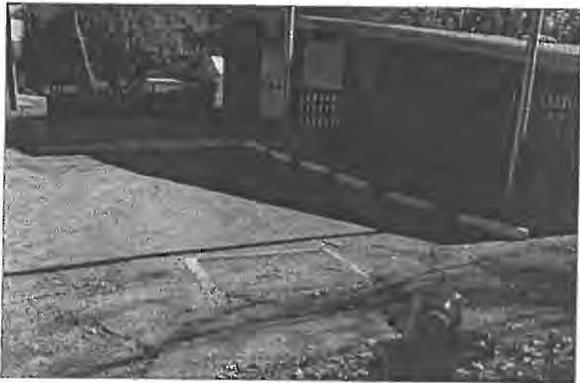
Parking Lot in Front of the Facility

Finding: Each designated accessible parking space required in the parking lot shall provide a post-mounted sign showing the International Symbol of Accessibility.

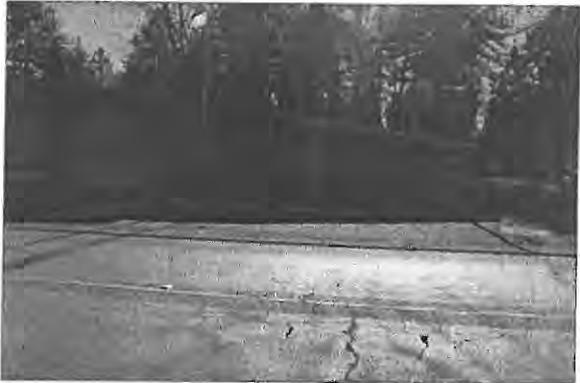
Parking Lot in Front of the Facility

Finding: There is no warning signage posted regarding unauthorized use of accessible parking spaces in the parking lot.

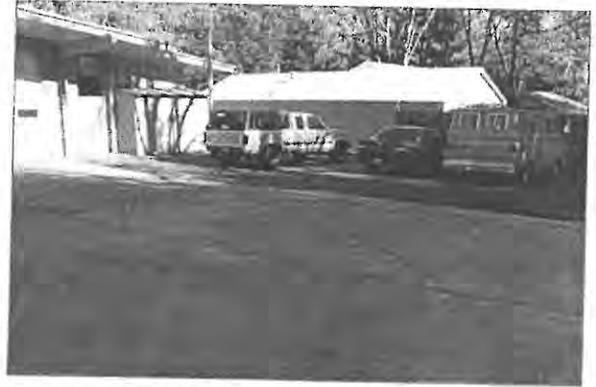
Parking Lot in the Rear of the Facility

Finding: Paved parking is provided in the rear of the facility. There are no marked parking spaces in the parking lot. There are approximately four parking spaces in the parking lot. There are no accessible parking spaces designated out of the four approximate parking spaces provided in the parking lot.

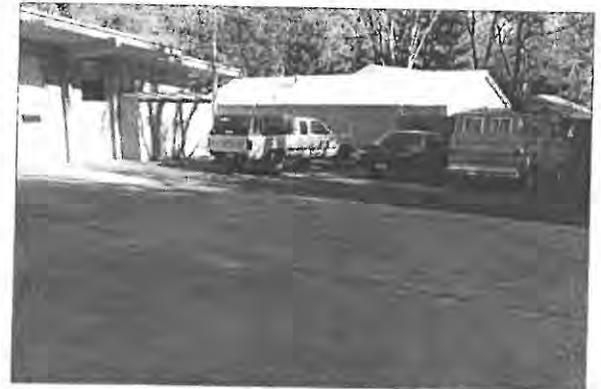
Parking Lot in the Rear of the Facility

Finding: Each designated accessible parking space required in the parking lot shall provide a post-mounted sign showing the International Symbol of Accessibility.

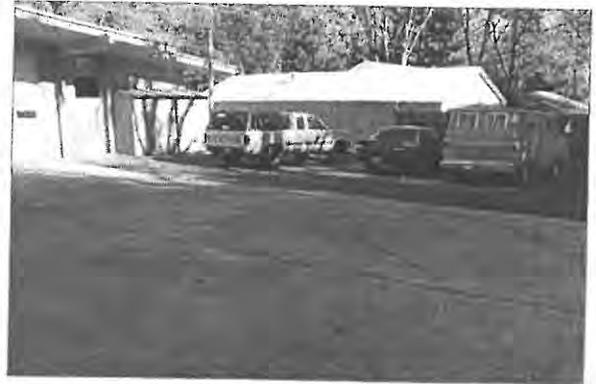
Parking Lot in the Rear of the Facility

Finding: There is no warning signage posted regarding unauthorized use of accessible parking spaces in the parking lot.

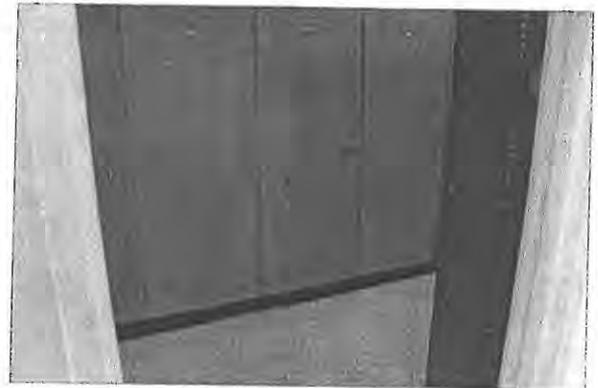
Lockers in the Dormitory

Finding: Lockers are available for use in the dormitory. The hardware on the lockers, does not provide at least 1 1/2 inches of clearance between the hardware and the locker door.

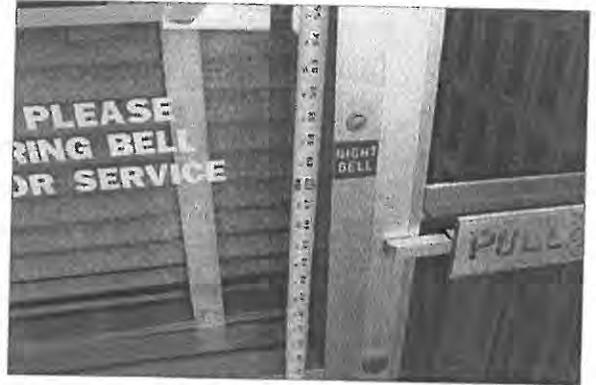
Night Bell at the Main Entrance

Finding: The forward reach height of the night bell at the main entrance is greater than 48 inches above the ground surface.

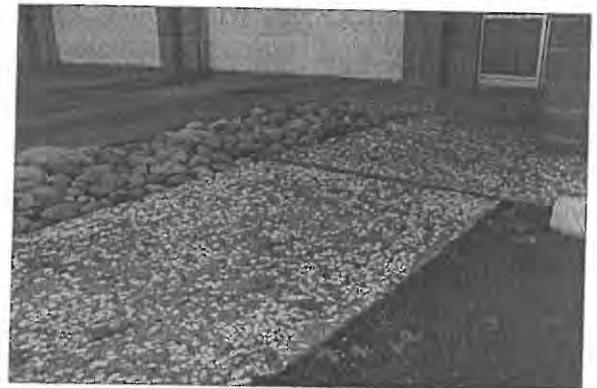
Path of Travel Between the Entrance and Parking

Finding: There is a change in elevation greater than 1/2 inch on the primary path of travel between the parking lot in front of the facility and the main entrance at the concrete to asphalt transition point.

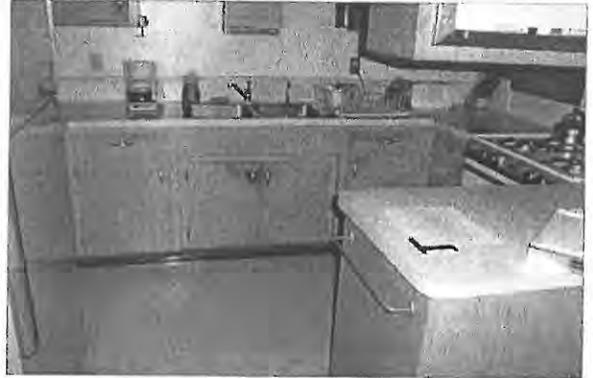
Sinks in the Kitchen and Apparatus Room

Finding: The sink in each the kitchen and apparatus room is in an enclosed cabinet, thereby preventing an accessible forward approach.

Alternative Rec: (Where Available) No action is required at this time regarding the front approach clearance of each sink, unless major renovation occurs in the area.

Full Rec Sinks must provide clear floor space in front of the sink for an accessible forward approach and shall provide at least 27 inches clear knee space and a minimum of nine inches clear toe space (see ADAAG 4.19.2). If neither clear floor space and knee and toe clearance can be provided, remove the sink cabinet and replace with an accessible wall-mounted sink unit.

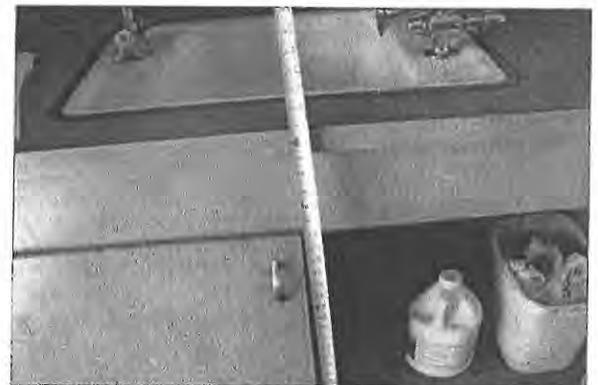
Sinks in the Kitchen and Apparatus Room

Finding: The hardware on the cabinet enclosing the sink in each the kitchen and apparatus room, does not provide at least 1 1/2 inches of clearance between the hardware and the cabinet.

Alternative Rec: (Where Available) No action is required at this time regarding the hardware on the cabinet enclosing each sink, unless major renovation occurs in the area.

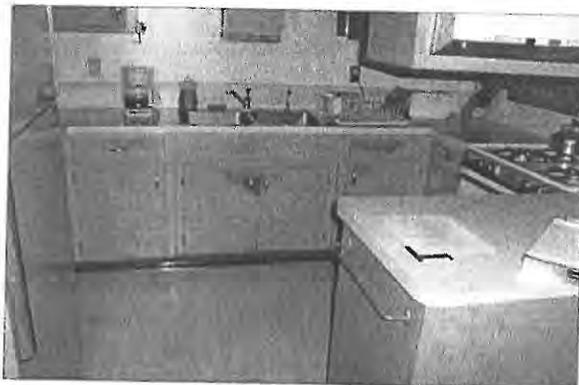
Sinks in the Kitchen and Apparatus Room

Finding: The pipes under the sink in each the kitchen and apparatus room do not provide protection against contact.

Alternative Rec: (Where Available) No action is required at this time regarding the pipes under each sink, unless major renovation occurs in the area.

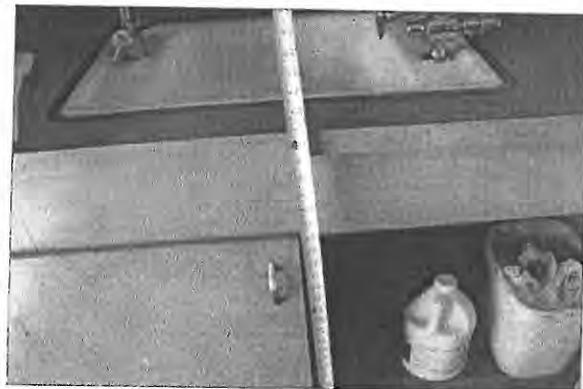
Sinks in the Kitchen and Apparatus Room

Finding: The height of the counter surface of the sink in each the kitchen and apparatus room is greater than 34 inches above the finished floor.

Alternative Rec: (Where Available) No action is required at this time regarding the height of the rim surface of each sink, unless major renovation occurs in the area.

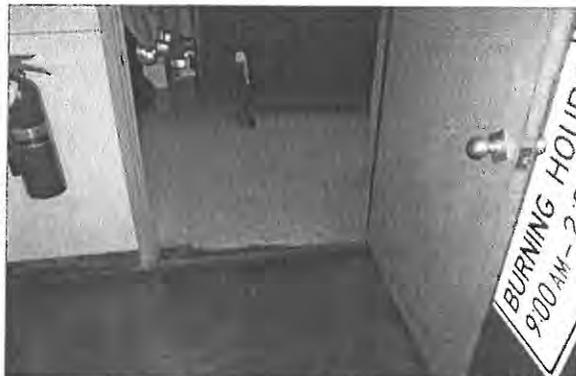
Entrance Door Threshold

Finding: The height of the threshold at each entrance door, to the apparatus from the office, to the apparatus room from the dormitory, to the shop off the apparatus room and the storage room off the apparatus room, is greater than 1/2 inch.

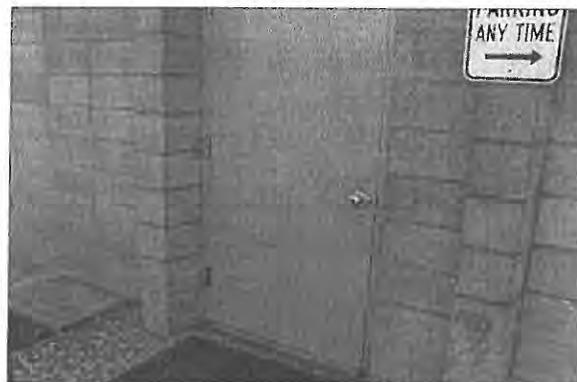
Exterior Door Hardware

Finding: Exterior passage doors, to the apparatus room from the office, north entrance door to the apparatus room, south (employee) entrance, have round doorknobs, which require twisting of the wrist to operate.

Full Rec Replace the existing door hardware with accessible hardware (see ADAAG 4.13.9).

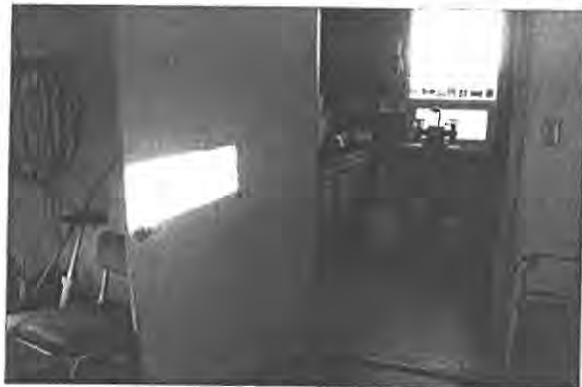
Interior Door Hardware

Finding: Interior passage doors, throughout the facility, have round doorknobs, which require twisting of the wrist to operate.

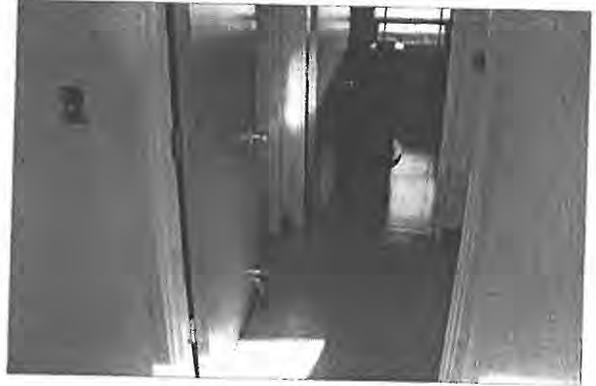
Interior Doors

Finding: The clear opening width of each interior door, to the dormitory, is less than 32 inches.

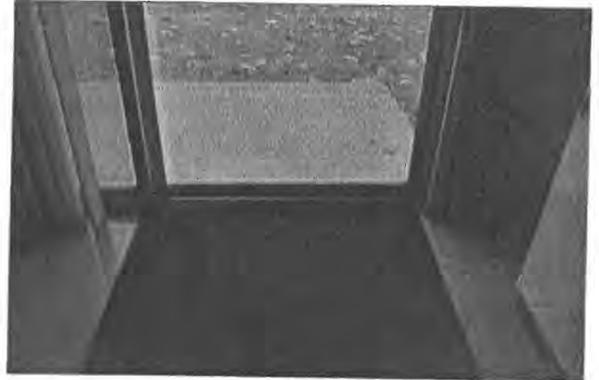
Sliding Glass Door

Finding: The sliding glass door, on the west side of the facility, has finger-pull hardware with less than 1 1/2 inches of clearance between the door and the hardware.

Full Rec Replace the existing door hardware with accessible hardware (see ADAAG 4.13.9).

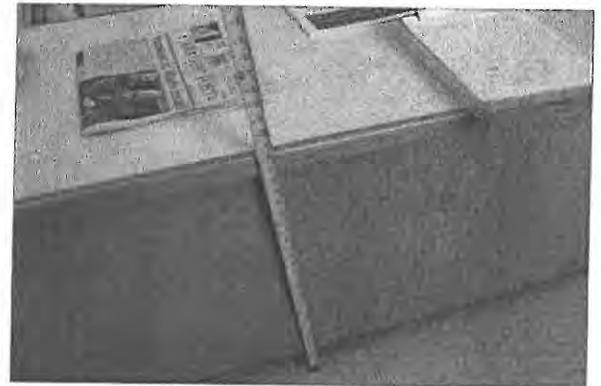
Office Reception

Finding: The office reception counter was inspected and was found to comply with height and length requirements.

Full Rec Make certain that services provided at the office reception counter are accessible and that a clear accessible route to the desk is provided at all times.

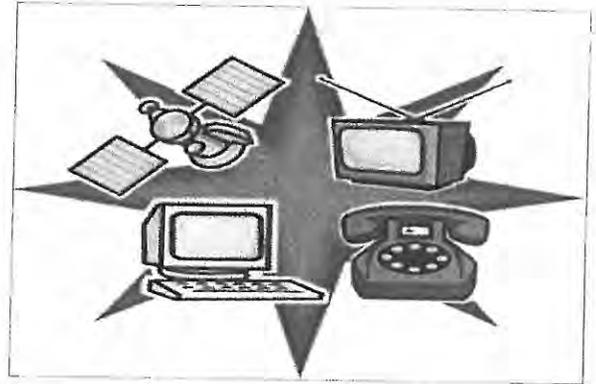
Finding: The facility does not provide information at the main office about accessible services, such as TDD/TTY machines, assistive listening systems (ALS), and alternative formats of facility materials.

Full Rec Provide information at the facility office concerning accessible services such as TDD/TTY machines (see CBC 1117B.2.9.3), assistive listening systems (ALS) (see CBC 1104B.2.4), and alternative formats of facility materials. Request forms for auxiliary aids (such as large print materials, signers at public events, etc.), should also be kept at the main office. A large-print sign with wording similar to the following should be displayed at the office counter; "Access to individuals with disabilities is provided to programs, services and activities. Please inquire if assistance is needed."

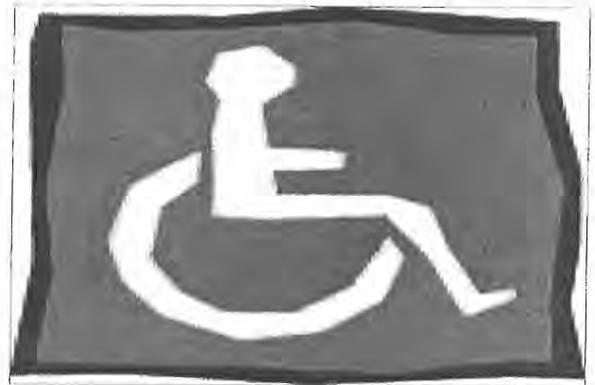
Facility Signage

Finding: There is no signage with the International Symbol of Accessibility on the entrance door to the facility designating it as accessible.

Full Rec The International Symbol of Accessibility shall be the standard used to identify facilities that are accessible to and usable by physically disabled persons (see CBC 1117B.5.1). All building entrances that are accessible to and usable by persons with disabilities shall be identified with an ISA symbol (see CBC 1117B.5.7).

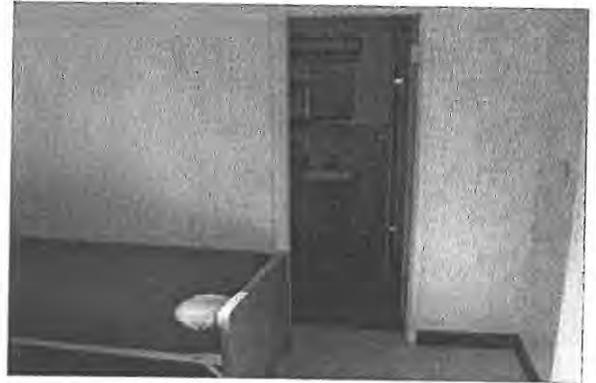
Men's Restroom in the Dormitory

Finding: There is no signage indicating accessibility on the latch side of the entry door of the restroom.

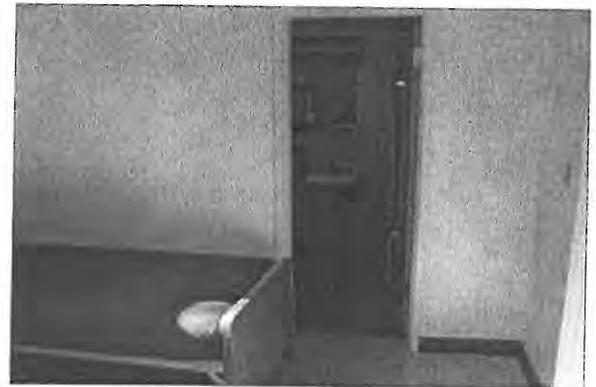
Men's Restroom in the Dormitory

Finding: The clear opening width of the entrance doorway to the restroom is less than 32 inches.

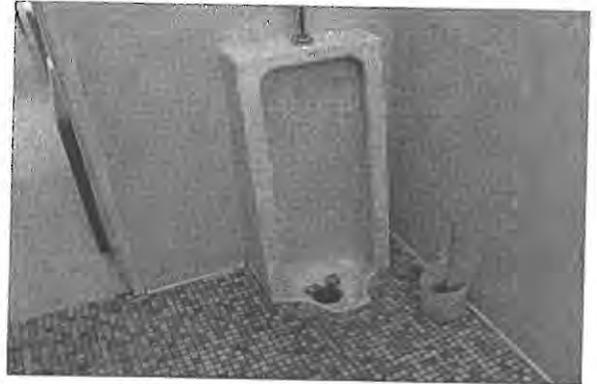
Men's Restroom in the Dormitory

Finding: The urinal in the restroom is floor mounted and does not provide a tapered, elongated rim. The flush control valve on the urinal is greater than 44 inches above the finished floor.

Full Rec Replace the urinal designated to be accessible in the restroom with a wall-mounted or stall-type tapered, elongated rim unit complying with ADAAG 4.18.2. The height of the rim surface of the urinal designated to be accessible shall not exceed 17 inches above the finished floor and the flush control valve shall not exceed a height of 44 inches above the finished floor.

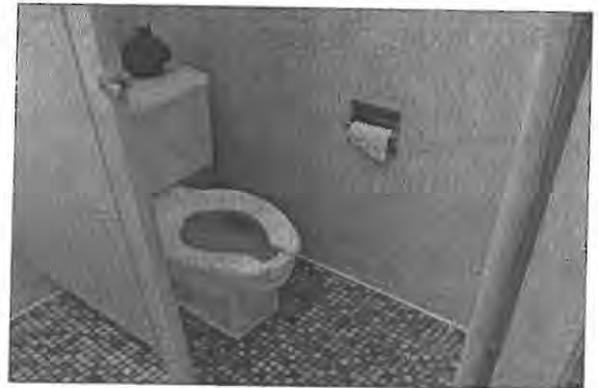
Men's Restroom in the Dormitory

Finding: There is insufficient clear floor space in the stall designated to be accessible in the restroom.

Full Rec Modify or replace the stall designated to be accessible in the restroom so that it complies with ADAAG 4.17.3, CBC 1115B and CBC Figures 11B-1A and 1B. Standard accessible stalls require 60 inches in width with 56 inches depth for wall-mounted toilets or 59 inches depth for floor-mounted toilets to accommodate individuals in wheelchairs. A minimum 48 inches of clear space shall be provided in front of the toilet. Door shall swing outward, close automatically and provide accessible hardware.

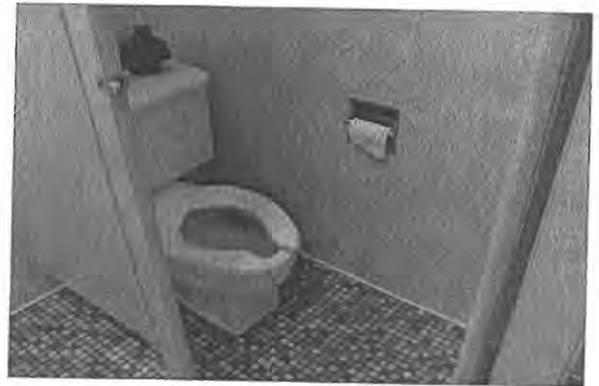
Men's Restroom in the Dormitory

Finding: There are no grab bars in the stall designated to be accessible in the restroom.

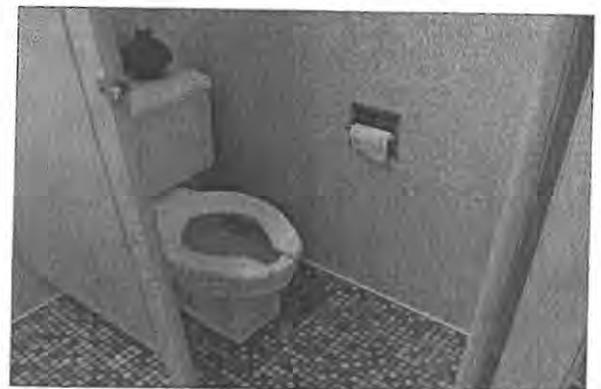
Men's Restroom in the Dormitory

Finding: The height of the toilet seat in the stall designated to be accessible in the restroom is less than 17 inches above the finished floor.

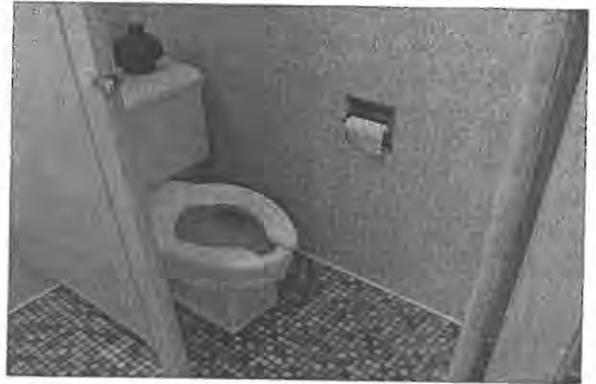
Men's Restroom in the Dormitory

Finding: The distance from the center of the toilet to the nearest side wall in the stall designated to be accessible in the restroom is less than 18 inches.

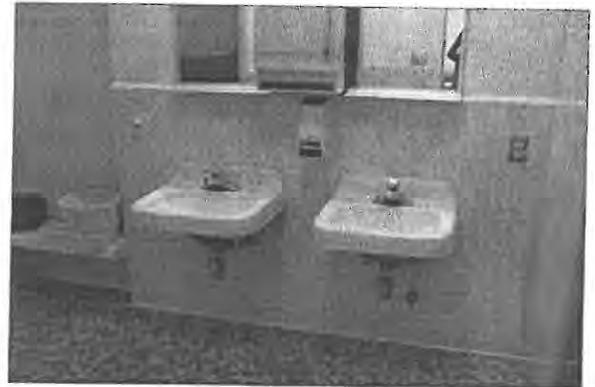
Men's Restroom in the Dormitory

Finding: The knee clearance space under the lavatory designated to be accessible in the restroom is less than 29 inches.

Full Rec Raise or replace the lavatory designated to be accessible in the restroom to provide at least 29 inches of clear knee space between the finished floor and bottom of the lavatory apron and at least 27 inches of knee clearance under the lavatory bowl at a knee depth of 8 inches (see ADAAG 4.19.2). Make certain the height of the top of the lavatory does not exceed 34 inches above the finished floor.

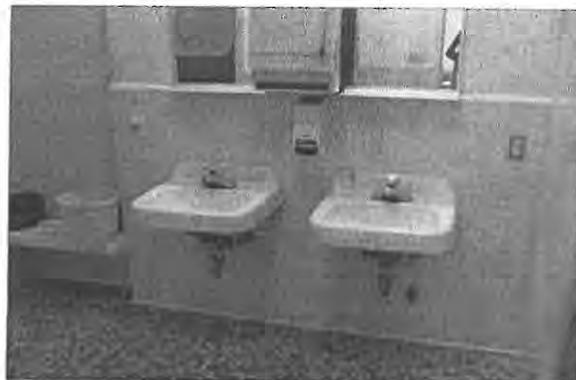
Men's Restroom in the Dormitory

Finding: The bottom edge of the reflecting surface of the mirror in the restroom is greater than 40 inches above the finished floor.

Full Rec Lower the mirror in the restroom so that the bottom edge of the reflecting surface is no higher than 40 inches above the finished floor and the topmost portion of the reflecting surface extends at least 74 inches above the finished floor (see ADAAG A4.19.6). A single, full-length mirror is recommended since it can accommodate all people. Make certain to provide a minimum clear floor space in front of the mirror of 30 inches in width and 48 inches in length.

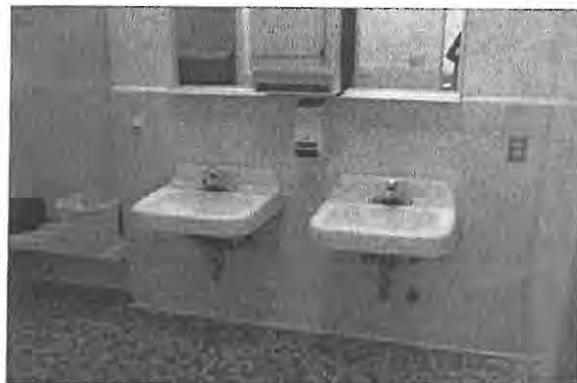
Men's Restroom in the Dormitory

Finding: The pipes under the lavatory in the restroom do not provide protection against contact.

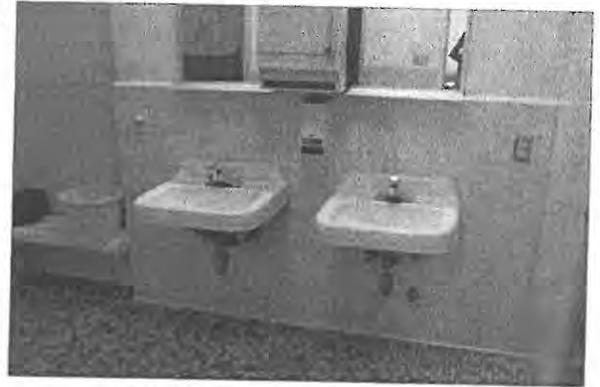
Men's Restroom in the Dormitory

Finding: The height of the controls and operating mechanisms for the paper towel dispenser in the restroom is greater than 40 inches above the finished floor.

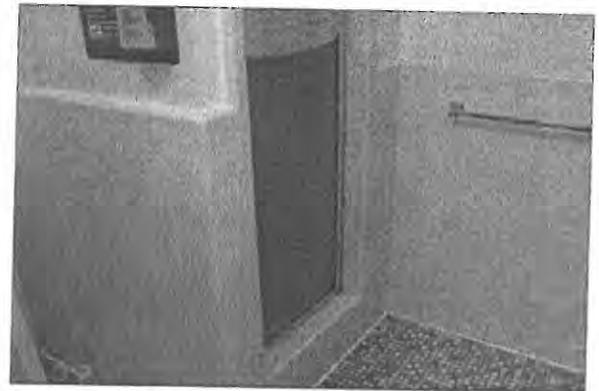
Men's Restroom in the Dormitory

Finding: There is a shower stall provided in the restroom.

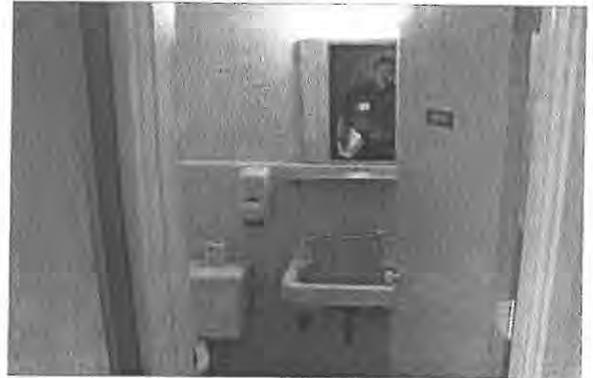
Women's Restroom Next to the Dormitory

Finding: There is no signage indicating accessibility on the latch side of the entry door of the restroom.

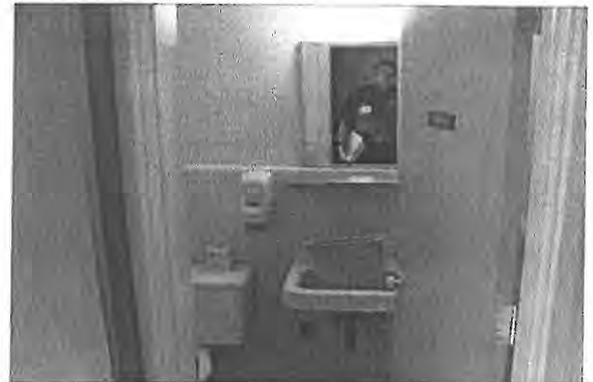
Women's Restroom Next to the Dormitory

Finding: The clear opening width of the entrance doorway to the restroom is less than 32 inches.

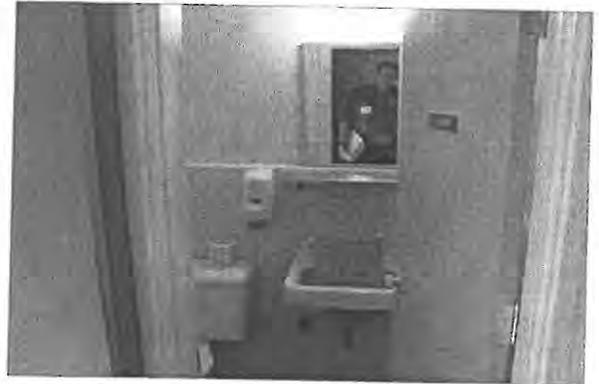
Women's Restroom Next to the Dormitory

Finding: The entrance door to the restroom has a round doorknob that requires tight grasping or twisting of the wrist to operate.

Full Rec Replace the door hardware mounted on the restroom complying with ADAAG 4.13.9. Make certain accessible door hardware is mounted no higher than 48 inches above the finished floor.

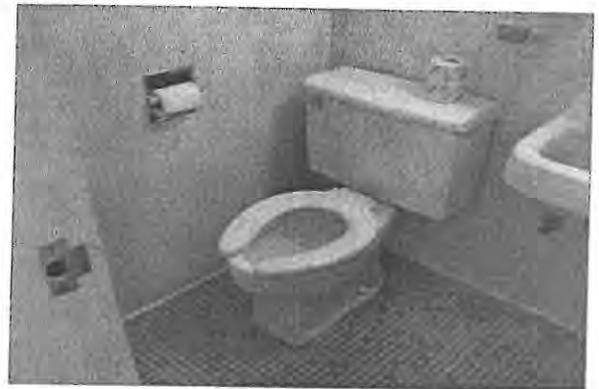
Women's Restroom Next to the Dormitory

Finding: This restroom is not accessible and cannot be easily altered. There is not sufficient clear floor space in the restroom to accommodate an individual in a wheelchair.

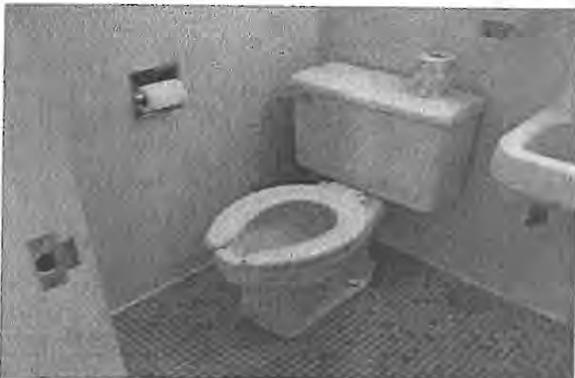
Women's Restroom Next to the Dormitory

Finding: There are no grab bars in the restroom.

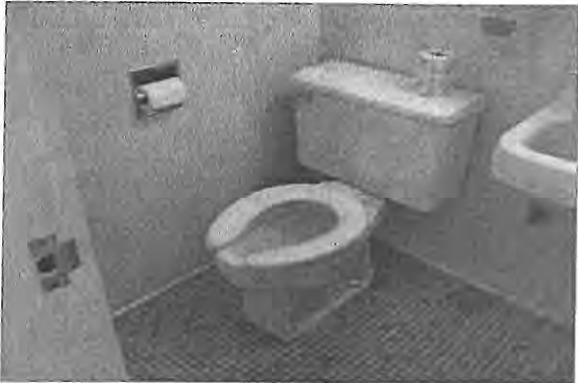
Women's Restroom Next to the Dormitory

Finding: The location of the toilet paper dispenser in the restroom is not within 12 inches of the front edge of the toilet seat.

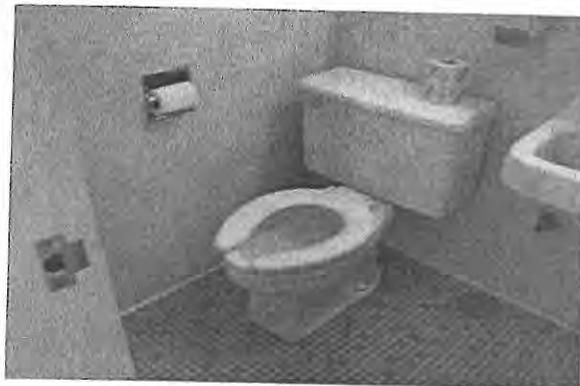
Women's Restroom Next to the Dormitory

Finding: The flush control on the toilet in the restroom is not on the wide (approach) side of the toilet.

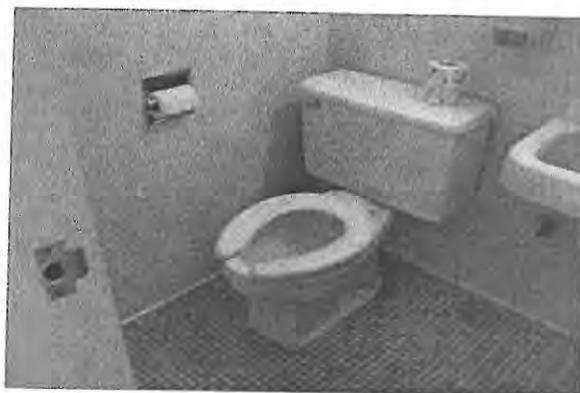
Women's Restroom Next to the Dormitory

Finding: The height of the toilet seat in the restroom is less than 17 inches above the finished floor.

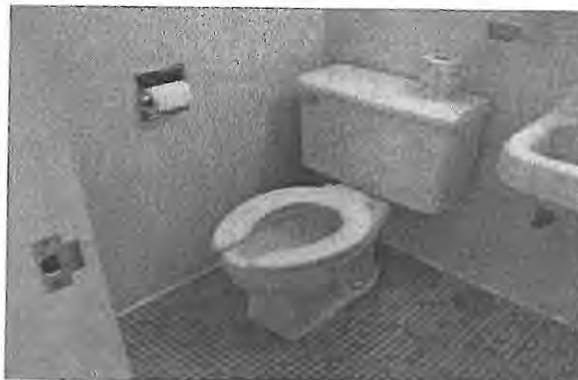
Women's Restroom Next to the Dormitory

Finding: The distance from the center of the toilet to the nearest side wall in the restroom is less than 18 inches.

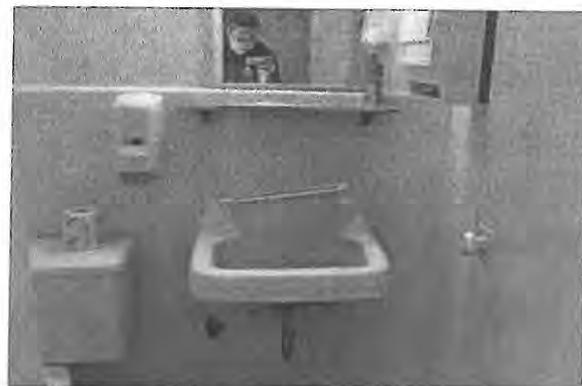
Women's Restroom Next to the Dormitory

Finding: The faucet controls on the lavatory in the restroom require tight grasping, pinching, or twisting of the wrist and are not accessible.

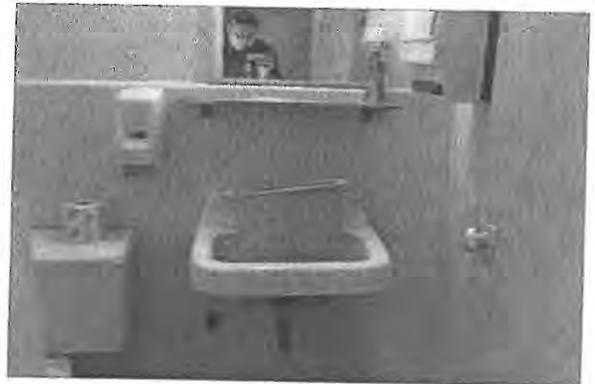
Women's Restroom Next to the Dormitory

Finding: The knee clearance space under the lavatory designated to be accessible in the restroom is less than 29 inches.

Full Rec Raise or replace the lavatory designated to be accessible in the restroom to provide at least 29 inches of clear knee space between the finished floor and bottom of the lavatory apron and at least 27 inches of knee clearance under the lavatory bowl at a knee depth of 8 inches (see ADAAG 4.19.2). Make certain the height of the top of the lavatory does not exceed 34 inches above the finished floor.

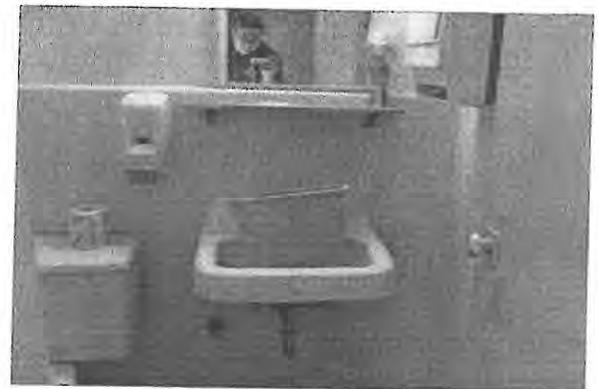
Women's Restroom Next to the Dormitory

Finding: The pipes under the lavatory in the restroom do not provide protection against contact.

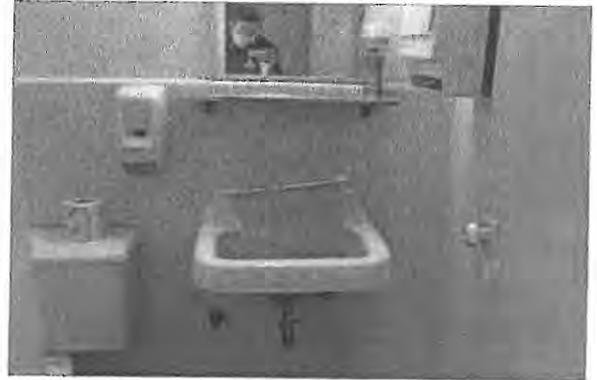
Women's Restroom Next to the Dormitory

Finding: The bottom edge of the reflecting surface of the mirror in the restroom is greater than 40 inches above the finished floor.

Full Rec Lower the mirror in the restroom so that the bottom edge of the reflecting surface is no higher than 40 inches above the finished floor and the topmost portion of the reflecting surface extends at least 74 inches above the finished floor (see ADAAG A4.19.6). A single, full-length mirror is recommended since it can accommodate all people. Make certain to provide a minimum clear floor space in front of the mirror of 30 inches in width and 48 inches in length.

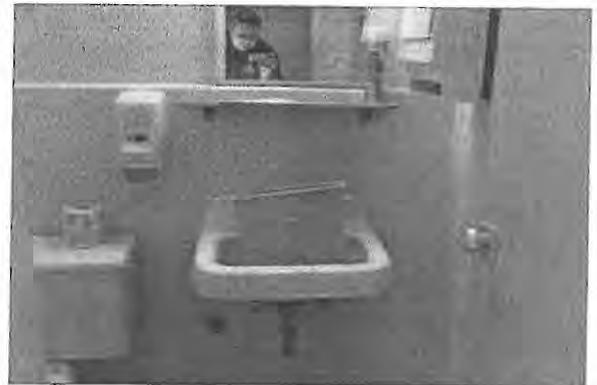
Women's Restroom Next to the Dormitory

Finding: The height of the controls and operating mechanisms for the paper towel dispenser in the restroom is greater than 40 inches above the finished floor.

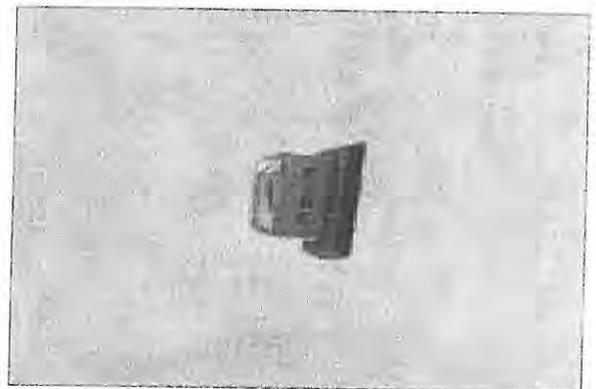
Finding: There are no visual warning devices at the facility.

Alternative Rec: (Where Available) Altering a facility's programs, or addressing higher priority barriers can reduce or eliminate the need for an area of rescue assistance, such as making certain that an individual with a disability participates in programs located near an already accessible exit. Otherwise creating an accessible exit can provide an acceptable alternative to providing an area of rescue assistance.

Full Rec Install visual warning devices integrated with the facility's alarm system complying with CBC 1114B.2.5, ADAAG 4.1.3(14) and ADAAG 4.28 in all common areas such as hallways, classrooms and general use rooms, and in accessible restrooms and other accessible rooms.

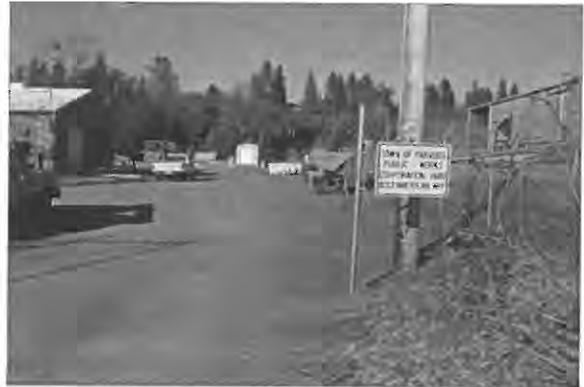
Finding: The Town of Paradise Public Works Corporate Yard is located at 933 American Way (next to animal control) in Paradise. The facility consists of a single story structure with a mezzanine storage area and a gravel parking area. The facility is not open to the public. The facility was inspected by Disability Access Consultants, Inc., on January 15, 2002. It is noted that there have been permits issued for construction or renovation in this facility after January 26, 1992.

Full Rec: Any renovation or new construction that occurred after January 26, 1992, is subject to meet full code specifications for the California Building Code and ADAAG guidelines. All recommendations in this report that specify relocating Programs, Services or Activities, or make other allowances which avoid physical barrier removal as an alternative minimum compliance will have no effect or bearing on the non-compliant elements of newly constructed or renovated facilities. Consult with your Architect to determine which elements are affected by this requirement. It is recommended that Disability Access Consultants, Inc. is consulted for inspection of any new construction or renovation at the facility.

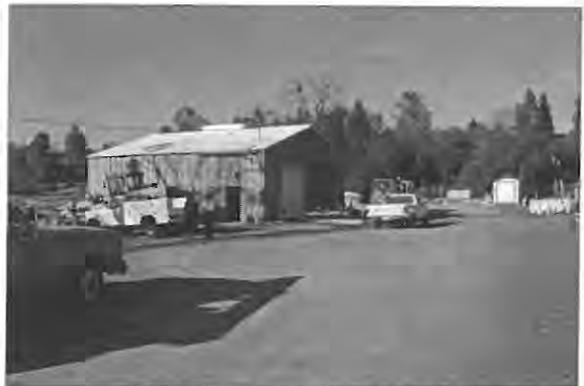
Parking Lot Outside of the Facility

Finding: The surface of the parking lot is gravel, preventing access to individuals with mobility impairments.

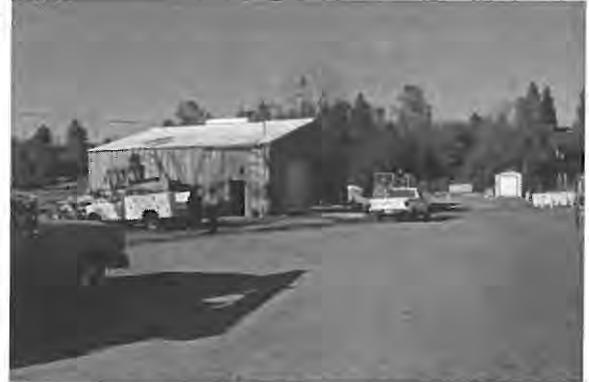
Parking Lot Outside of the Facility

Finding: The gravel parking lot provides approximately 10 parking spaces. There are no accessible parking spaces designated out the approximate 10 parking spaces provided in the parking lot.

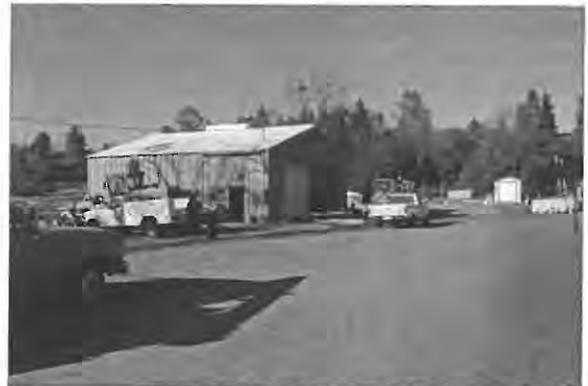
Parking Lot Outside of the Facility

Finding: Each designated accessible parking space required in the parking lot shall provide a post-mounted sign showing the International Symbol of Accessibility.

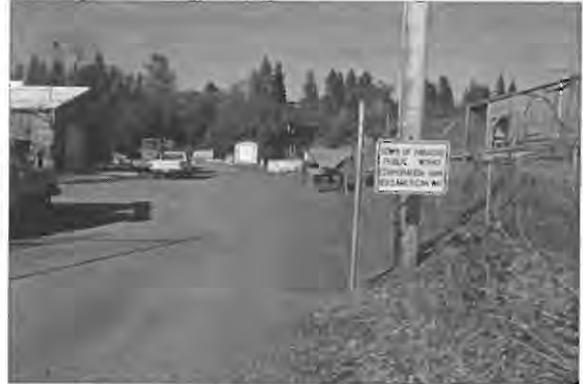
Parking Lot Outside of the Facility

Finding: There is no warning signage posted regarding unauthorized use of accessible parking spaces in the parking lot.
