Town of Paradise

ADA self-evaluation transition plan

June 2015

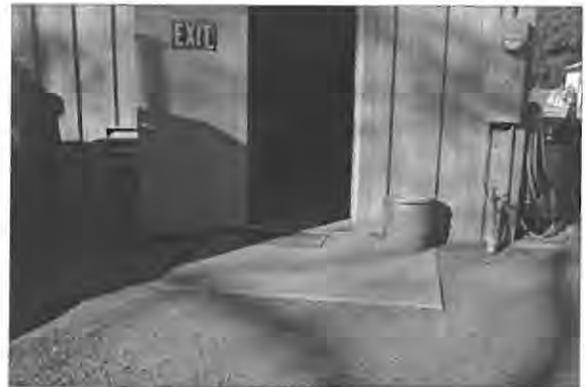
Path of Travel to the Main Entrance

Finding: The path of travel to the main entrance is gravel, preventing access to individuals with mobility impairments.

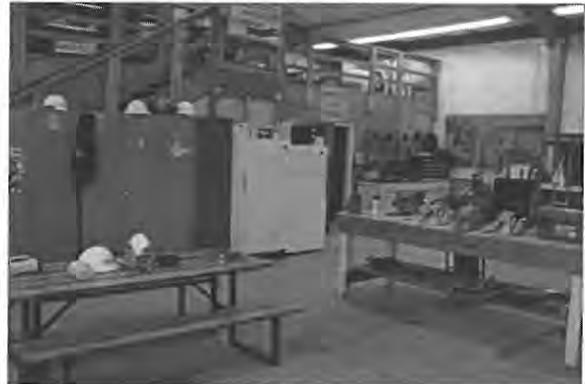
Storage Area

Finding: There are stairs on the primary path of travel to the storage area, preventing access to individuals with mobility impairments. The storage area is an employee only area.

Full Rec: At which time the area is open to the public, the path of travel will be required to be made accessible. At that time, it is recommended that a ramp be installed or other means of vertical access to the area.

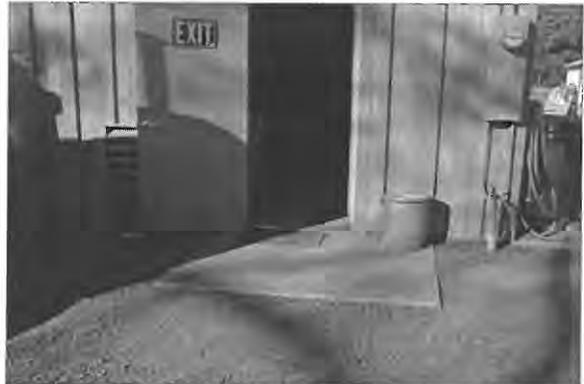
Exterior Door Threshold

Finding: The height of the threshold at the main entrance door is greater than 1/2 inch.

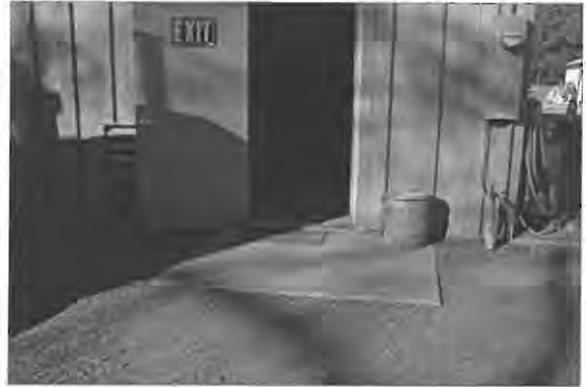
Exterior Doors

Finding: The door opening force for some exterior doors is greater than 8 1/2 pounds of force.

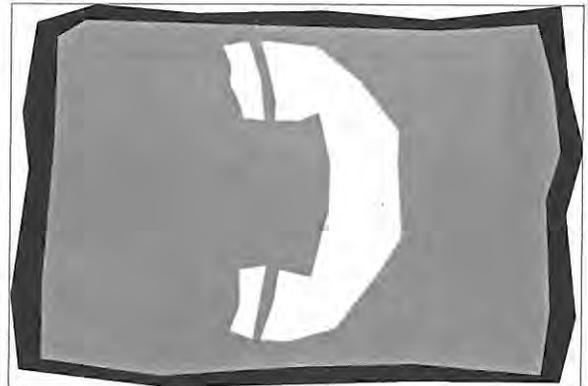
Finding: The facility does not provide information at the office about accessible services, such as TDD/TTY machines, assistive listening systems (ALS), and alternative formats of facility materials.

Full Rec: Provide information at the facility office concerning accessible services such as TDD/TTY machines (see CBC 1117B.2.9.3), assistive listening systems (ALS) (see CBC 1104B.2.4), and alternative formats of facility materials. Request forms for auxiliary aids (such as large print materials, signers at public events, etc.), should also be kept at the main office. A large-print sign with wording similar to the following should be displayed at the office counter; "Access to individuals with disabilities is provided to programs, services and activities. Please inquire if assistance is needed."

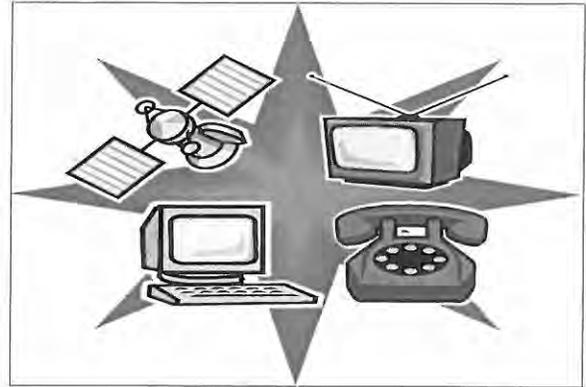
Finding: Hearing aid compatibility and handset amplification decibel range for telephones available for use by the public (for example, in the office) could not be determined by visual inspection.

Full Rec: Determine whether telephones available for use by the public are hearing aid compatible or are equipped with handset amplification. If they are not, modify or replace them with appropriate peripheral devices.

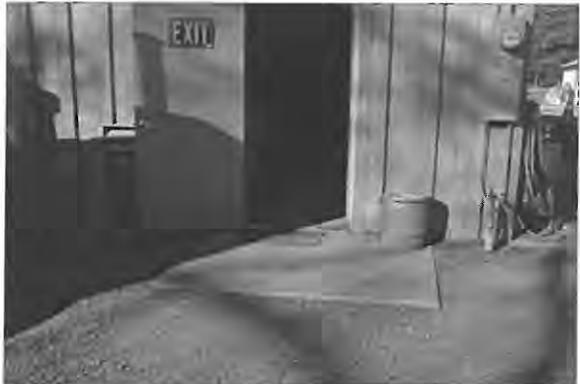
Facility Signage

Finding: The main entrance does not have accessible signage mounted on the wall adjacent to the latch side of the door.

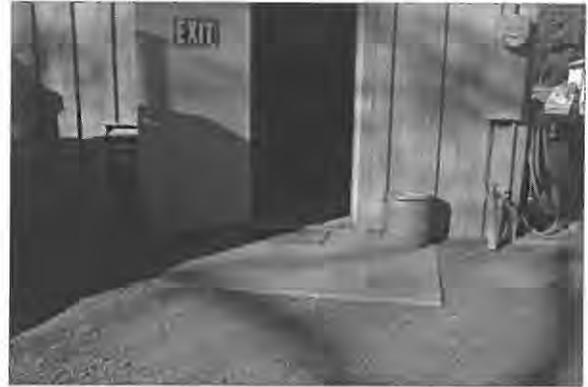
Facility Signage

Finding: There is no signage with the International Symbol of Accessibility on the entrance door to the facility designating it as accessible.

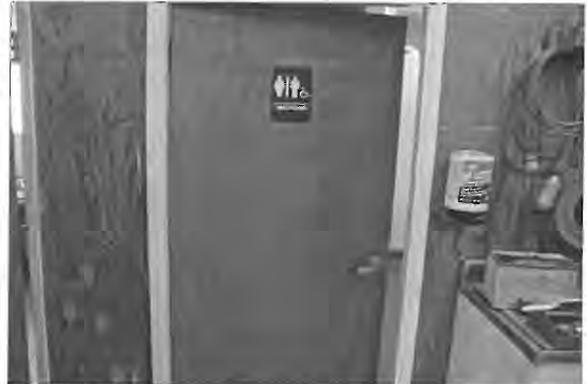
Unisex Restroom in the Shop Area

Finding: There is signage posted on the entry door to the restroom. The signage is not centered 60 inches above the floor on the latch side of the entrance door and does not include the gender use symbols.

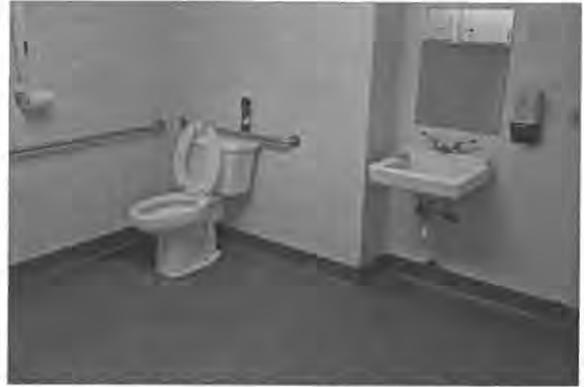
Finding: The toilet paper dispenser in the restroom interferes with the use of the side grab bar.

Full Rec: Remount the toilet paper dispenser in the restroom so that it does not interfere with the use of the side grab bar (see ADAAG 4.16.6 and Figure 29(b)). Toilet paper dispensers must allow continuous paper flow.

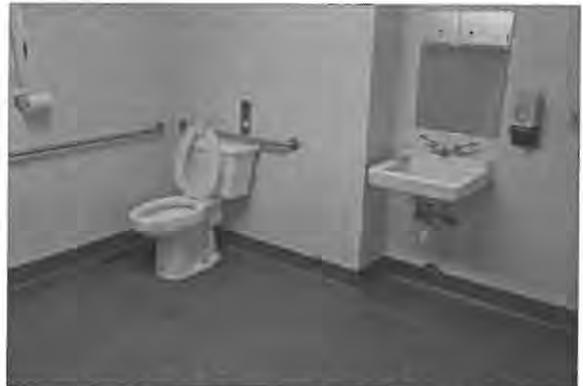
Finding: The flush control on the toilet in the restroom is not on the wide (approach) side of the toilet.

Full Rec: Relocate the flush control on the toilet in the restroom so that it is on the wide (approach) side of the toilet area (see ADAAG 4.16.5). Flush controls shall be hand-operated or automatic mechanisms.

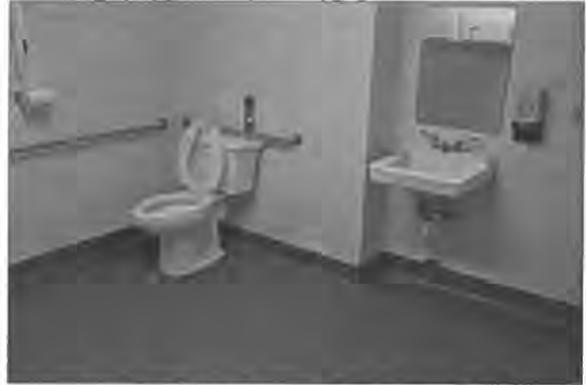
Unisex Restroom in the Shop Area

Finding: The distance from the center of the toilet to the nearest side wall in the restroom is greater than 18 inches.

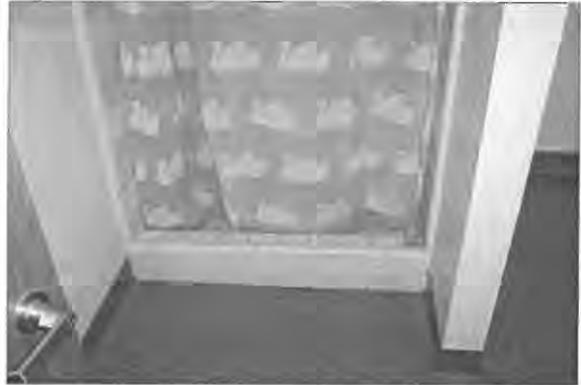
Unisex Restroom in the Shop Area

Finding: There is a shower stall provided in the restroom

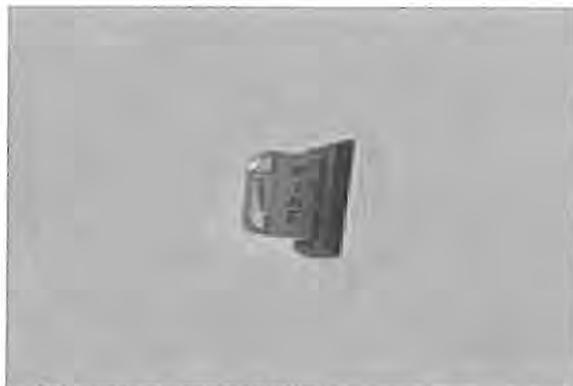
Finding: There are no visual warning devices at the facility.

Full Rec: Install visual warning devices integrated with the facility's alarm system complying with CBC 1114B.2.5, ADAAG 4.1.3(14) and ADAAG 4.28 in all common areas such as hallways, classrooms and general use rooms, and in accessible restrooms and other accessible rooms.

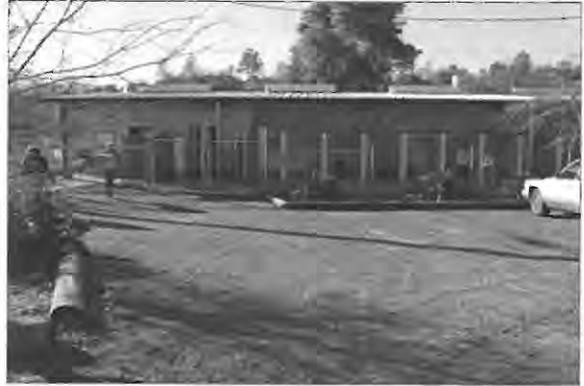
Parking Lot East of the Facility

Finding: Parking is provided east of the facility. There are no striped parking spaces in the parking lot. There are approximately eight parking spaces in the parking lot. There are no accessible parking spaces designated out of the approximate eight parking spaces provided in the parking lot.

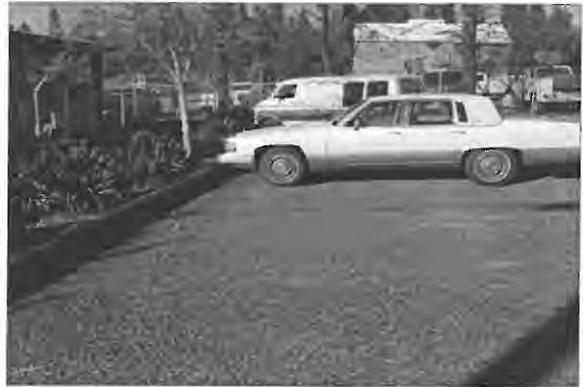
Parking Lot East of the Facility

Finding: Each designated accessible parking space required in the parking lot shall provide a post-mounted sign showing the International Symbol of Accessibility.

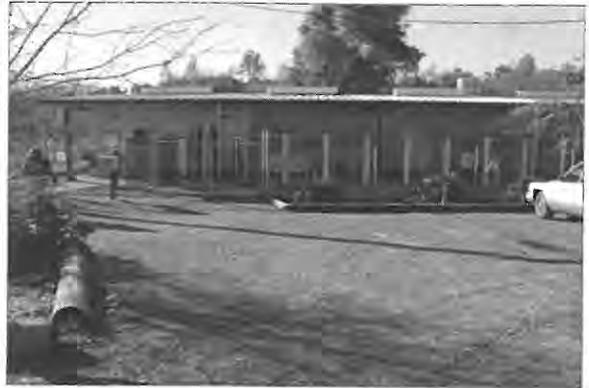
Parking Lot East of the Facility

Finding: There is no warning signage posted regarding unauthorized use of accessible parking spaces in the parking lot.

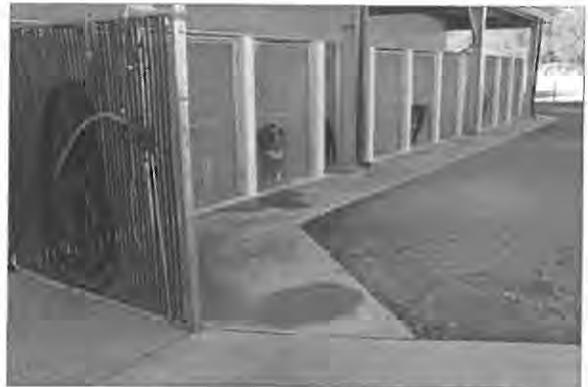
Path of Travel Around the Kennel Area

Finding: The concrete path of travel around the animal kennels is less than 48 inches wide.

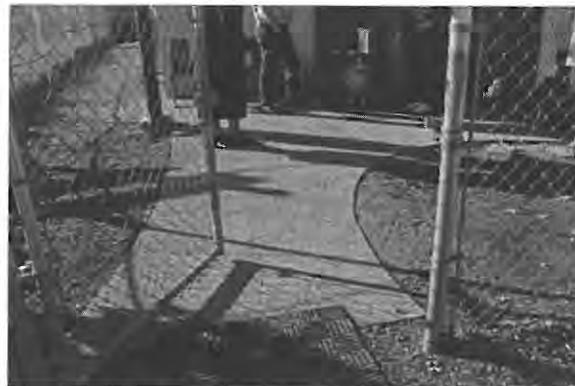
Path of Travel to the Main Entrance

Finding: The path of travel to the main entrance is gravel, preventing access to individuals with mobility impairments.

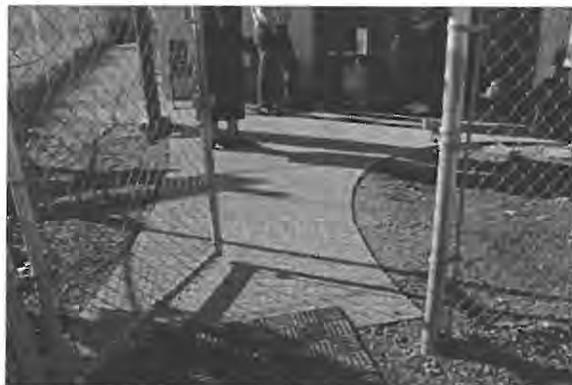
Path of Travel to the Main Entrance

Finding: The gate hardware at the main entrance requires tight grasping, pinching, or twisting of the wrist and is not accessible.

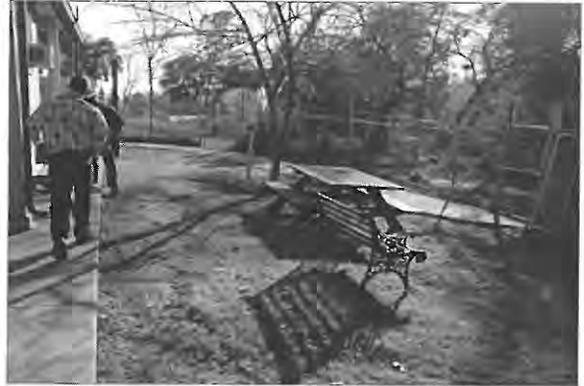
Picnic Table West of the Building

Finding: The path of travel to the picnic table area, west of the building, is grass, preventing access to individuals with mobility impairments.

Alternative Rec: Provide assisted service and transportation to the area where programs, services and activities are held.
(Where Available) Otherwise, relocate those programs, services and activities to an accessible location.

Full Rec: At which time the area is open to the public, the path of travel will be required to be made accessible. At that time, it is recommended that a 48 inch wide path of travel be installed with a firm, stable and slip-resistant surface. Slopes shall not exceed 5% in the direction of travel.

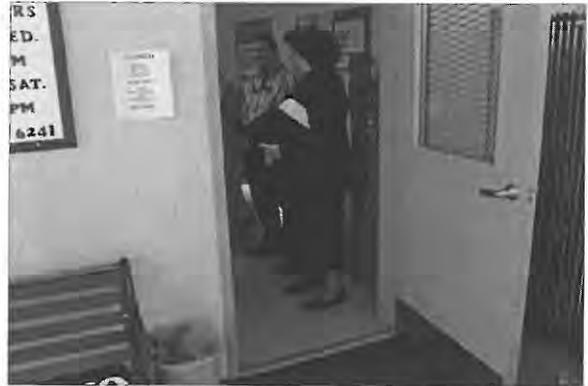
Entrance Door Hardware

Finding: Exterior and interior passage doors provide accessible hardware.

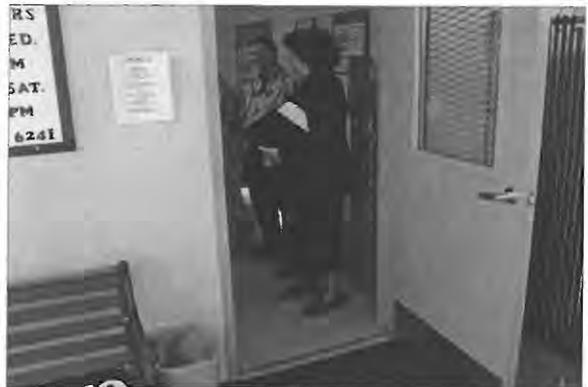
Exterior Doors

Finding: The door opening force for some exterior doors is greater than 8 1/2 pounds of force.

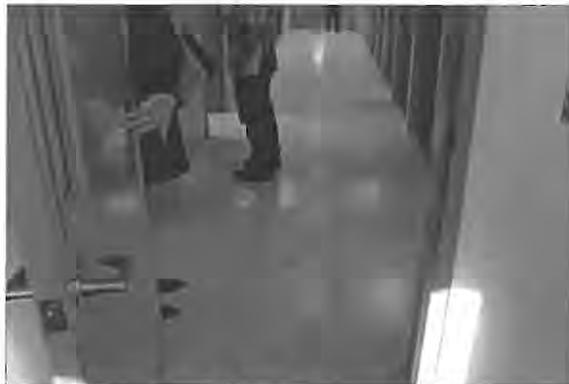
Interior Doors

Finding: The door opening force for some interior doors is greater than 5 pounds of force.

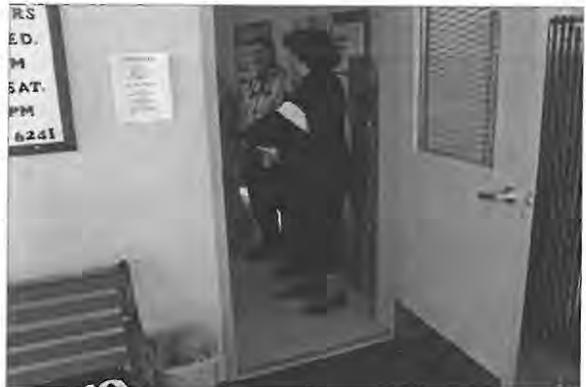
Finding: The main entrance and other common use areas do not have accessible signage mounted on the wall adjacent to the latch side of the door.

Full Rec: Install signage centered at 60 inches above the finished floor on the wall adjacent to the latch side of each entry doorway stating "ROOM" with raised UPPERCASE letters between 5/8 inch and 2 inches in height and Grade 2 Braille characters. The sign shall comply with the finish and contrast requirements set forth in CBC 1117B.5 and ADAAG 4.30.5. Signage should be located where a person may approach within three inches of the sign without encountering protruding objects or standing within the swing of the door.

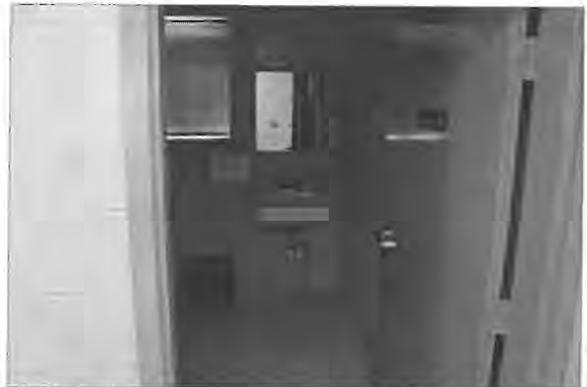
Unisex Restroom in the Main Hallway

Finding: There is no signage indicating accessibility on the latch side of the entry door of the restroom.

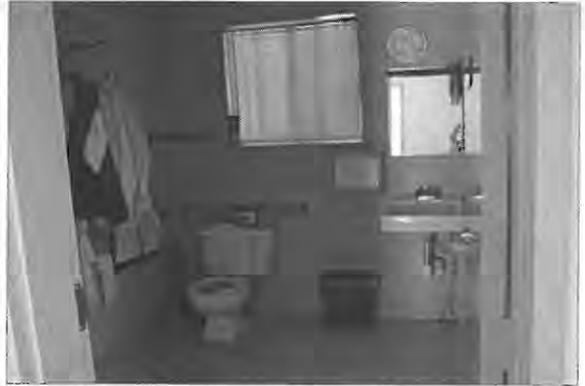
Unisex Restroom in the Main Hallway

Finding: The side grab bar in the restroom does not extend 54 inches from the back wall.

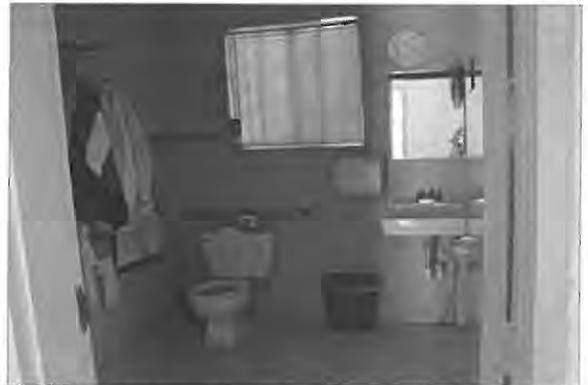
Unisex Restroom in the Main Hallway

Finding: The flush control on the toilet in the restroom is not on the wide (approach) side of the toilet.

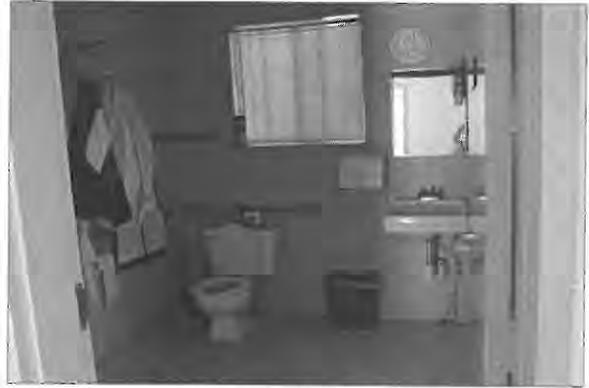
Unisex Restroom in the Main Hallway

Finding: The height of the toilet seat in the restroom is less than 17 inches above the finished floor.

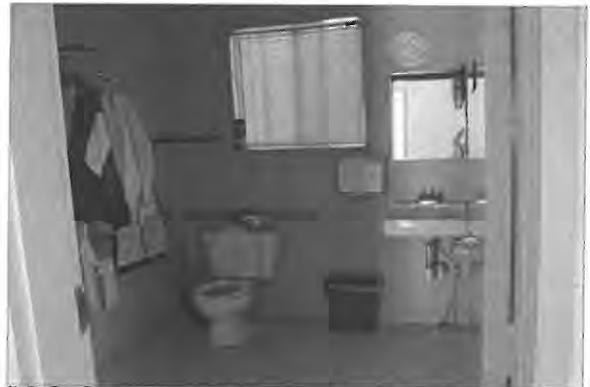
Unisex Restroom in the Main Hallway

Finding: The distance from the center of the toilet to the nearest side wall in the restroom is greater than 18 inches.

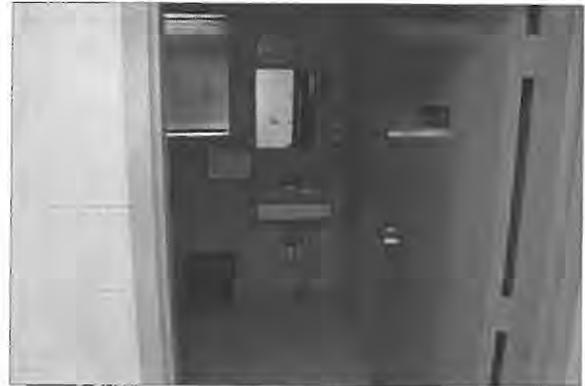
Unisex Restroom in the Main Hallway

Finding: The faucet controls on the lavatory in the restroom require tight grasping, pinching, or twisting of the wrist and are not accessible.

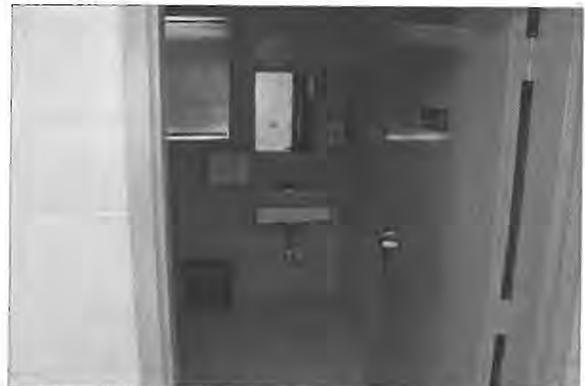
Unisex Restroom in the Main Hallway

Finding: The height of the rim surface of the lavatory designated to be accessible in the restroom is greater than 34 inches above the finished floor.

Citations: ADAAG 4.19.2

Full Rec: Relocate or replace the lavatory designated to be accessible in the restroom to provide a maximum rim surface height of no greater than 34 inches above the finished floor (see ADAAG 4.19.2).

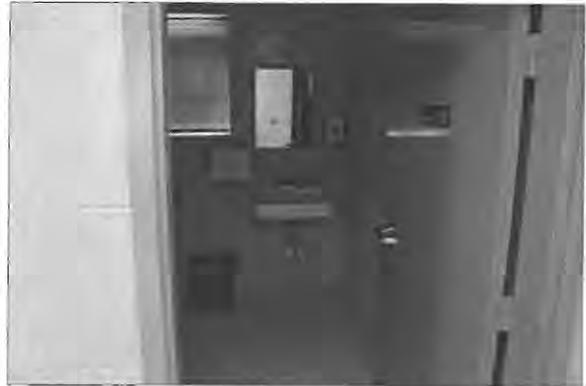
Unisex Restroom in the Main Hallway

Finding: The pipes under the lavatory in the restroom do not provide protection against contact.

Citations: ADAAG 4.19.4

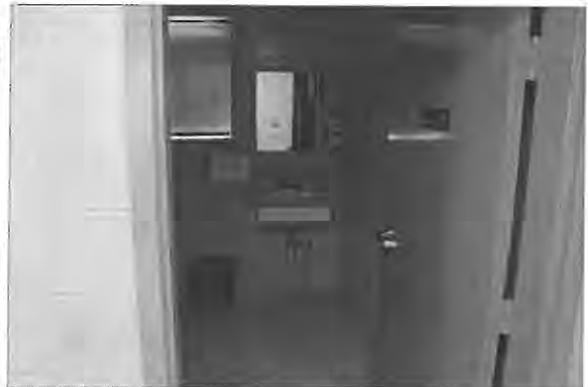
Unisex Restroom in the Main Hallway

Finding: The bottom edge of the reflecting surface of the mirror in the restroom is greater than 40 inches above the finished floor.

Citations: ADAAG A4.19.6; CBC 1115B.9.1.2; ADAAG 4.19.6

Full Rec: Lower the mirror in the restroom so that the bottom edge of the reflecting surface is no higher than 40 inches above the finished floor and the topmost portion of the reflecting surface extends at least 74 inches above the finished floor (see ADAAG A4.19.6). A single, full-length mirror is recommended since it can accommodate all people. Make certain to provide a minimum clear floor space in front of the mirror of 30 inches in width and 48 inches in length.

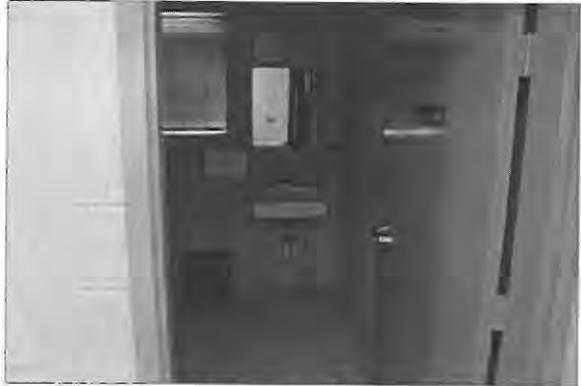
Unisex Restroom in the Main Hallway

Finding: The height of the controls and operating mechanisms for the soap dispenser in the restroom is greater than 40 inches above the finished floor.

Citations: CBC 1115B.9.2; ADAAG A4.27

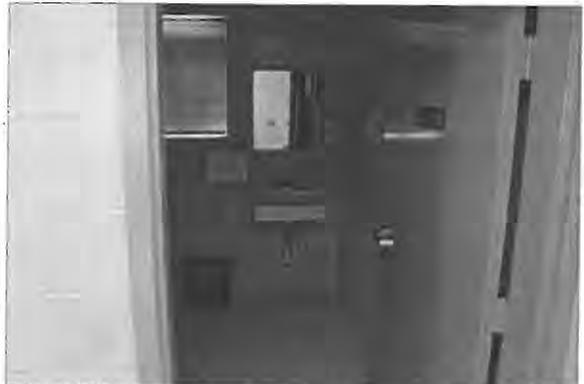
Unisex Restroom in the Main Hallway

Finding: The controls and operating mechanisms on the paper towel dispenser in the restroom require tight grasping, pinching, or twisting of the wrist and the use of two hands to operate. The height of the operating controls on the dispenser is greater than 40 inches above the finished floor.

Citations: ADAAG 4.27.4, CBC 1117B.6.4

Full Rec: Modify or replace the paper towel dispenser in the restroom so that its controls and operating mechanisms can be operated with one hand and comply with ADAAG 4.27.4 and CBC 1117B.6.4. Make certain that the force to activate the operating controls shall be no greater than 5 pounds and that the height shall be no greater than 40 inches above the finished floor.

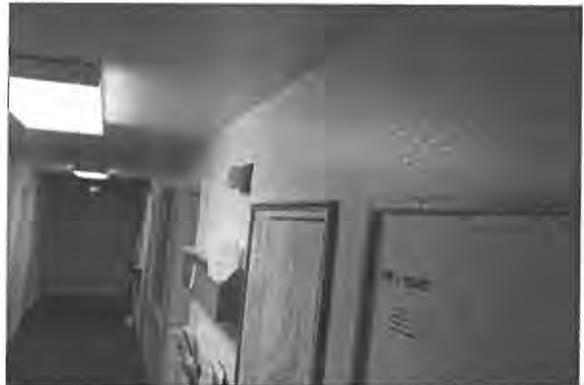
Finding: There are no visual warning devices at the facility.

Alternative Rec: Altering a facility's programs, or addressing higher priority barriers can reduce or eliminate the need for an area of rescue assistance, such as making certain that an individual with a disability participates in programs located near an already accessible exit. Otherwise creating an accessible exit can provide an acceptable alternative to providing an area of rescue assistance.

Full Rec: Install visual warning devices integrated with the facility's alarm system complying with CBC 1114B.2.5, ADAAG 4.1.3(14) and ADAAG 4.28 in all common areas such as hallways, classrooms and general use rooms, and in accessible restrooms and other accessible rooms.

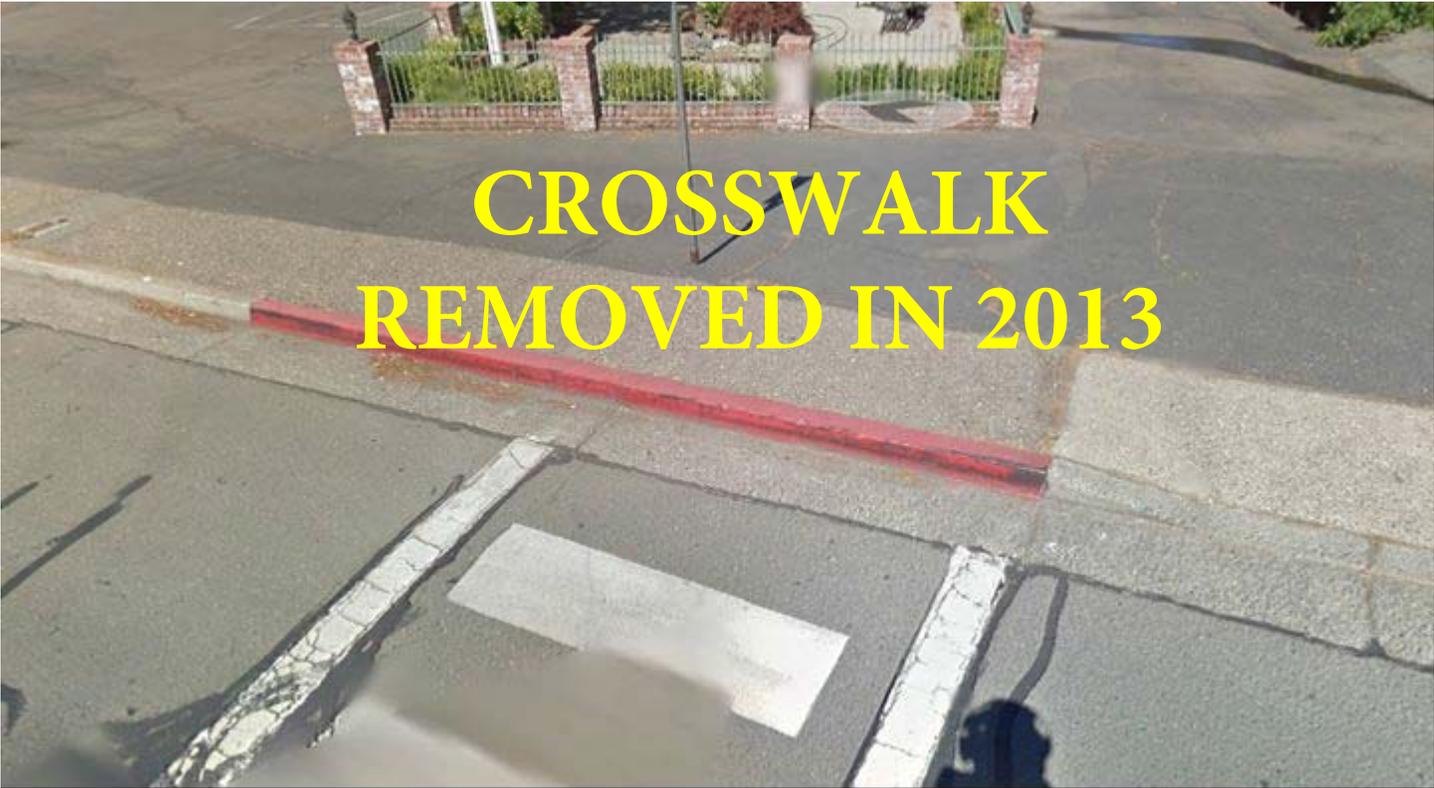
- Skyway Crosswalk at Terry Ashe Park North End ES Berry

**CROSSWALK
REMOVED IN 2013**
